Environmental Impact Assessment Report

Appendix 16.2

Dublin Port 3FM Archaeo-geophysical survey report

October & November 2022

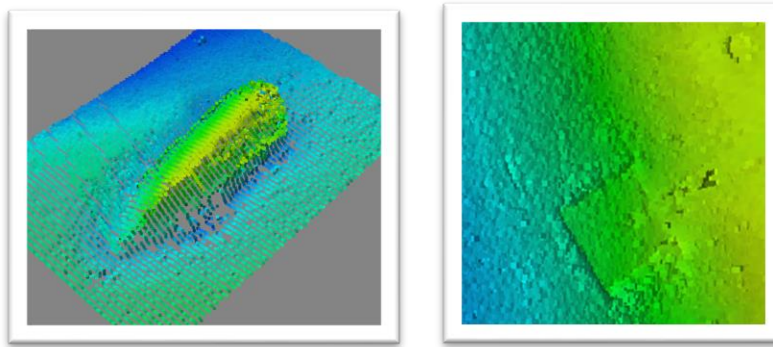
Figure 5 shows example of the multibeam data for Zone 1 and 2, corresponding to a sunken boat (left) and to an anchor block (right).

Figure 5: MBES data from Zone 1 (left showing a wreck) and for Zone 2 (right showing an anchor block)

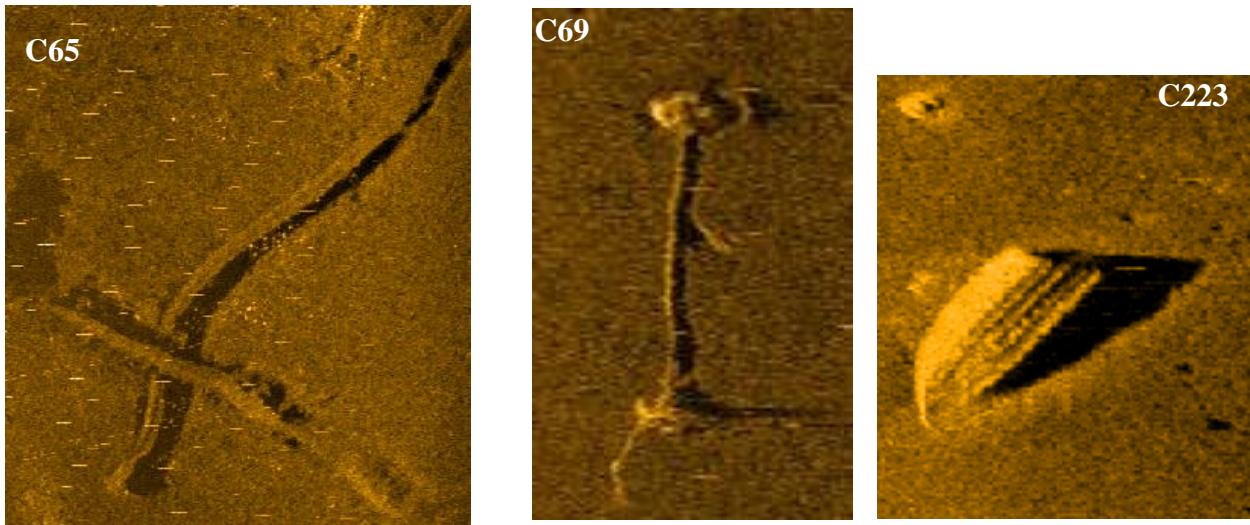
Figure 7: Pictures of sonar contacts C65 (Dredging marks), C69 (Mooring with a chain), and C223 (Wreck).

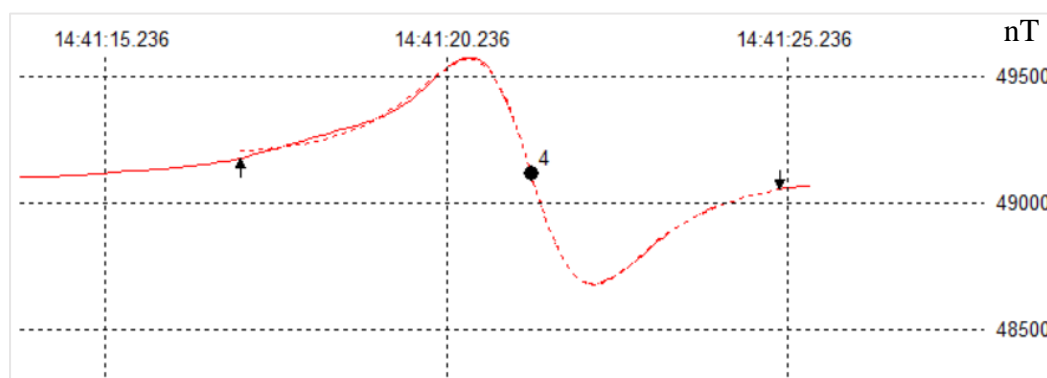
Figure 10 presents the magnetic anomalies of 824 nT recorded for target 18. The vertical axis corresponds to the magnetic Amplitude in nT.

Figure 10: Target 18 magnetic anomalies recorded. Horizontal axis is the time, vertical axis is the magnetic amplitude in nT

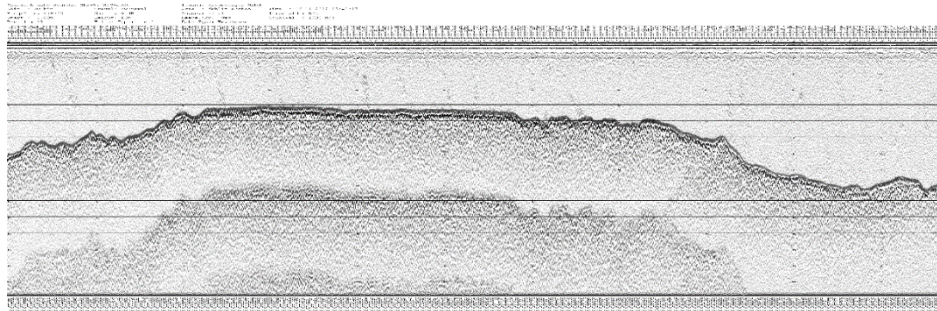
The seabed is at a depth of about 10 m in the western part of zone 1, and shallows to 4-6 m in an eastward direction. There is very little acoustic penetration beyond the seabed. This lack of penetration has been interpreted as being the result of a sediment layer with high Organic matter content, at, or just below the surface. This layer is about 0.3- 0.5 m in thickness in most Zones. Organic matter causes air bubble to be present in the sediment and these bubbles are impenetrable to sound. This results in acoustic blanking rendering any seismic Units below such a layer invisible (Figure 11).

Figure 11: Example seismic profile from zone 1 showing a sediment layer immediately below the surface.

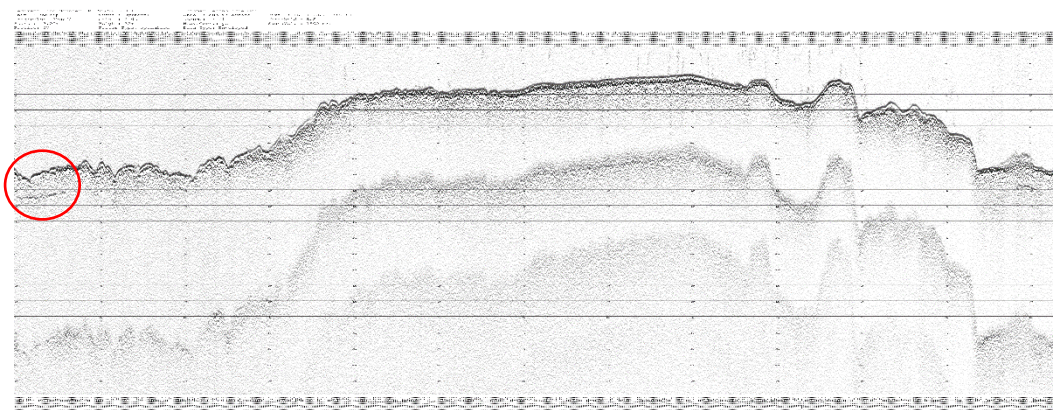
Penetration occurs to a depth of about 1.5 m below the seabed (bsd) in the western Zone part of zone 1. This might be due to reduced Organic matter content in the surface layer (Figure 12).

Figure 12: Example seismic profile from zone 1 showing a sediment layer immediately below the surface and penetration on of about 1.5 m in on the right (red circle) (west).

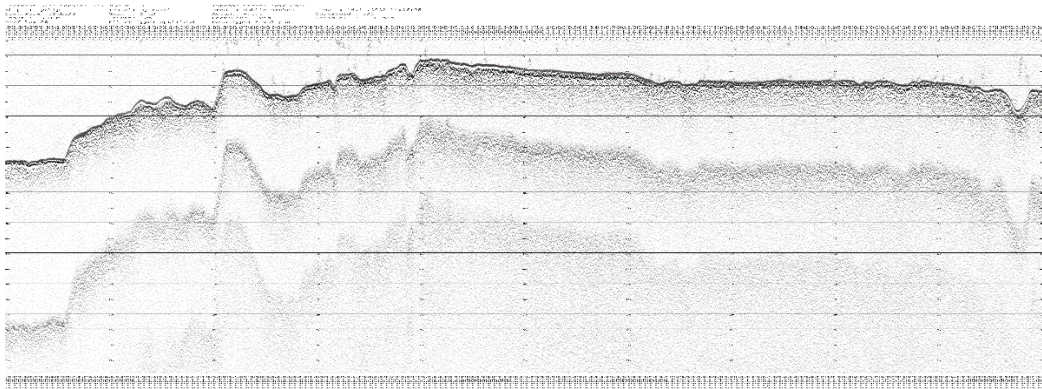
The seabed in zone 2 is between 5 and 12 m in depth and there is very little acoustic penetration beyond the seabed. This lack of penetration has been interpreted as being the result of a sediment layer with high organic matter content, at, or just below the surface. This layer is about 0.3 – 0.5 m in thickness. Organic matter causes air bubble to be present in the sediment and these bubbles are impenetrable to sound. This results in acoustic blanking rendering any seismic units below such a layer invisible (Figure 13).

Figure 13: Example seismic profile from zone 2 showing a sediment layer immediately below the surface.

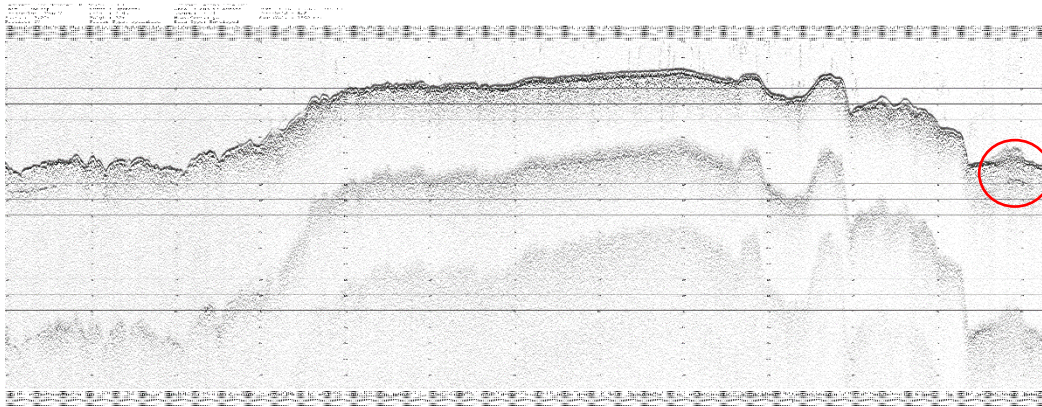
Penetration occurs to a depth of about 1.5 m bsd in the easternmost part of zone 2. Reduced penetration might be due to gas from organic matter content at the surface which is common in silt areas (Figure 14).

Figure 14: Example seismic profile from zone 2 showing a sediment layer immediately below the surface and penetration on of about 1.5 m on the left (red circle) (east).

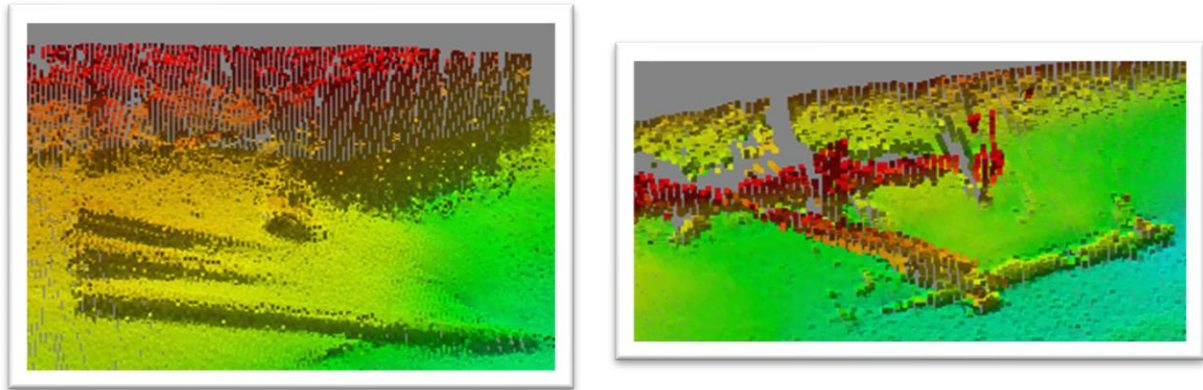
Figure 17 shows example of the multibeam data for Zone 3 and 4, corresponding to three long debris lying down over the seabed (left) and to a broken pontoon in pigeon house harbour (right).

Figure 17: MBES data from Zone 3 (left long debris) and from Zone 4 (broken pontoon)

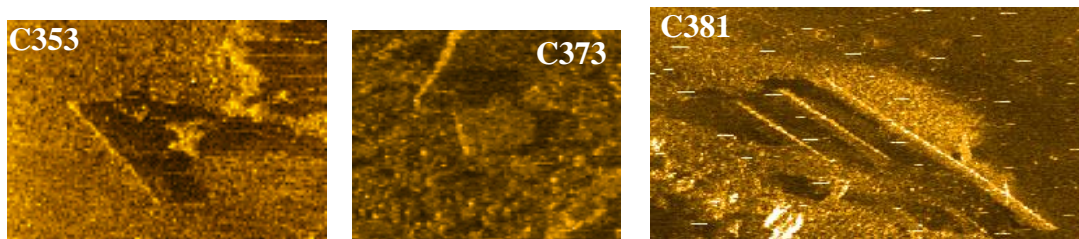
Figure 19: Picture of sonar contacts C353 (Long NI debris), C373 (Anchor block with rope), and C381 (3 long NI debris).

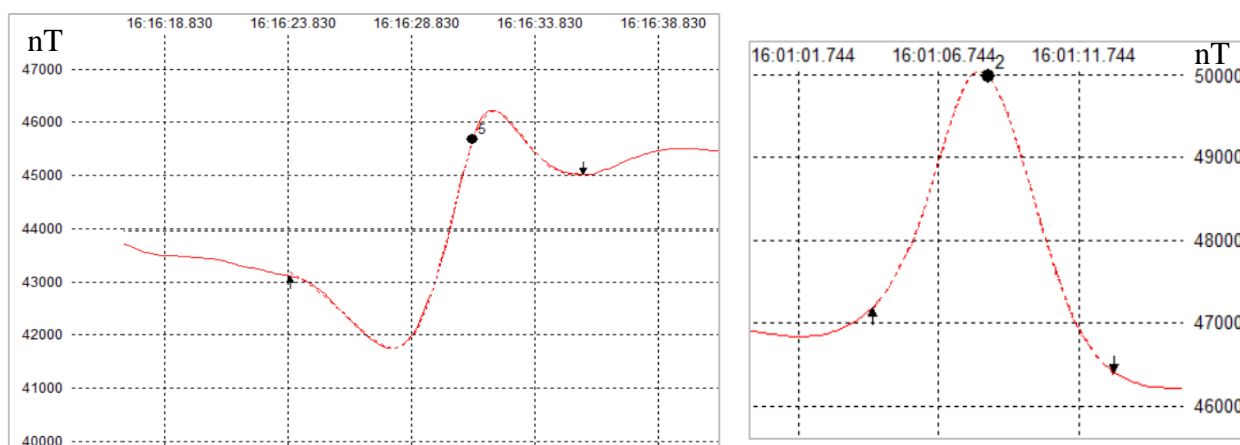
Figure 21 presents the magnetic anomalies of 3811 nT recorded for target 48 (Zone 3) on the left, and of 4906 nT recorded for target 38 (zone 4) on the right. The vertical axis corresponds to the magnetic Amplitude in nT.

Figure 21: Magnetic anomaly 48 on the left, and magnetic anomaly 38 on the right.. Horizontal axis is the time, vertical axis is the magnetic amplitude in nT

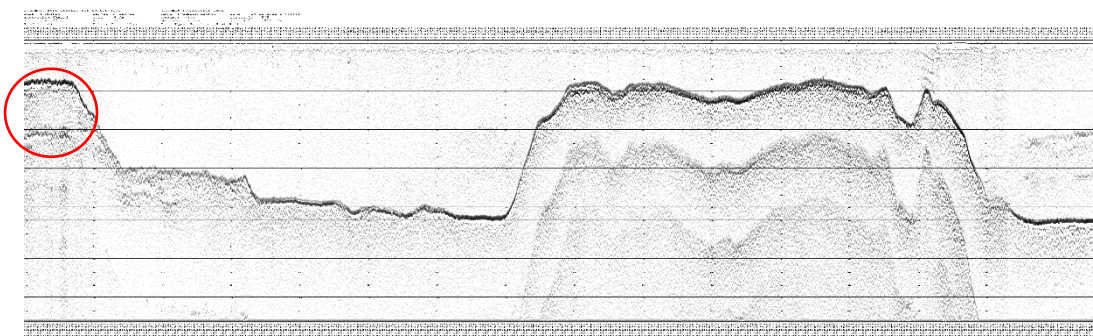
Towards the east of the survey Zone, it is possible to see a layer at a depth of approximately 2 – 3 m bsl. This layer is similar in character to the shallow layers visible in zones 1, 2 & and the western part of zone 3. It is interpreted to be comprised largely of organic rich sediment, resulting in the blanking of any subsequent layers.

Figure 23: Example seismic profile from zone 3 showing a sediment layer immediately below the surface and deeper layer on the right (red circle) (east)

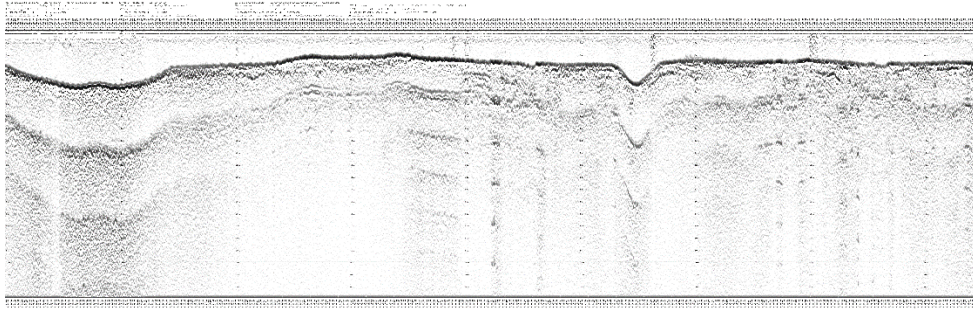
The seabed in zone 4 is 3-5 m in depth with a layer of what is thought to be organic rich sediment about 0.5-1 m in thickness immediately below the surface. Any subsequent layers were not visible due to the acoustic impenetrability (Figure 24).

Figure 24: Example seismic profile from zone 4 showing a sediment layer immediately below the surface.
