**Underwater Archaeological Impact Assessment (UAIA)
ADCOCO Areas 1-4, River Liffey, Dublin Port**

**Dublin Port 3FM Project
Project Reference CP1770_021**

Final Report
Client
Project Director

29 May 2024
RPS for DPC
Rex Bangerter MA

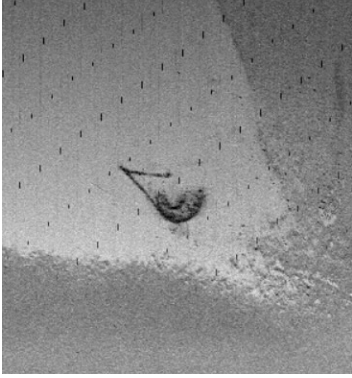
| Target No. | Coordinates [ITM] | Interpretation [ADCO] | Correlation [Hydromaster] | Side-scan Sonar Image | Underwater Inspection [ADCO] |
|---|---|---|---|--|--|
| SS_04 | 720486E, 733997N | Tyre 2.8m in diameter, half buried with linear feature extending from it; probably a mooring. Recorded several times. | H331 (debris). | | Target located close to mooring for Buoy No. 16 (mooring buried, but large steel ring and mooring bridle visible). Image shows probable tractor tyre, re-sued as a mooring. Feature likely buried in the deep deposit (c. 600mm) of silt that comprises the upper stratum of riverbed within this area. Probing carried out across this area, but object not encountered. |

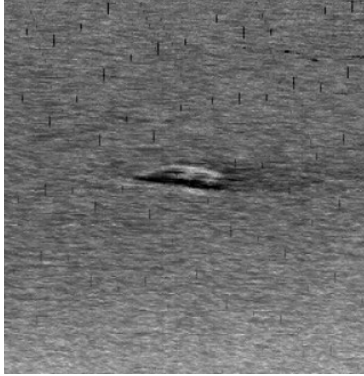
| Target No. | Coordinates [ITM] | Interpretation [ADCO] | Correlation [Hydromaster] | Side-scan Sonar Image | Underwater Inspection [ADCO] |
|---|---|---|--|---|--|
| SS_10 | 718635E, 734175N | Short linear feature, 400mm in length. | H141 (boulder). | | No object encountered at target location, likely to be mobile item (tree-debris) that is no longer present. |

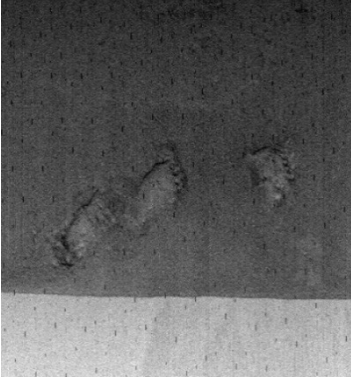
| Target No. | Coordinates [ITM] | Interpretation [ADCO] | Correlation [Hydromaster] | Side-scan Sonar Image | Underwater Inspection [ADCO] |
|---|---|--|---|--|--|
| SS_16 | 721226E, 734058N | Series of three (3) gridded features measuring 2.2m in width by 4m length. Possibly associated with anchoring for the Tern colony. | Not highlighted in Hydromaster survey, but located 6m east of magnetic anomaly. | | No object encountered at this location. However, riverbed is disturbed; irregular formation (clumps and ridges) present. Seabed is composed of deep deposit of silty-clay (>500mm penetration). |

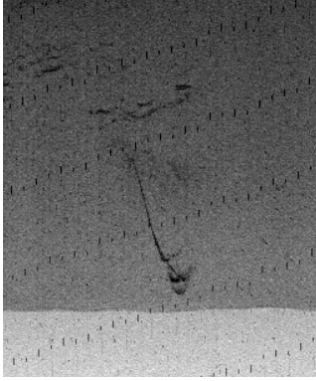
| Target No. | Coordinates [ITM] | Interpretation [ADCO] | Correlation [Hydromaster] | Side-scan Sonar Image | Underwater Inspection [ADCO] |
|---|---|--|---|--|--|
| SS_17 | 721406E, 734056N | Linear feature, possible anchor clump. | Not highlighted in Hydromaster survey; no other anomaly close by. | | Mooring line and steel-ring (attached to buried mooring block) rising to Buoy No. 14. Seabed is composed of deep deposit of silty-clay (>500mm penetration). |

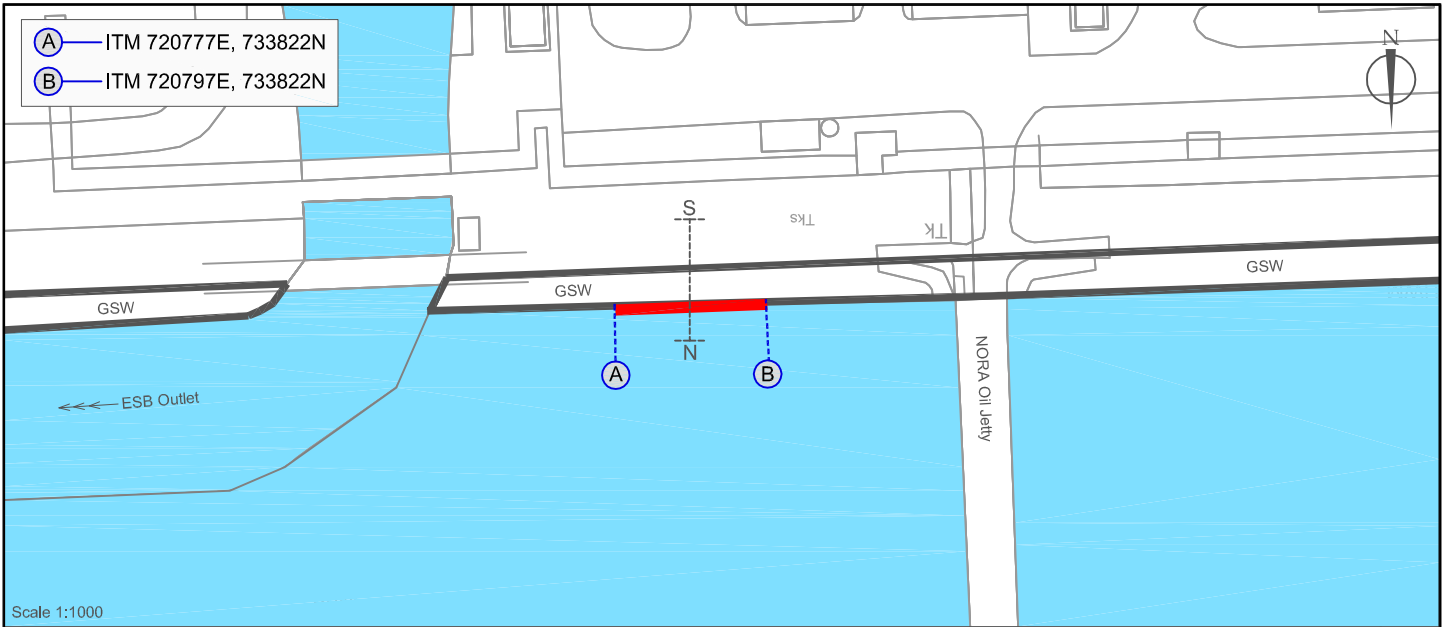
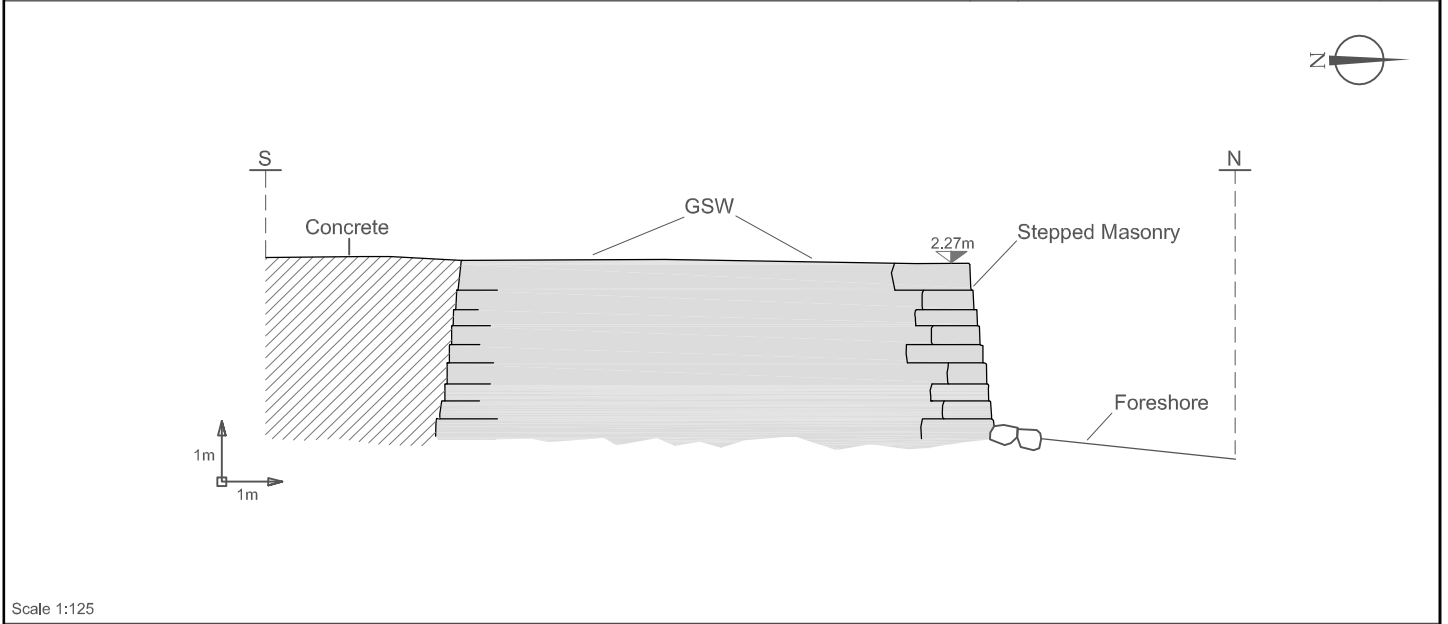
| | Notes - ADCO Laser-scan Survey undertaken 07/09.04.23 and 16-17.05.23. - All levels referenced to Malin Head OD. | | | Title Figure 28- Sample Cross-section and Elevation, Great South Wall, Area 4 (GSW-W3); ITM 720787E, 733822N (centrepoint). [see Figures 43-44 for laserscan imagery of area] | | | |

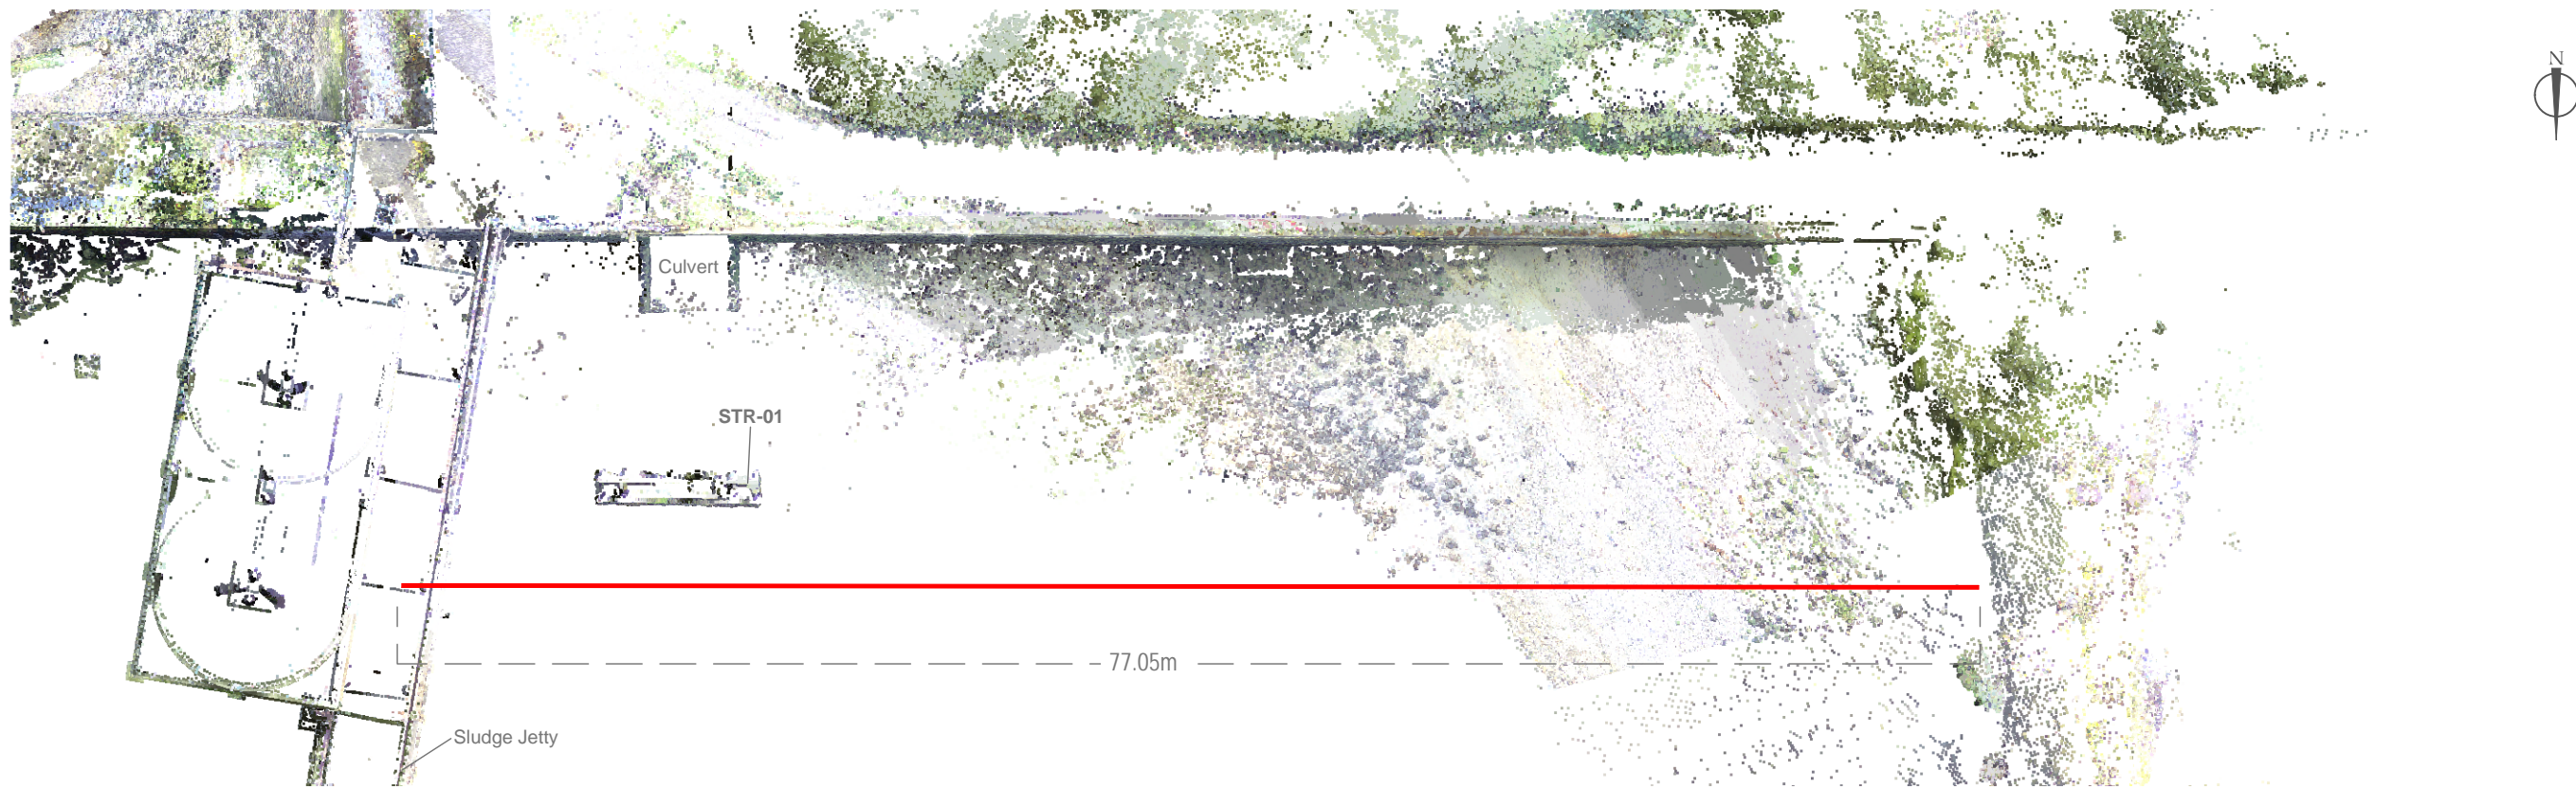
— Scan Extent [Elevation]
 PLAN
 Feature F02 - West
 Scale 1:300

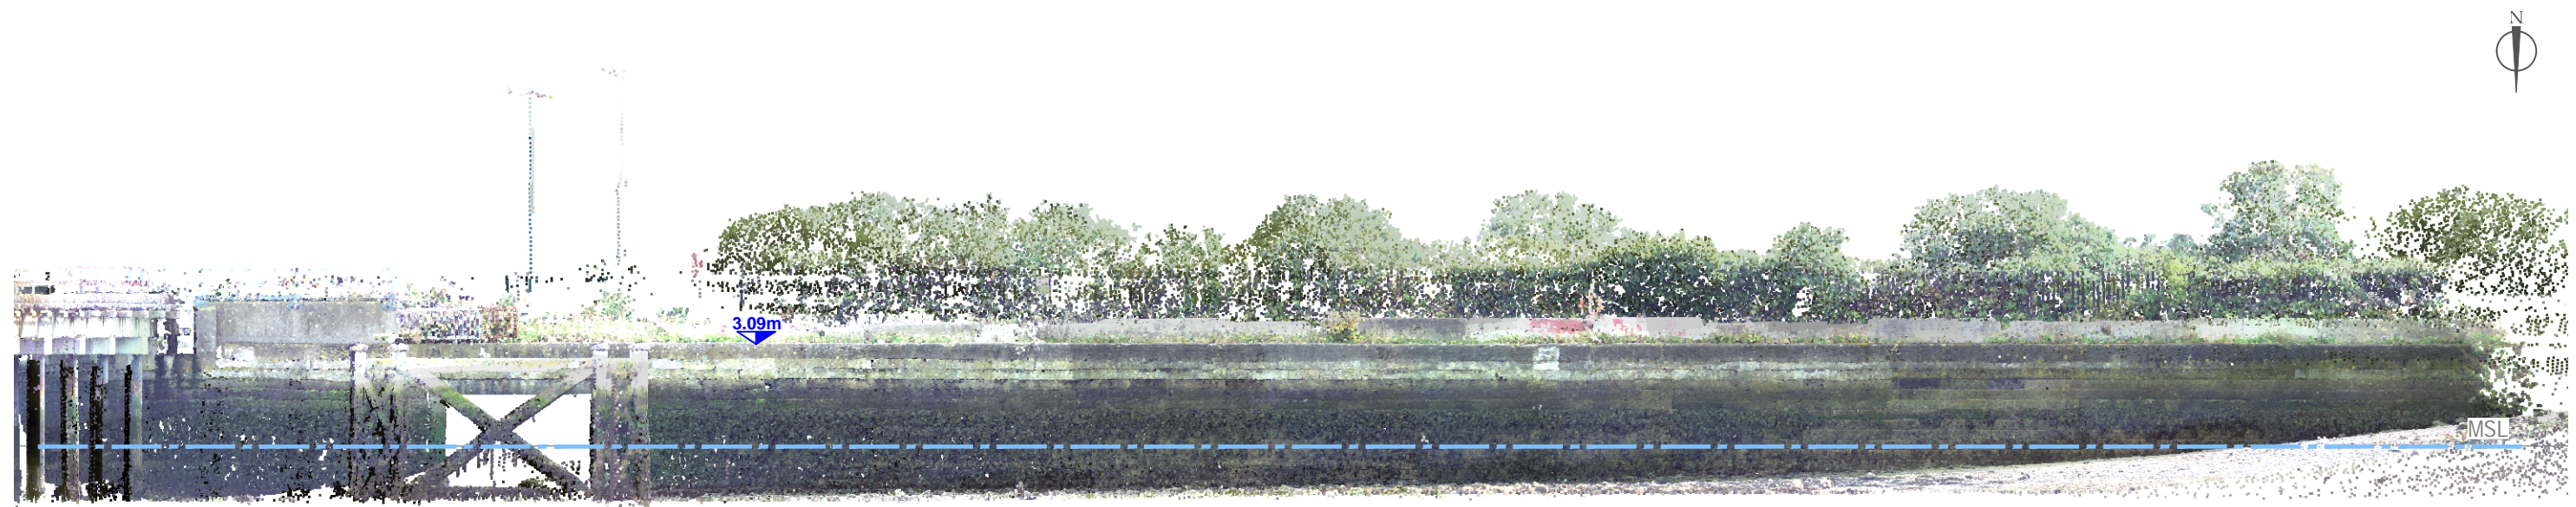
ELEVATION
 Feature F02 - West Section
 Scale 1:200

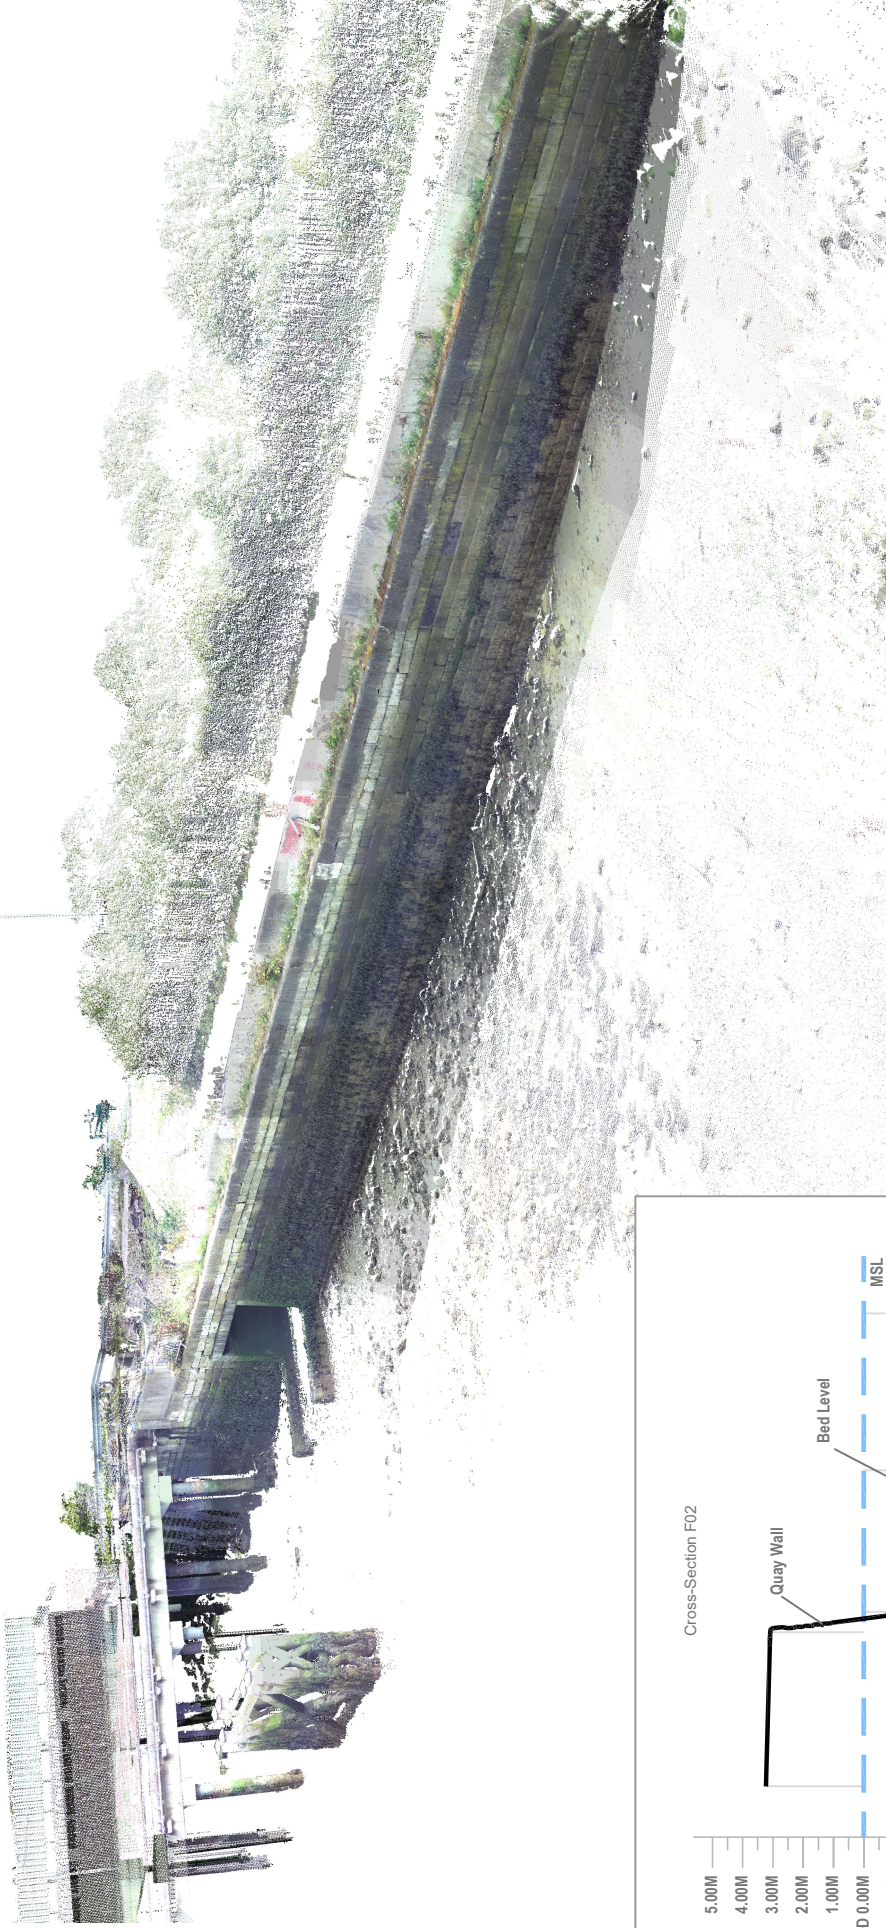
PERSPECTIVE VIEW
Feature F02 - West Section
NTS

Title
 Figure 30 - Point Cloud Plan and Elevation, Feature F02, quay wall to west of Sludge Jetty, ADCO Survey Area 2. [See Figure 31 for Perspective View]

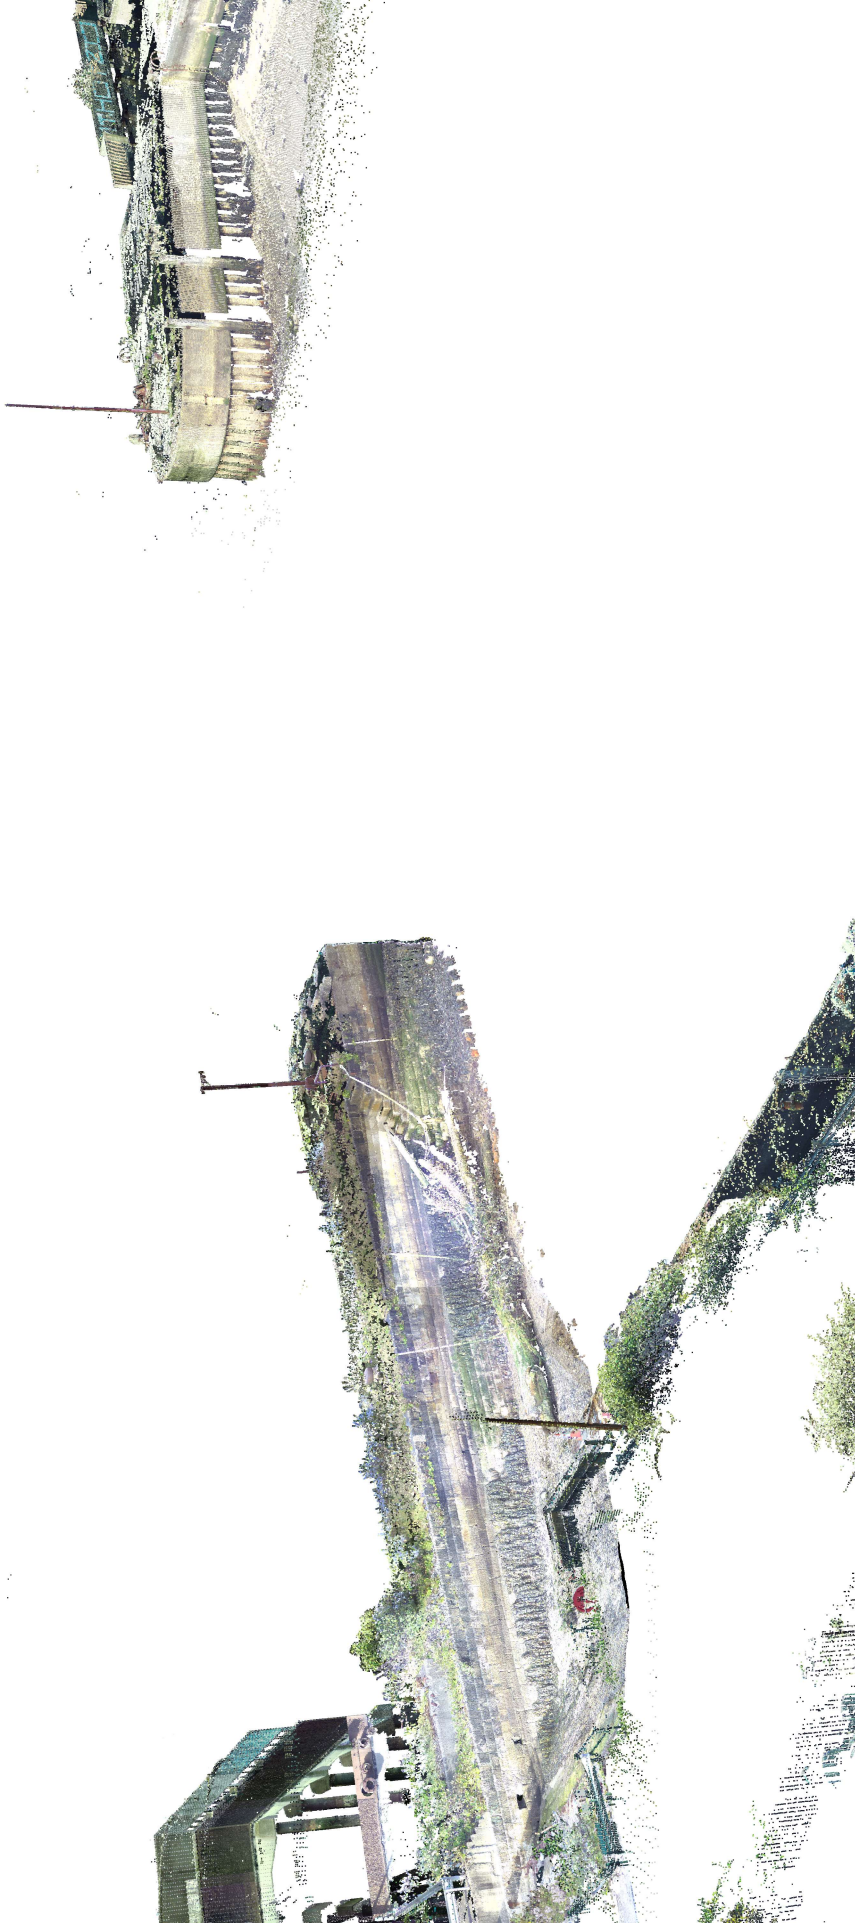
Title
 Figure 35 - Point Cloud Perspective View,
 Feature F02, Quay Wall at entrance 3 to Pigeon
 House Harbour, ADCO Survey Area 3.

PERSPECTIVE VIEW
 Feature F02 – Internal Section
 NTS

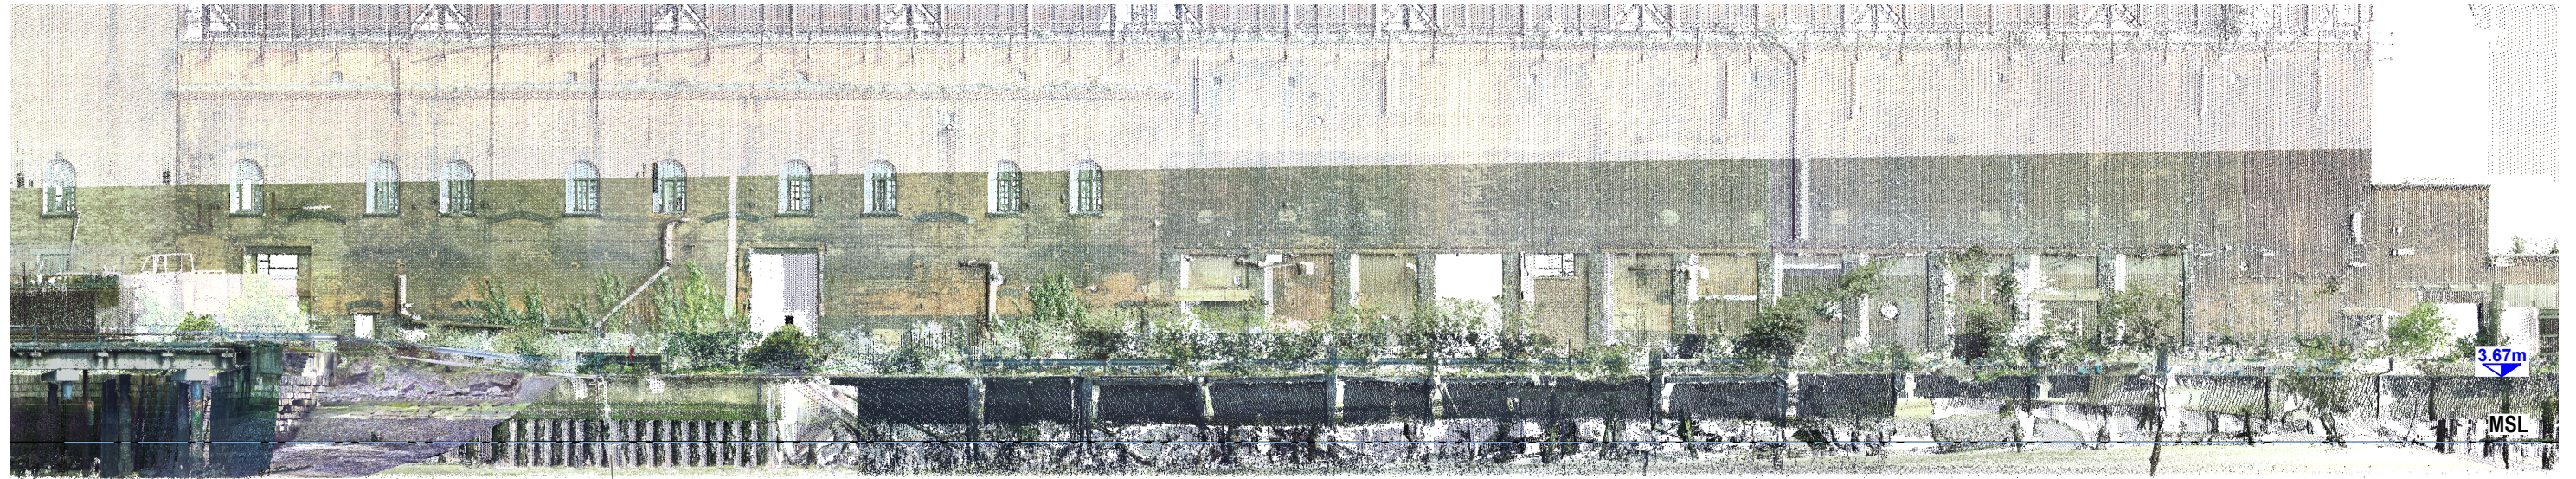
ELEVATION
Feature F03 - East Section
Scale 1:300

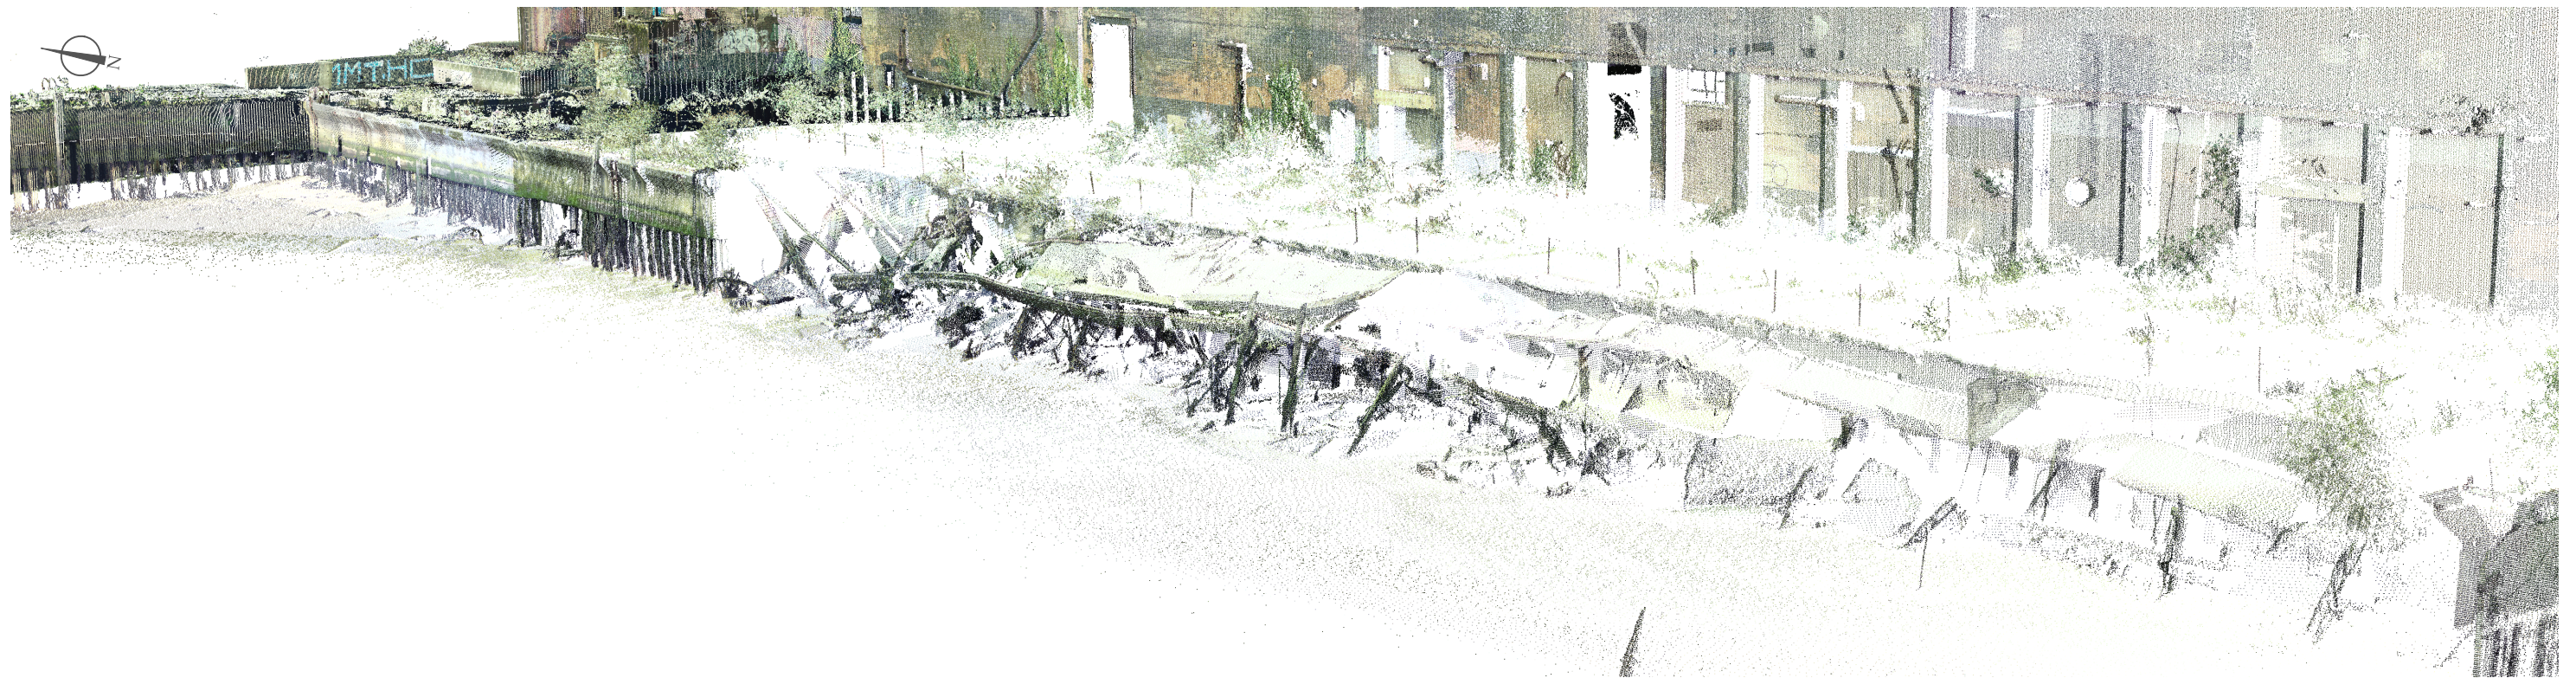
Feature F03
[quay wall located behind collapse]

PERSPECTIVE VIEW
Feature F03 - East Section
NTS

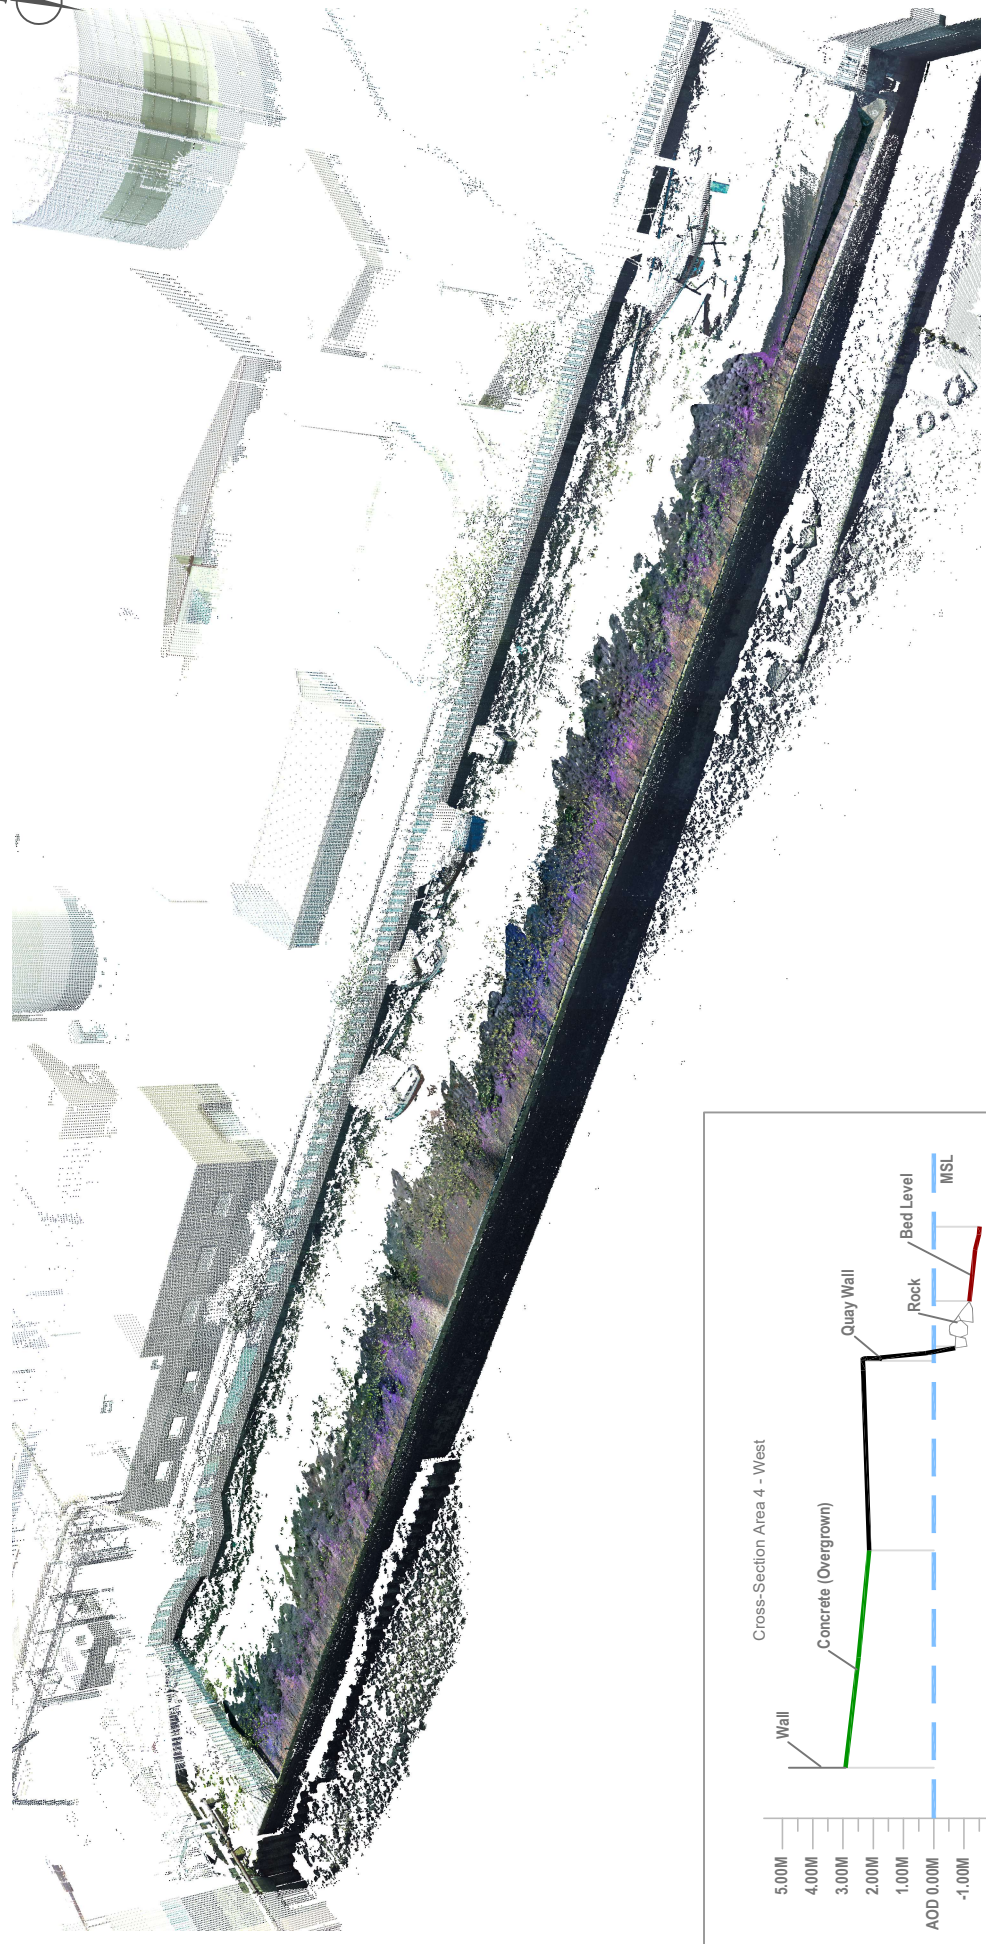
Title
Figure 38 - Point Cloud Perspective View, Great South Wall, ADCO Survey Area 4 [West].

PERSPECTIVE VIEW
GSW - Area 4 - West
NTS

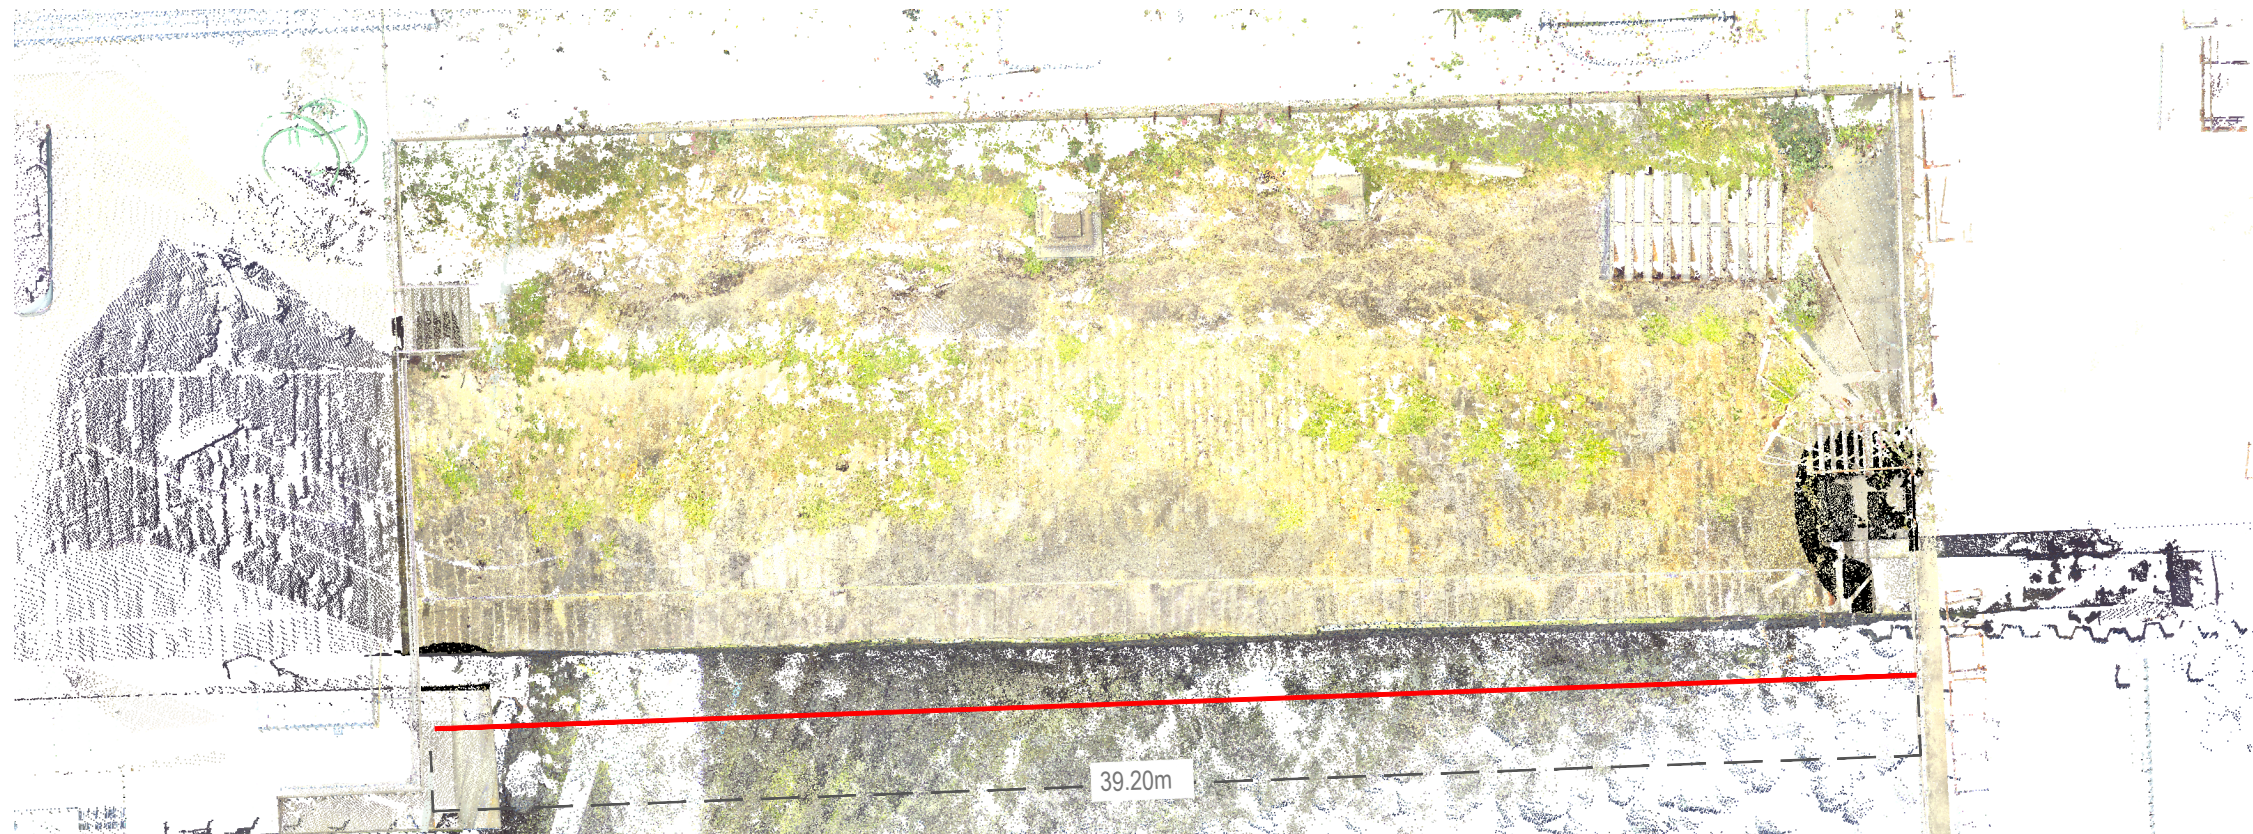
PLAN
 GSW - Area 4 - West 1
 Scale 1:200

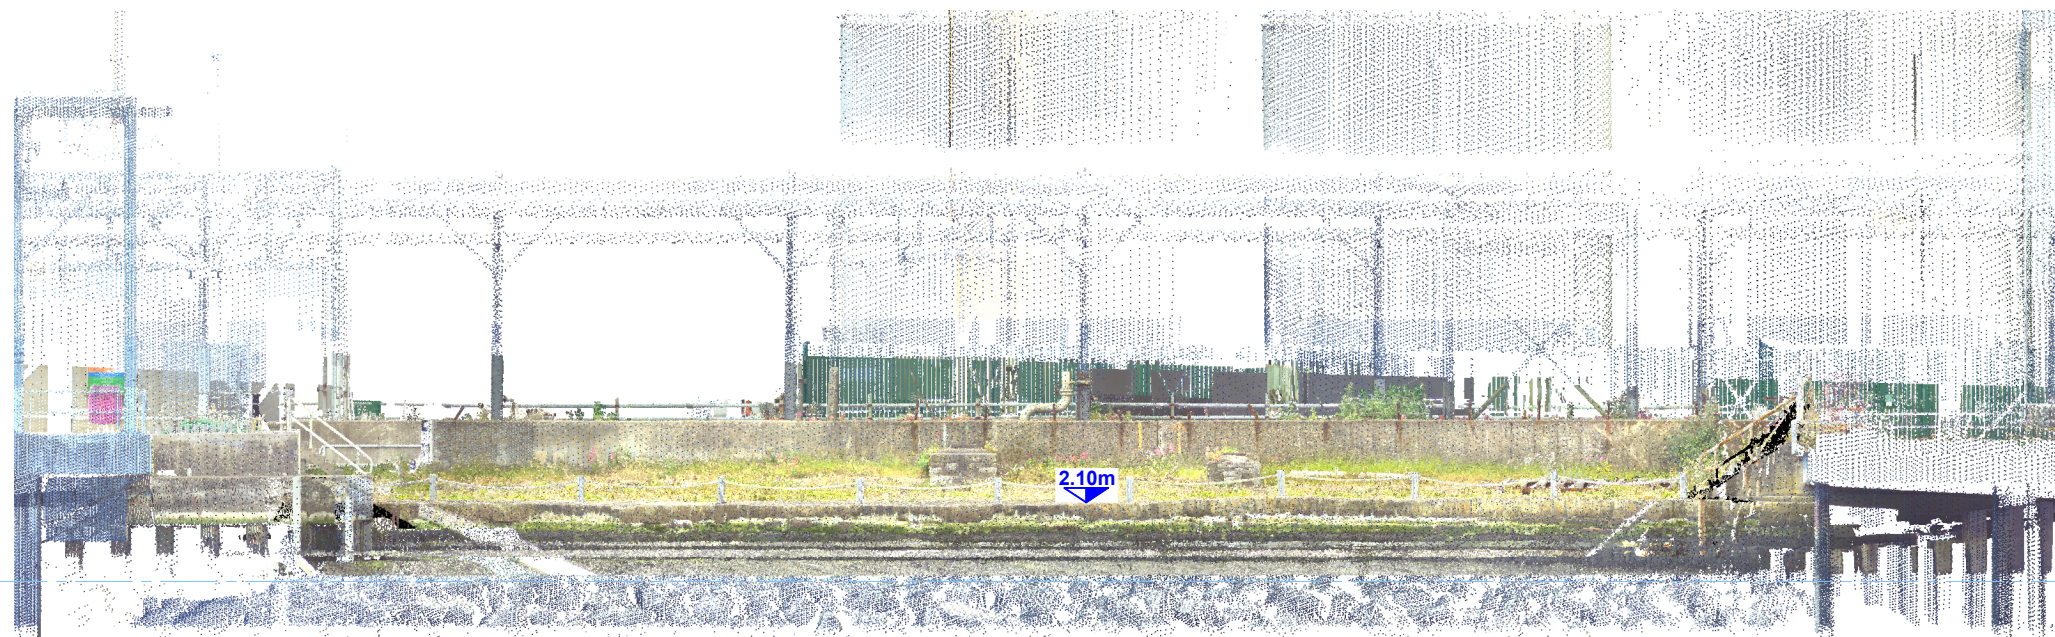
ELEVATION
 GSW - Area 4 - West 1
 Scale 1:200

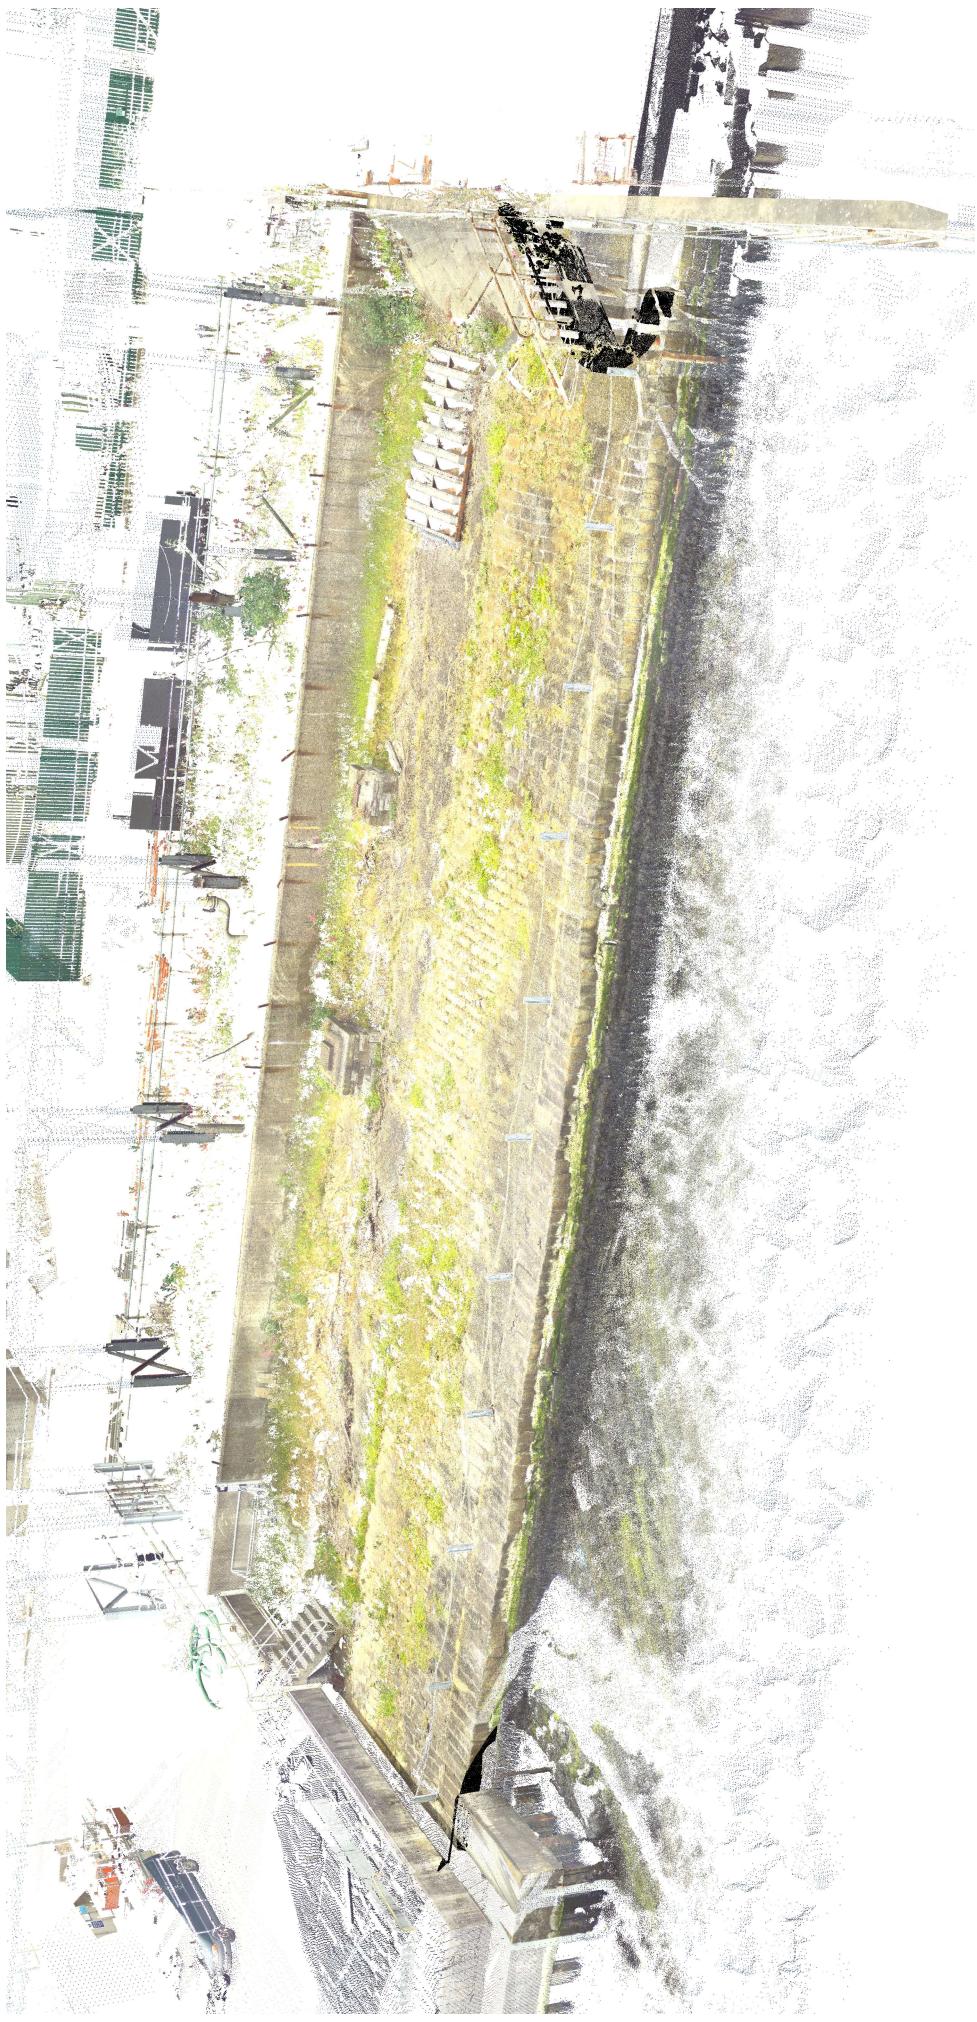
Title
 Figure 40 - Point Cloud Perspective View, Great South Wall, ADCO Survey Area 4 [West 1]

PERSPECTIVE VIEW
 GSW - Area 4 - West 1
 NTS

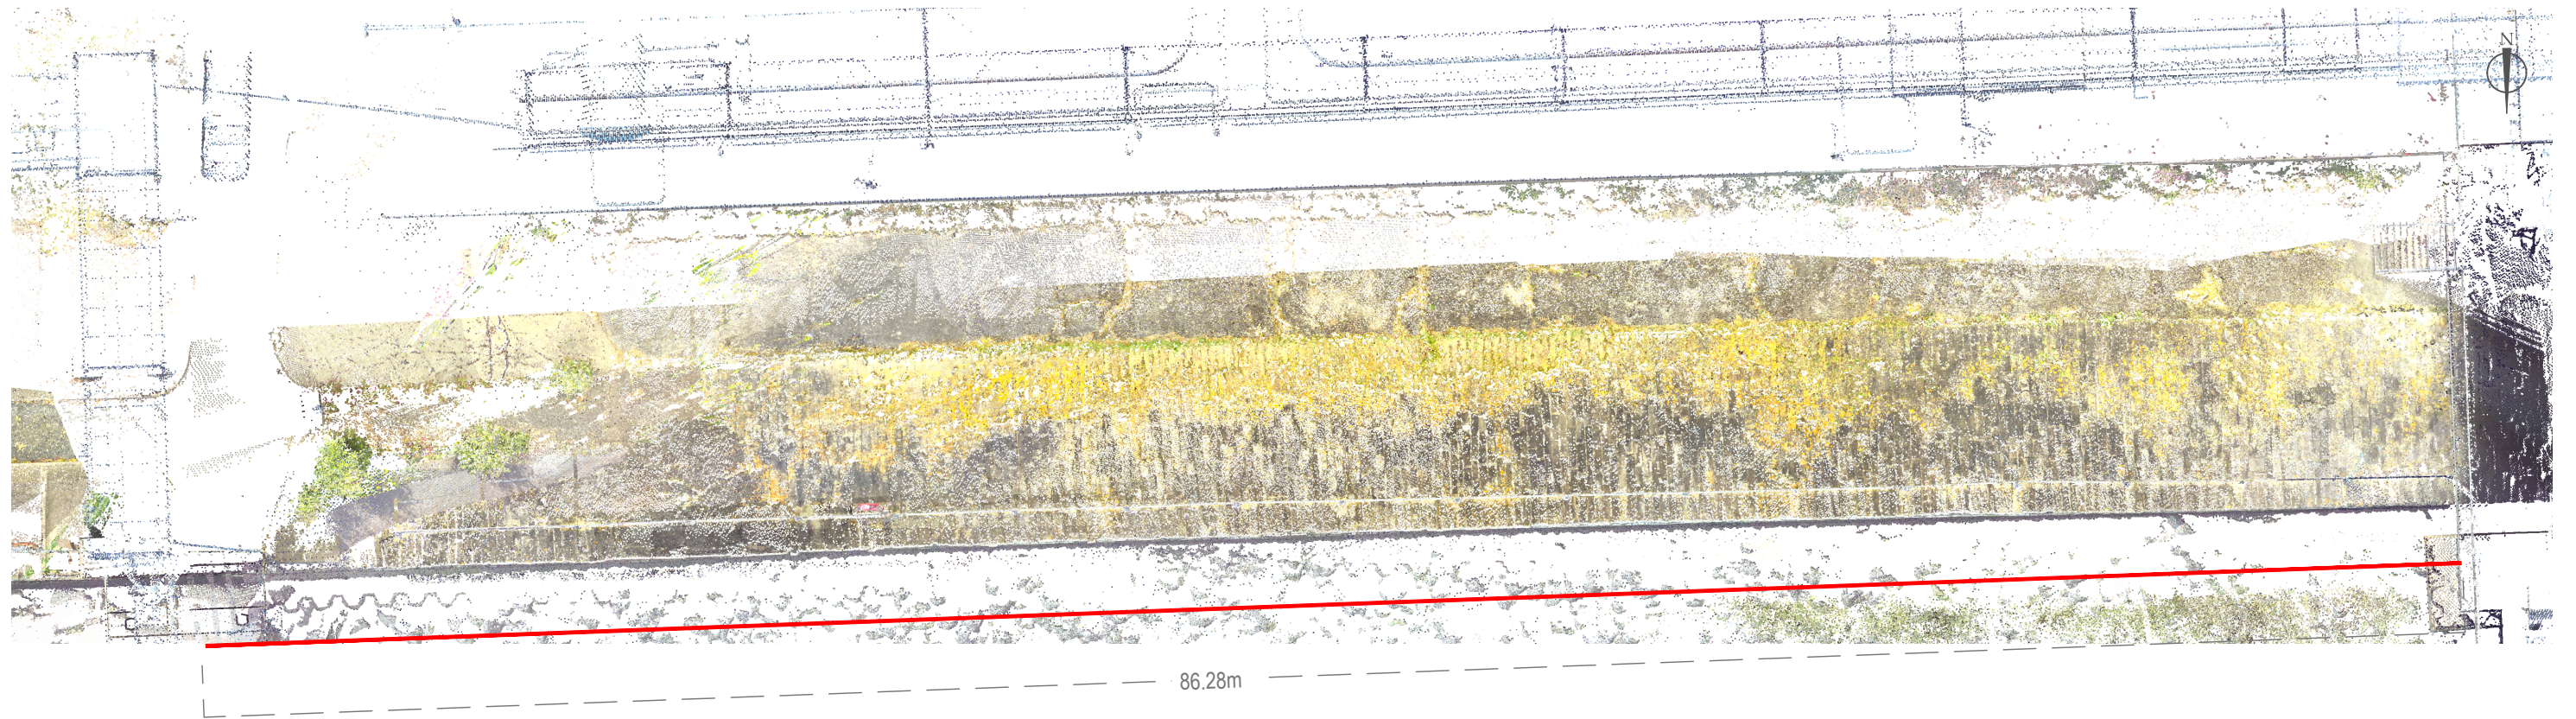
PLAN
GSW - Area 4 - West 2
Scale 1:250
