**Underwater Archaeological Impact Assessment (UAIA)
ADCOCO Areas 1-4, River Liffey, Dublin Port**

**Dublin Port 3FM Project
Project Reference CP1770_021**

Final Report
Client
Project Director

29 May 2024
RPS for DPC
Rex Bangerter MA

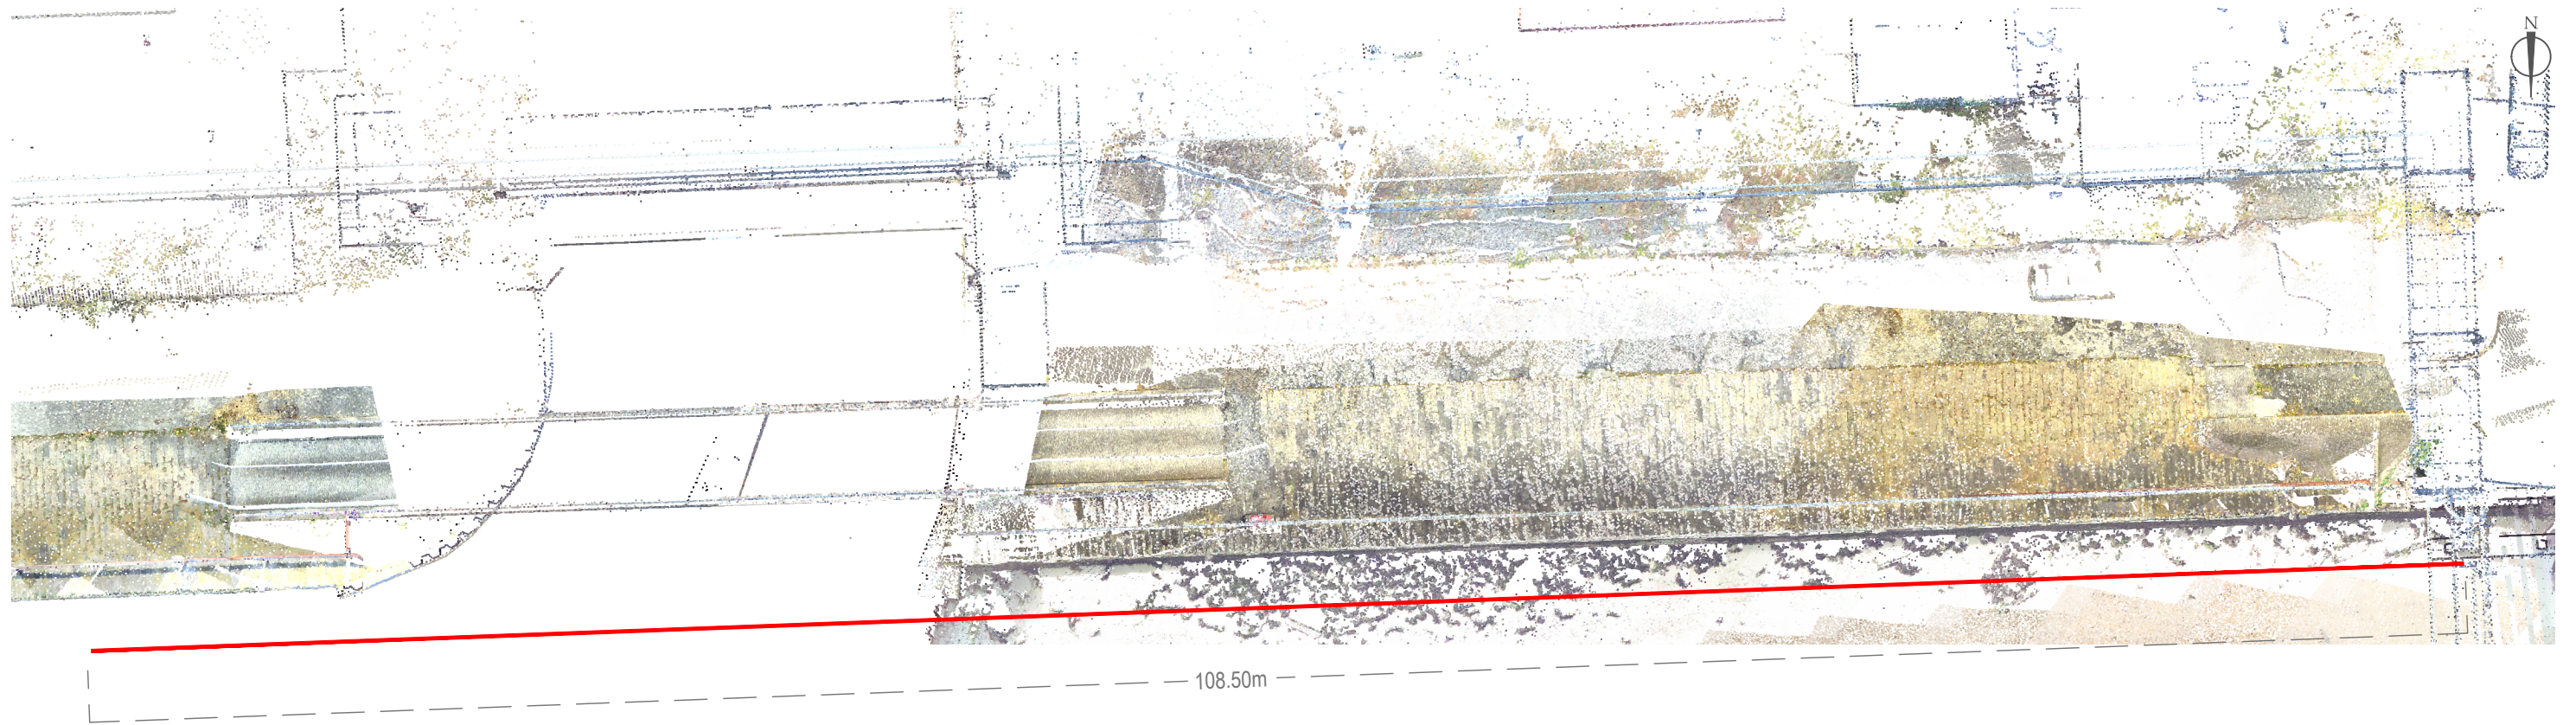
PLAN
 GSW - Area 4 - West 3
 Scale 1:300

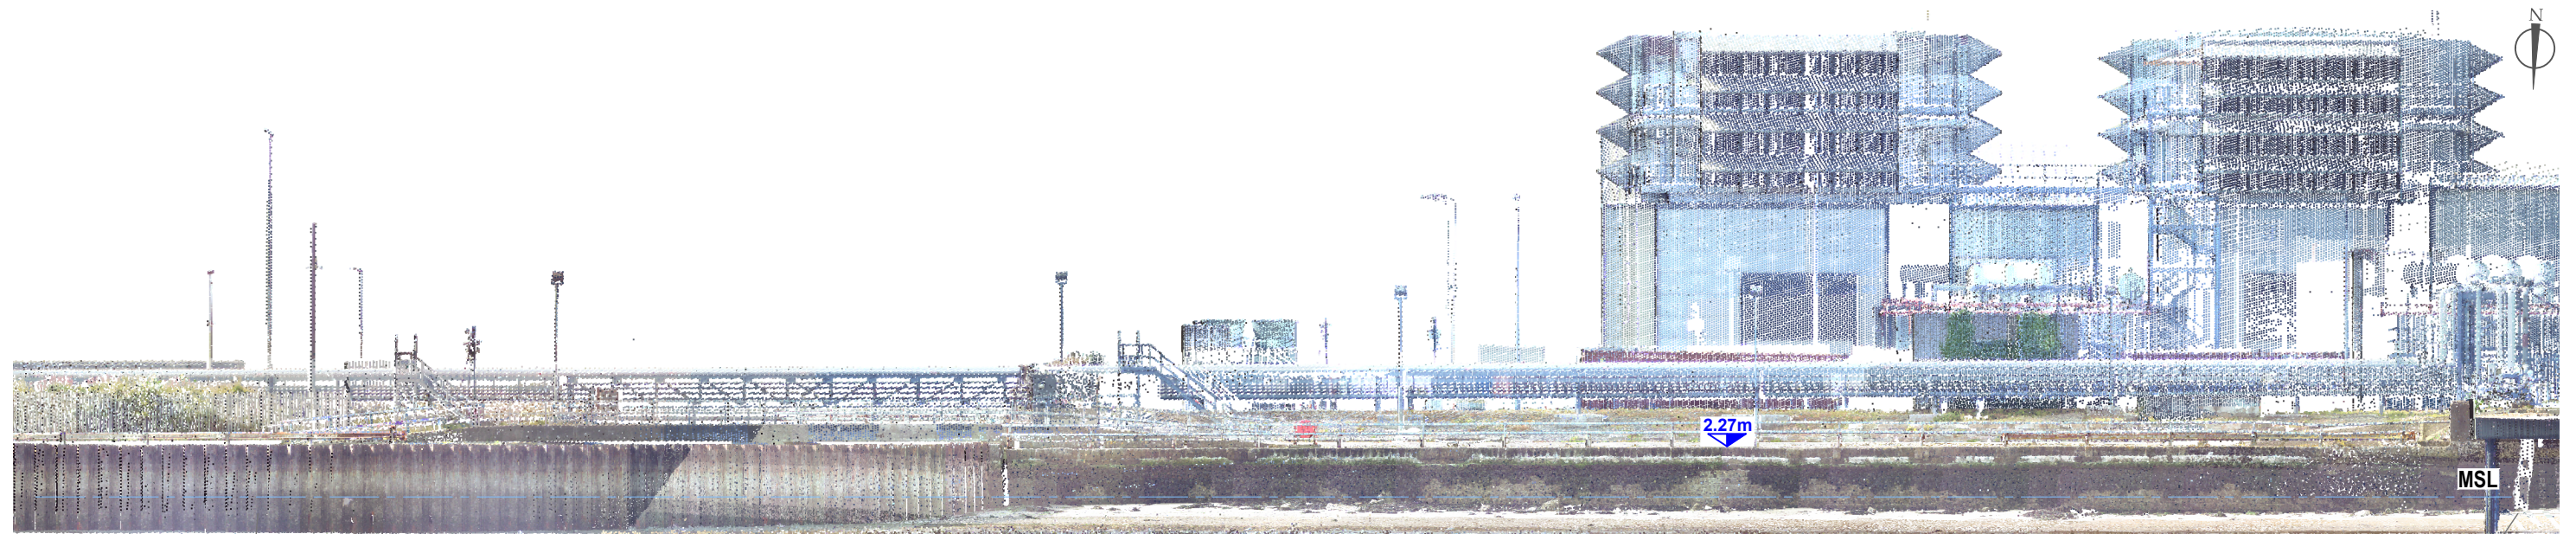
ELEVATION
 GSW - Area 4 - West 3
 Scale 1:300

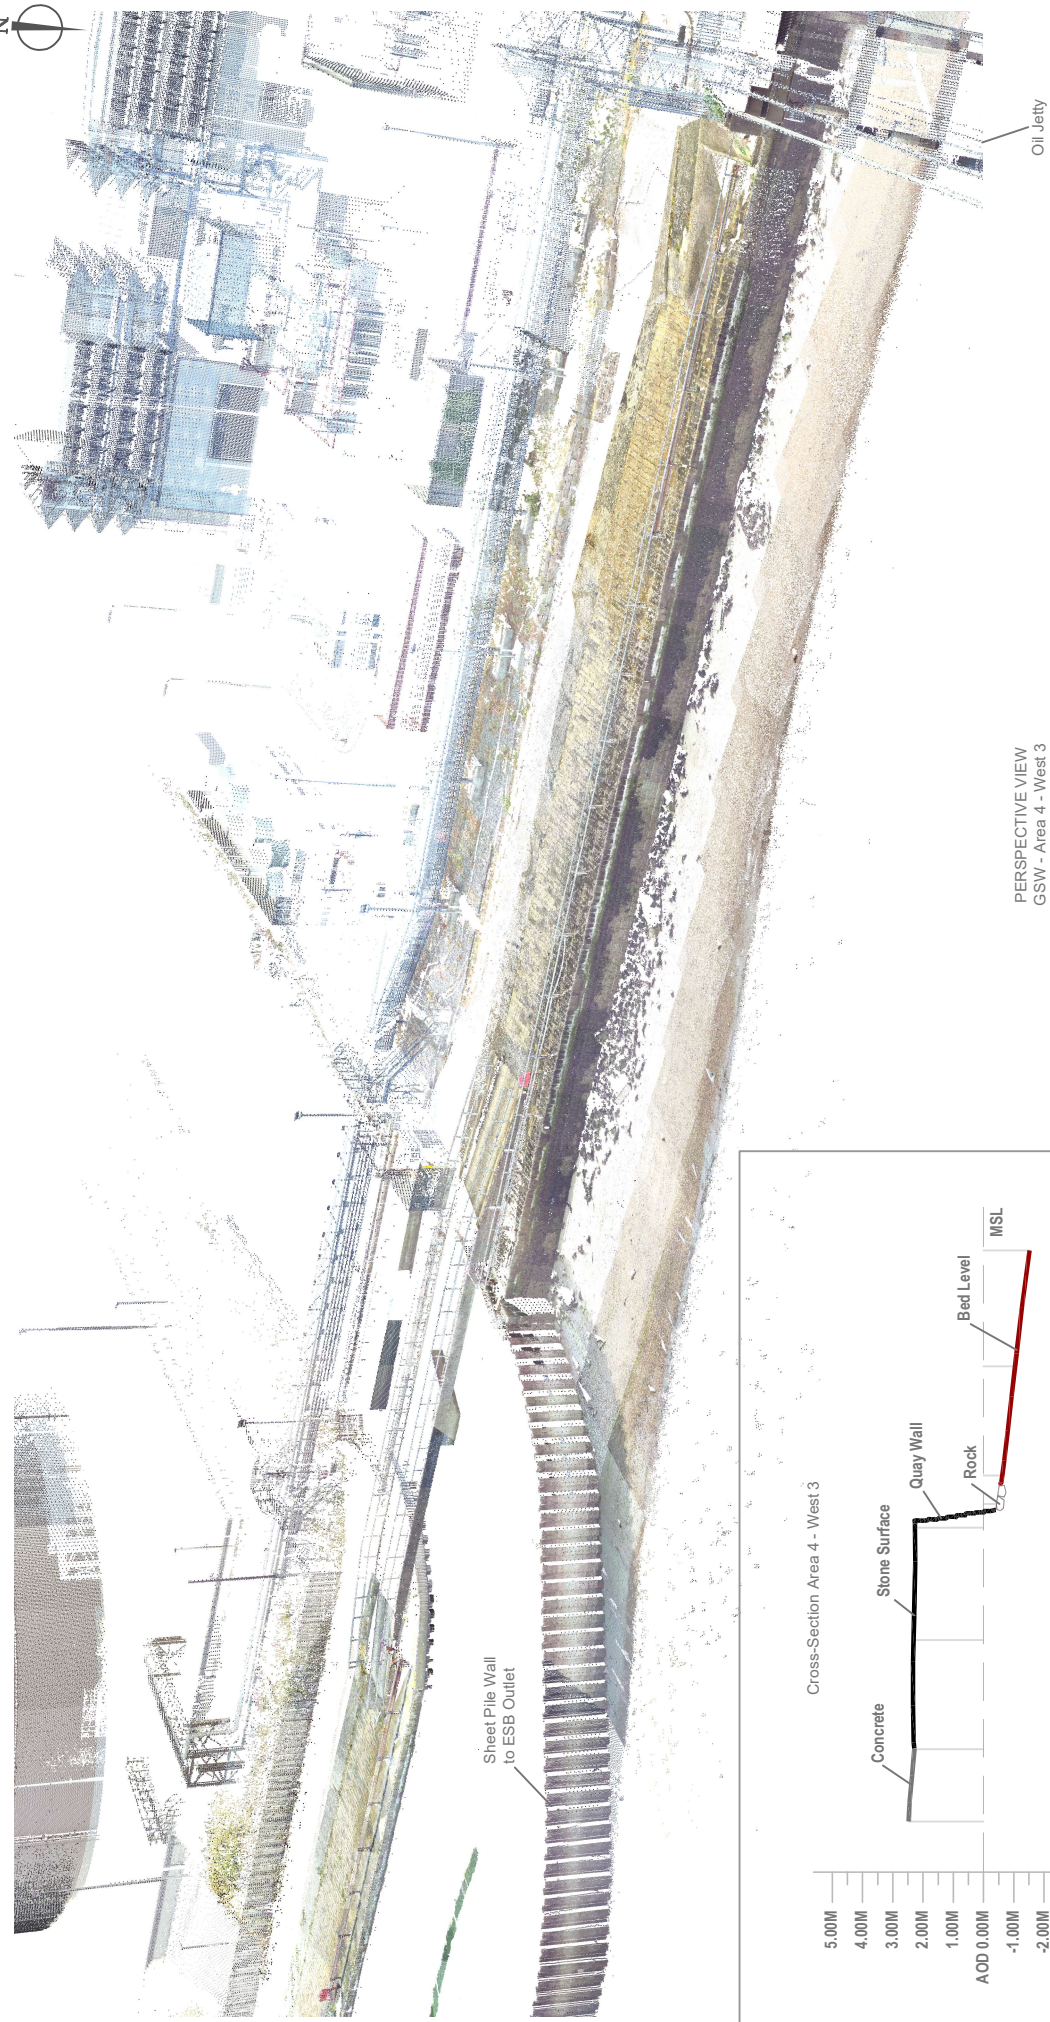
Title
Figure 44 - Point Cloud Perspective View, Great South Wall, ADCO Survey Area 4 [West 3]

PERSPECTIVE VIEW
GSW - Area 4 - West 3
NTS

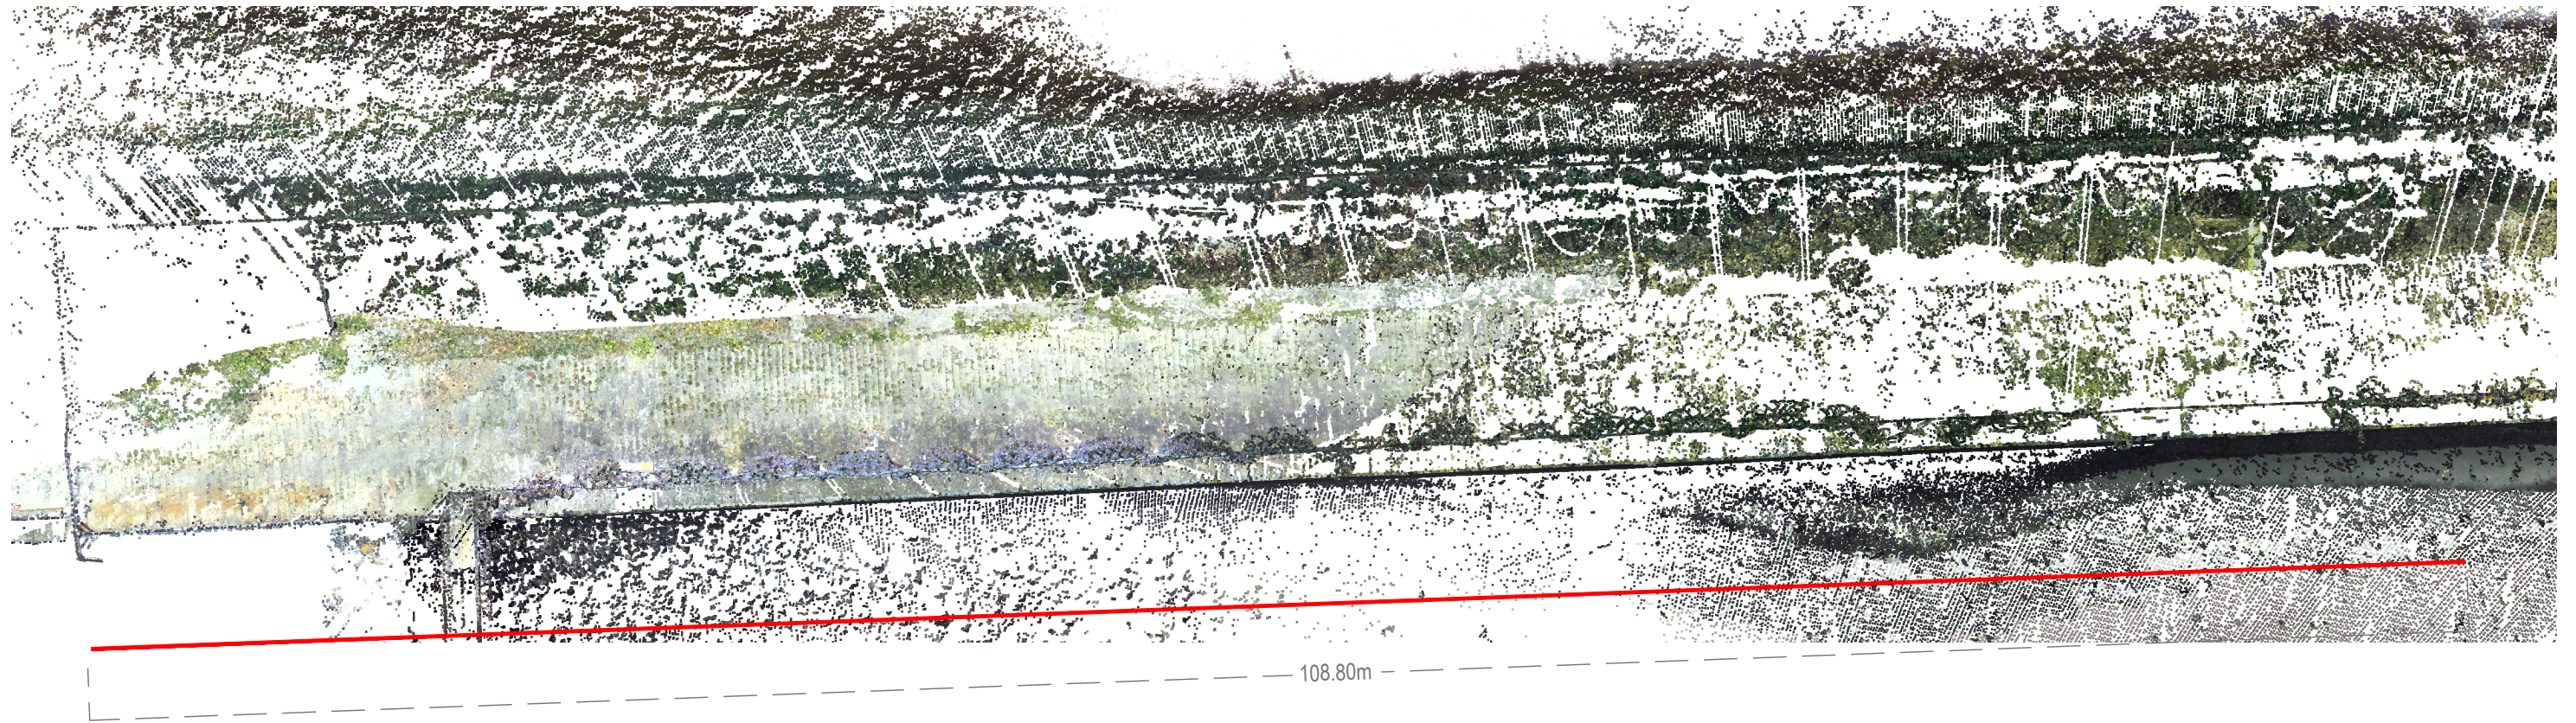
PLAN
 GSW - Area 4 - East
 Scale 1:300

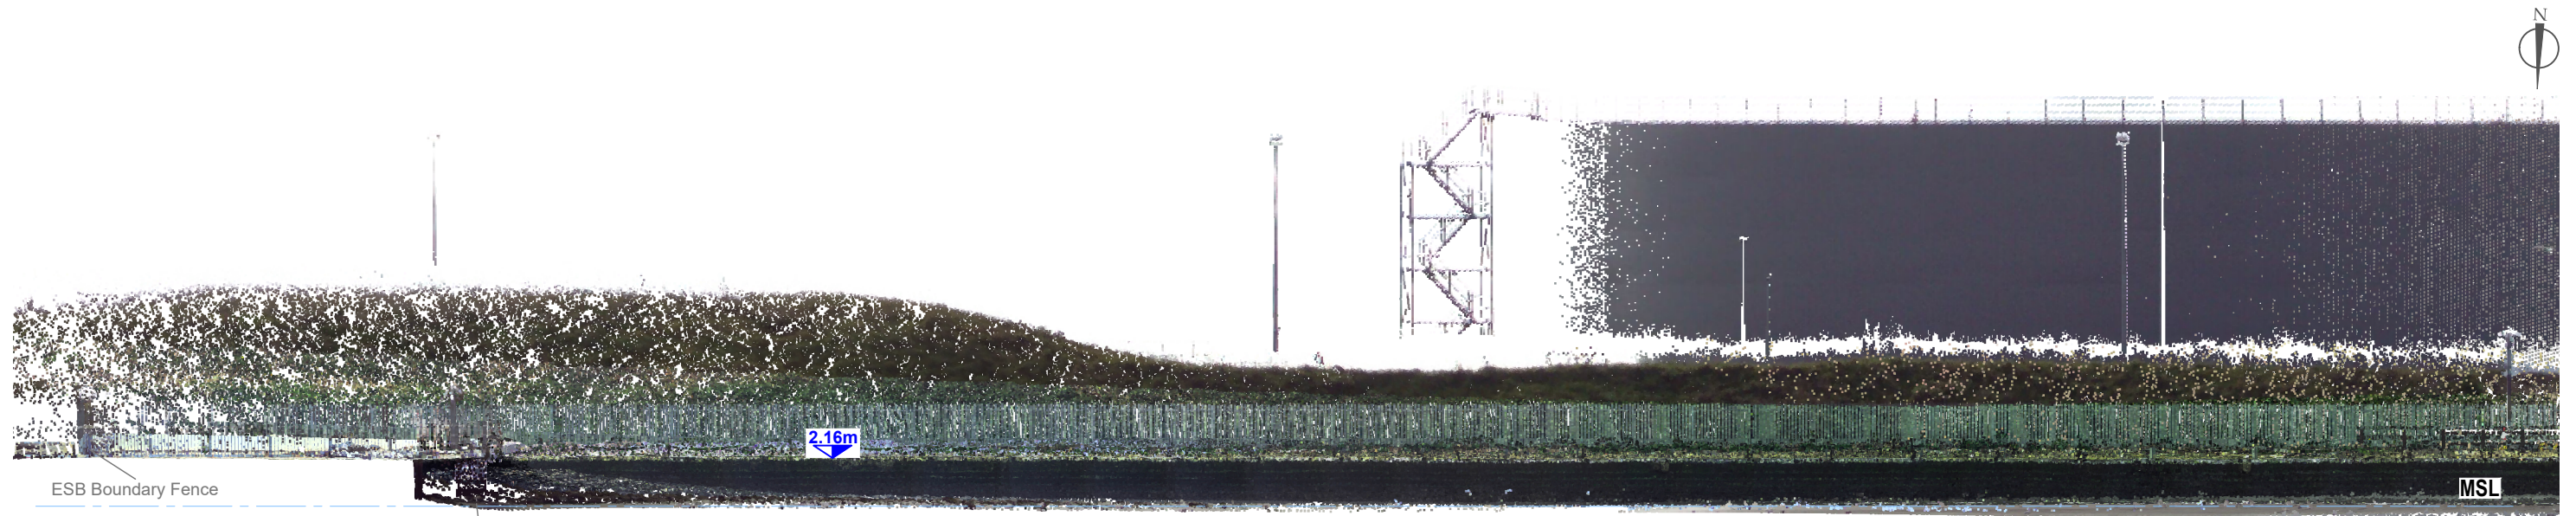
ELEVATION
 GSW - Area 4 - East
 Scale 1:300

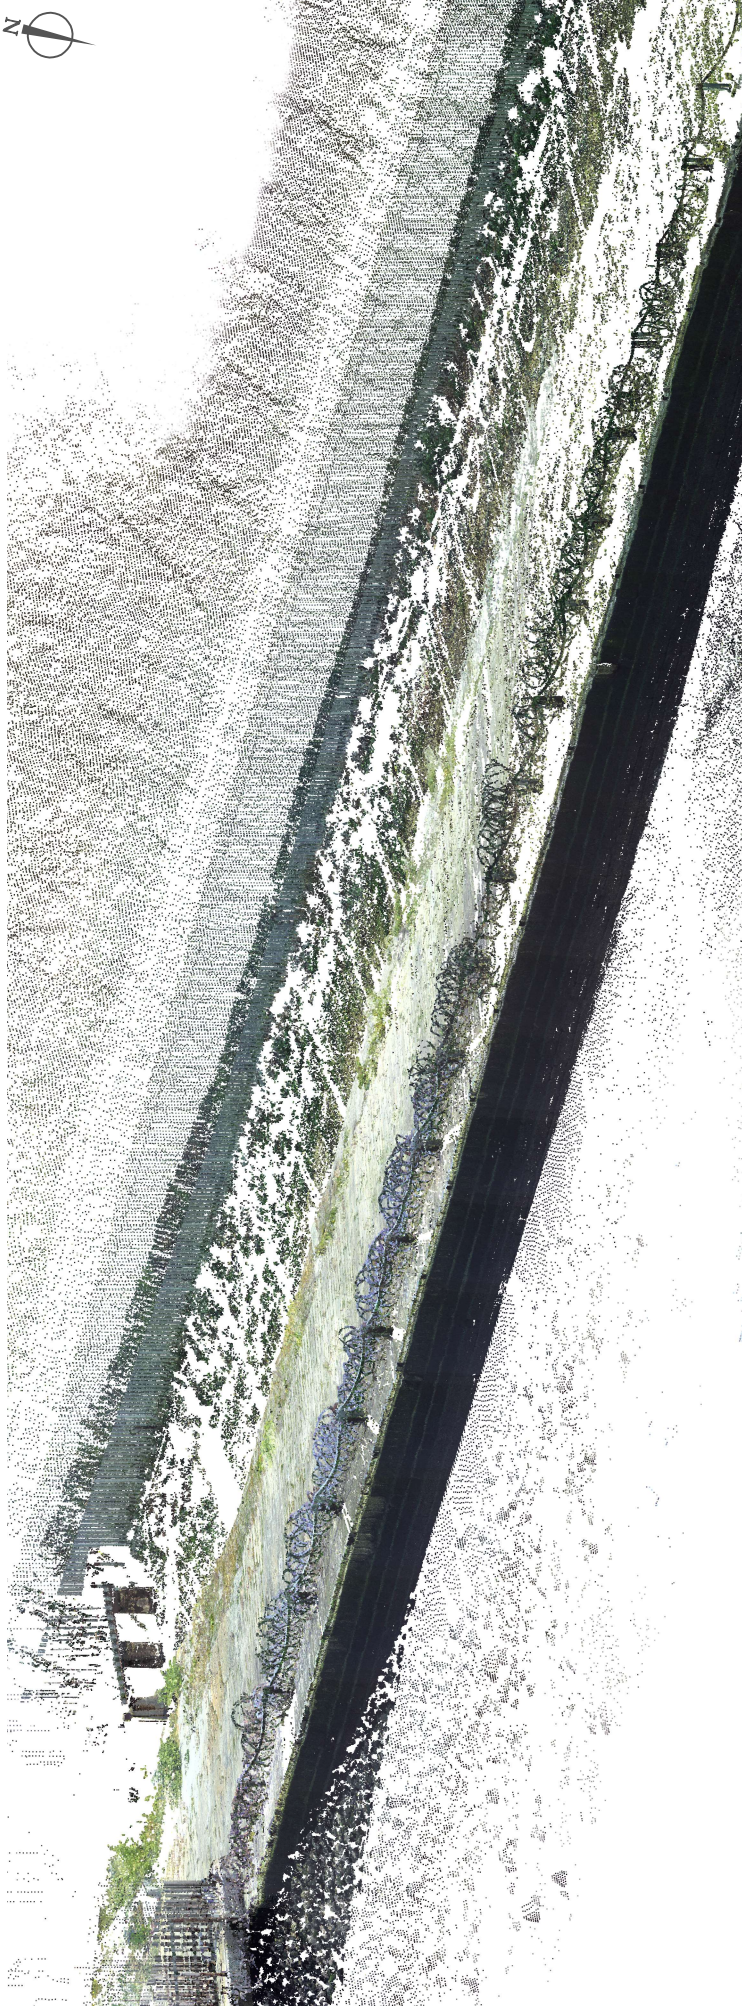
PERSPECTIVE VIEW
GSW - Area 4 - East
NTS

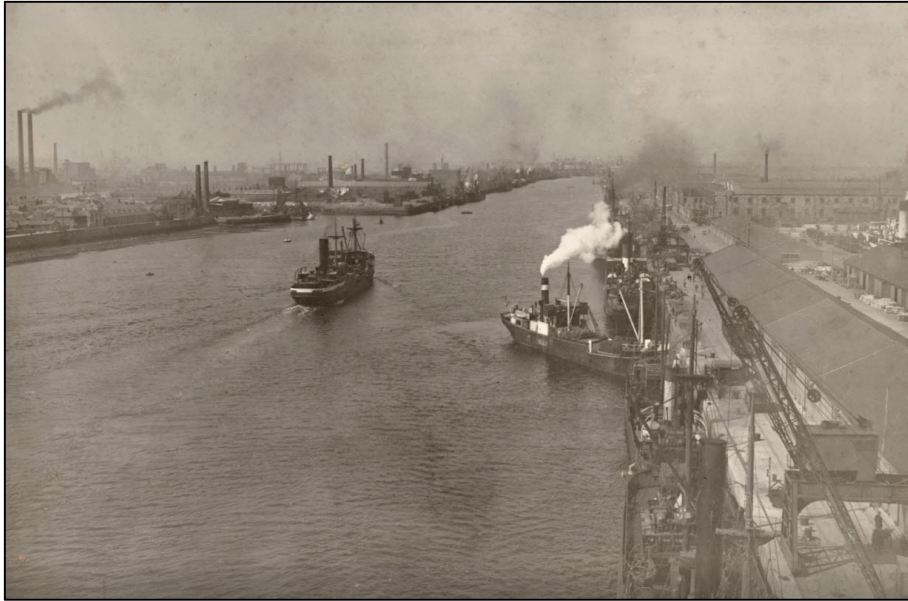
Plate 9: West-facing view along the NWQE (photograph taken 1905) showing crane-and-rail infrastructure and adjacent goods sheds [source: Dublin Port Archive].

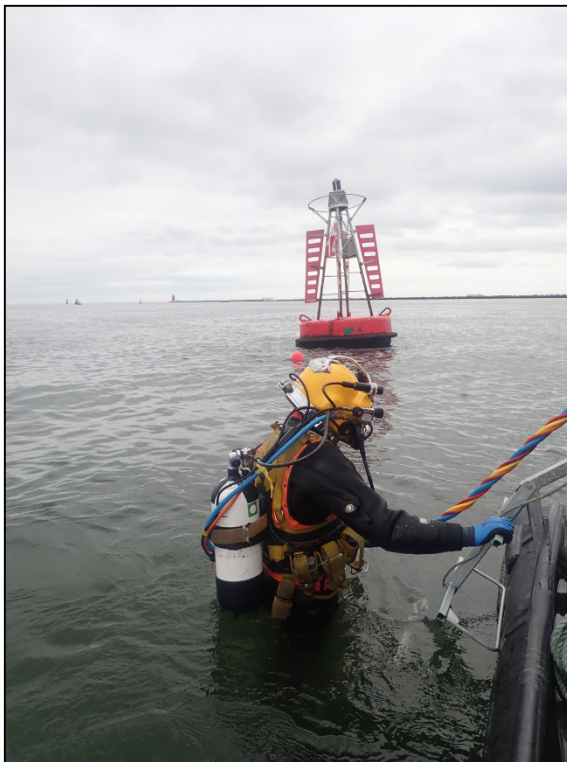
Plate 10: Example shot of diver entering water to carry out underwater survey [location: northwest corner of Survey Area 4, west of Buoy Number 14].

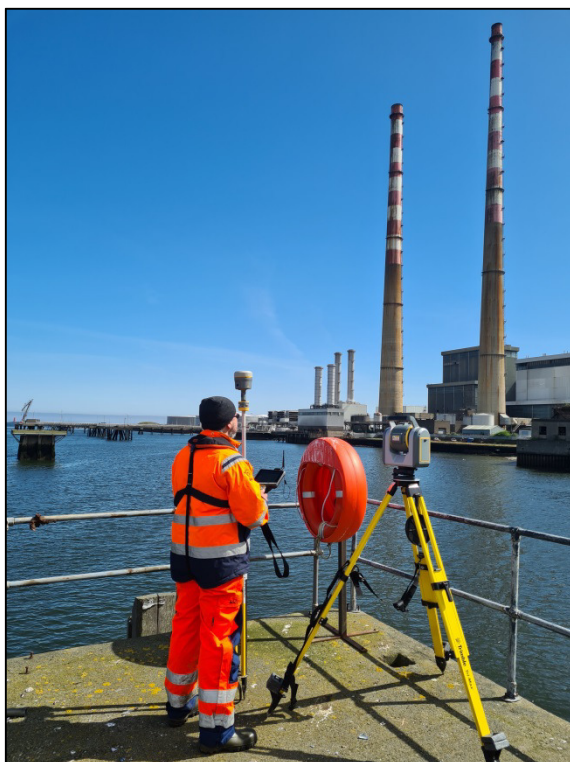
Plate 11: Laser-scan survey in progress at entrance to Pigeon House Harbour; scanning from the east dolphin of the Sludge Jetty.

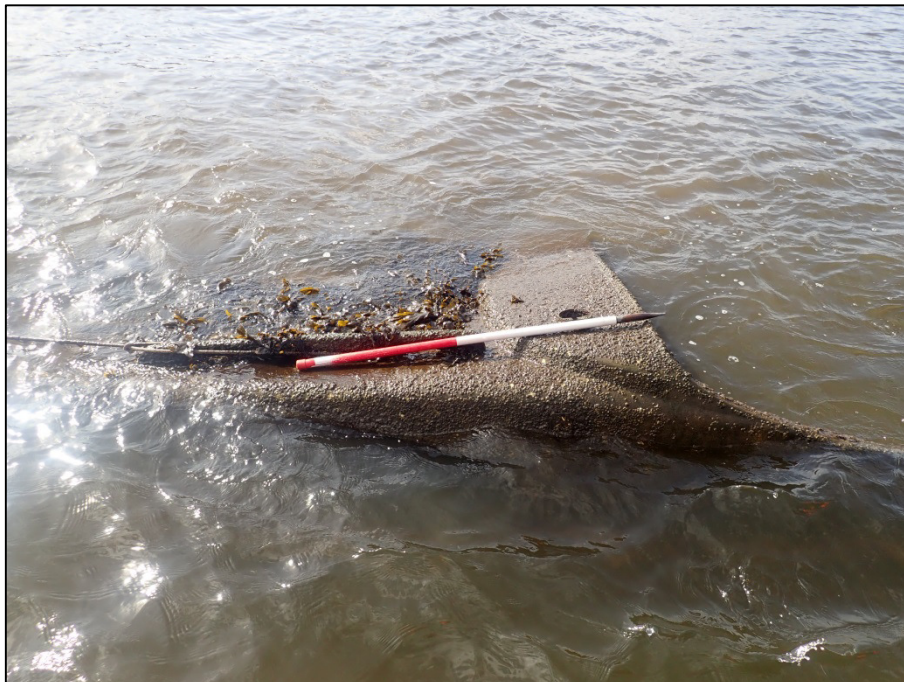
| Target No. | ITM | Underwater Inspection |
|---|---|--|
| SS_15 | 718416E, 734145N | Boat (Shetland Motorboat), upstanding from riverbed; vessel measures 6m length by 2m width. Boat is lying on its keel, listing to starboard (c. 20° angle). Outboard engine still attached to stern-board. Two (2) car-tyres (boat fenders) located a short distance from the bow section, to the west and south. Vessel partially visible protruding from water at Low Water [see Plate 12]. |

Plate 12: Boat-wreck (Shetland Motorboat), upstanding from riverbed at target location of SS_15; ITM 718416E, 734145N (1m scale).

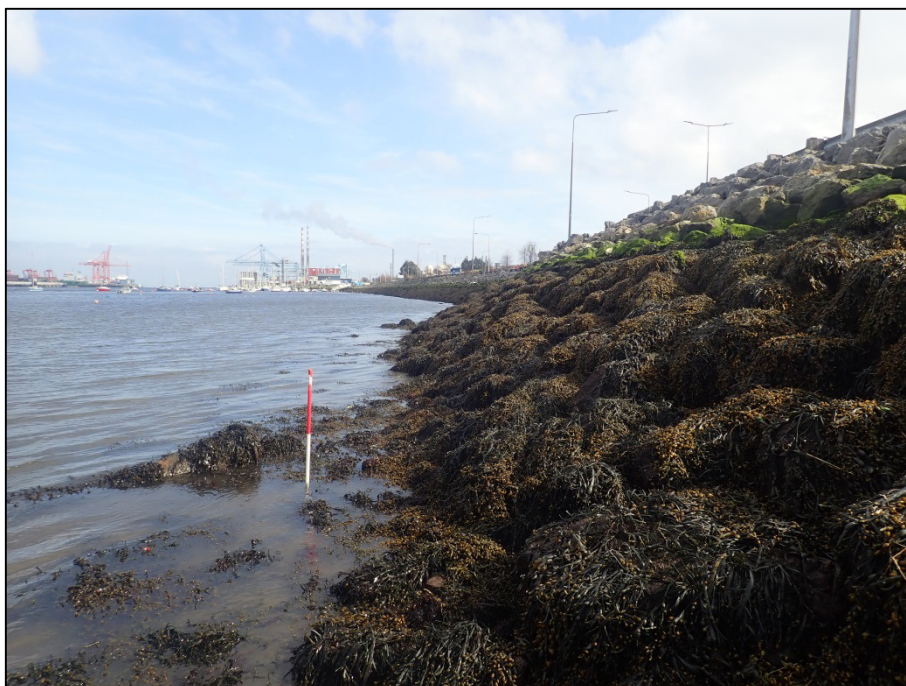
The riverbed on the southern side of the channel is intertidal in character, exposing c. 15m-section of riverbed at Low Water. This area is delineated by extensive rock-armour protection, placed as part of the construction of the East-link Toll Road (Plate 13). A compact deposit of silty-sand with frequent overlying patches of gravel, pebbles, and small cobbles extends (to the north) for a distance of c. 20m from the base of the rock-armour (Plates 14-15). Frequent nineteenth- and twentieth-century material was observed within the inertial area, comprising frequent pottery fragments and glassware (Plates 16-17).

Plate 13: East-facing view along rock-armour that delineates the foreshore on the south side of the River Liffey, within Survey Area 1 (1m scale).

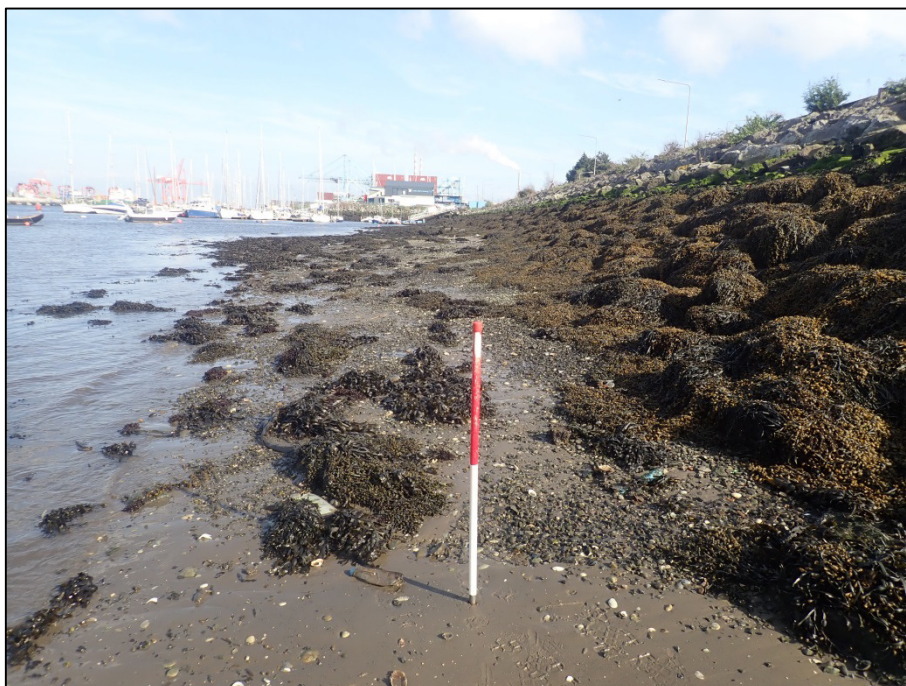
Plate 14: East-facing view of intertidal foreshore on south side of the River Liffey, Survey Area 1; Poolbeg Marina in distance (1m scale).

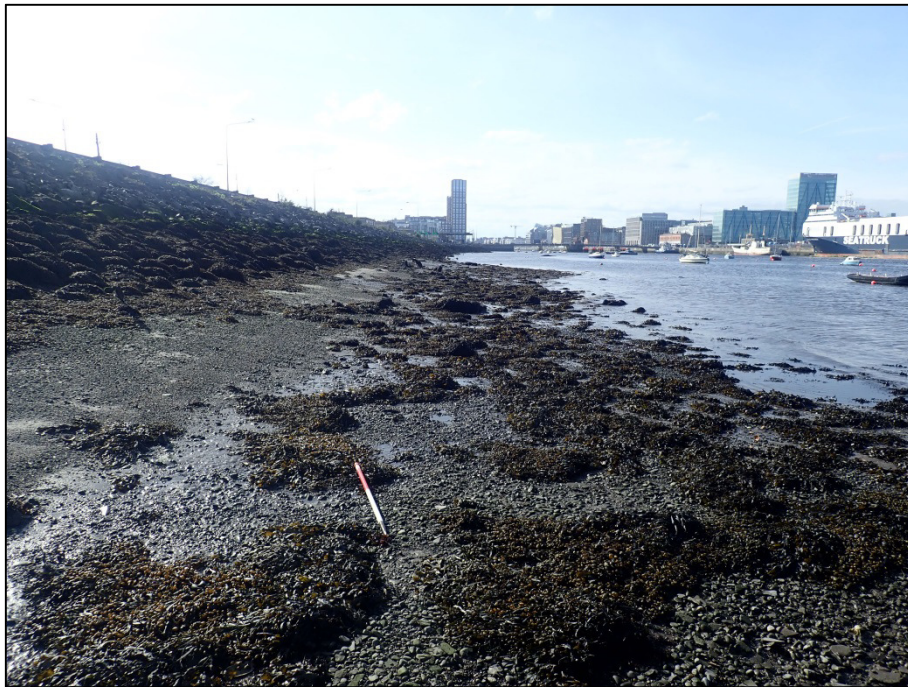
Plate 15: West-facing view of intertidal foreshore on south side of the River Liffey, Survey Area 1; Tom Clarke Bridge in distance (1m scale).

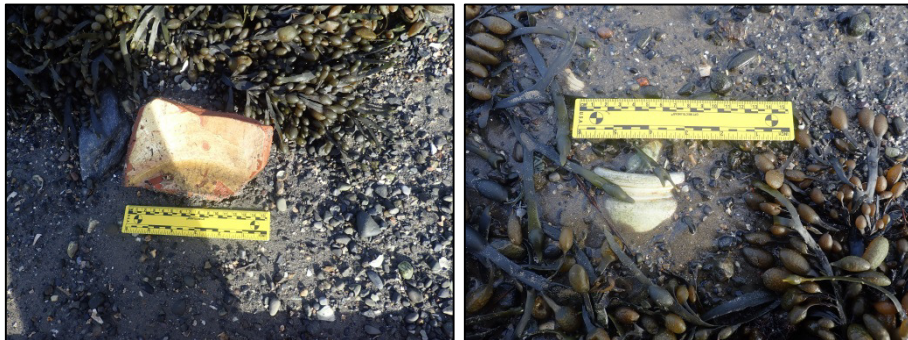
Plate 16: Example shots of early twentieth-century ceramic fragments located within foreshore deposits on south side of the River Liffey, Survey Area 1 (150mm scale).

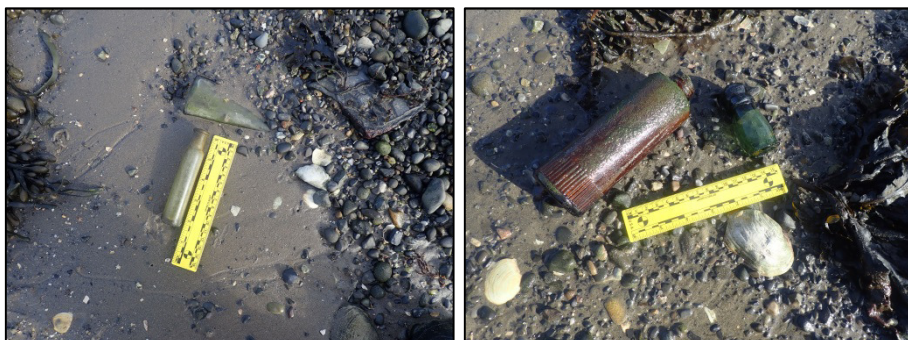
Plate 17: Example shots of nineteenth-/ early twentieth-century bottles present within foreshore deposits on south side of the River Liffey, Survey Area 1 (150mm scale).

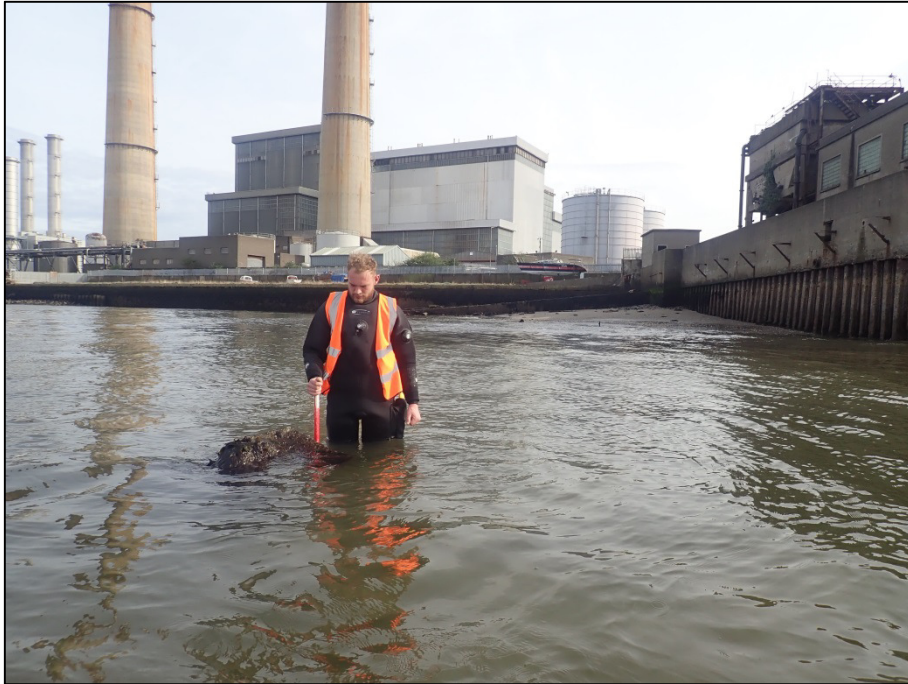
Occasional boulders (displaced rock-armour elements) are located at distance of up to 8m from the sea-wall. Scouring is evident on the channel side of these boulders, measuring 400mm-500mm in depth. No archaeologically significant features were observed protruding from the surface of the seabed, although a number of modern items were encountered (Plate 18).

Plate 18: Modern metallic debris, machinery-part reused as mooring, located towards the western limit of Survey Area 4.

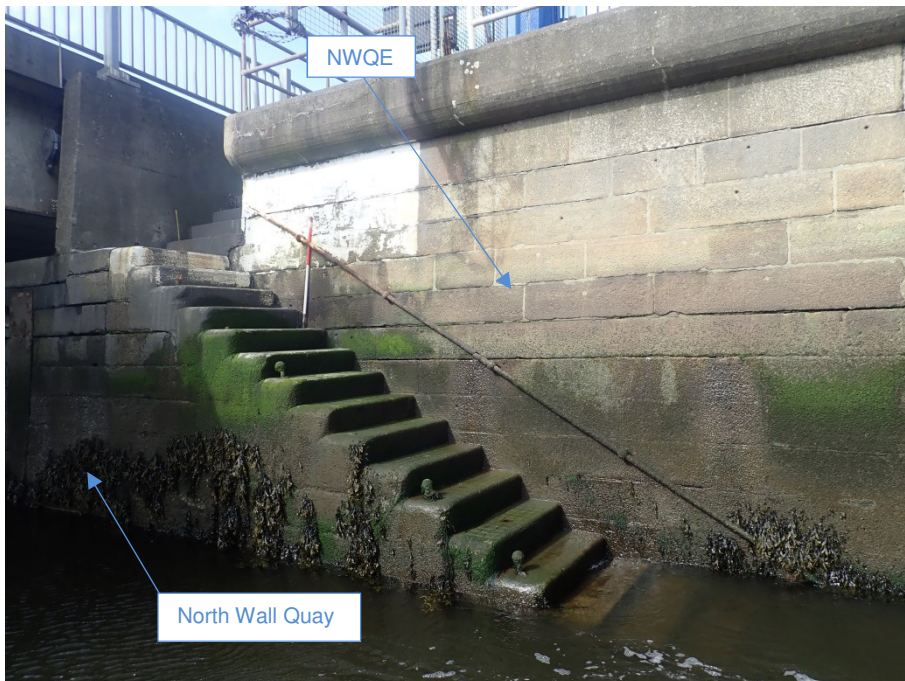
Plate 19: Northwest-facing view of river access steps (RAS-01) located on downstream side of Tom Clarke Bridge (1m scale).

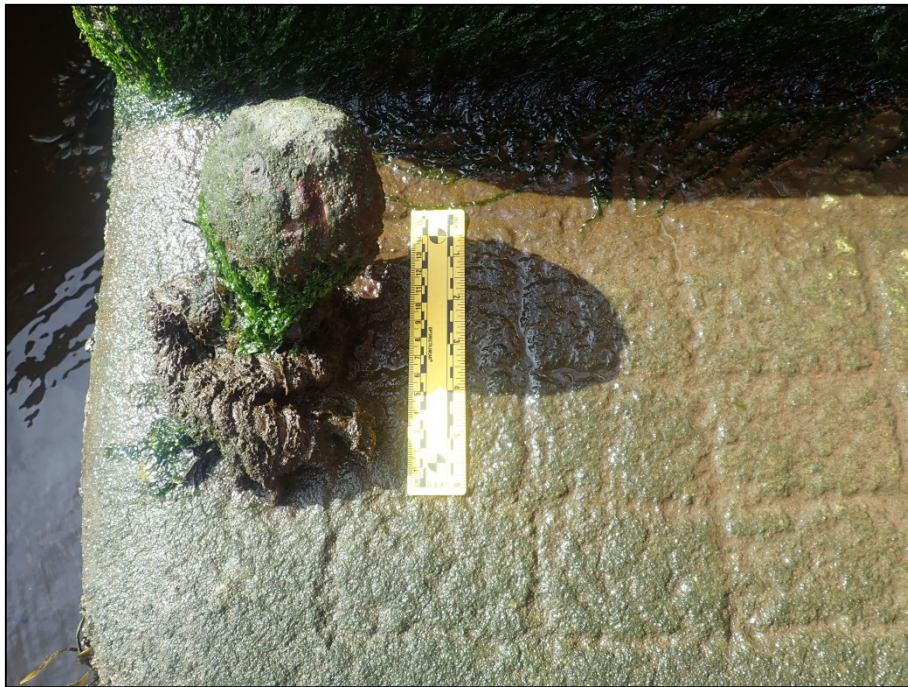
Plate 20: Detail shot showing eroded boat tie-off fitting from RAS-01 (150mm scale).

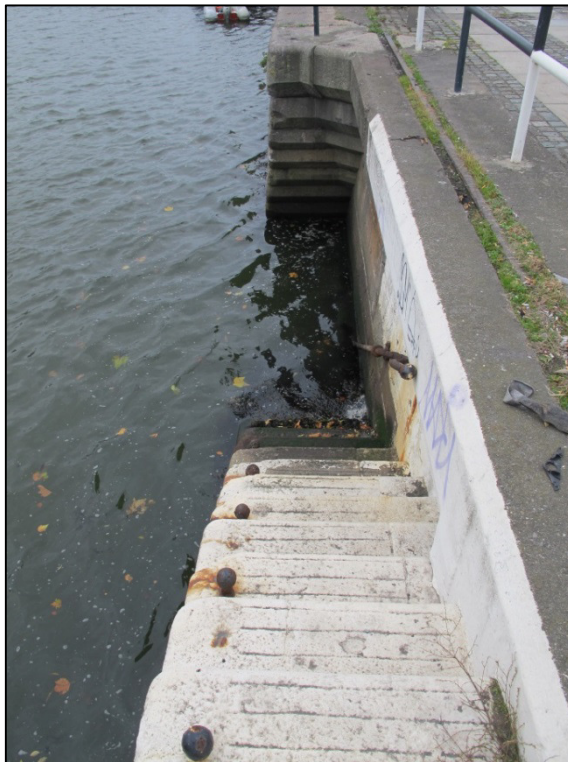
Plate 21: West-facing view of river access steps located immediately upstream of Tom Clarke Bridge.

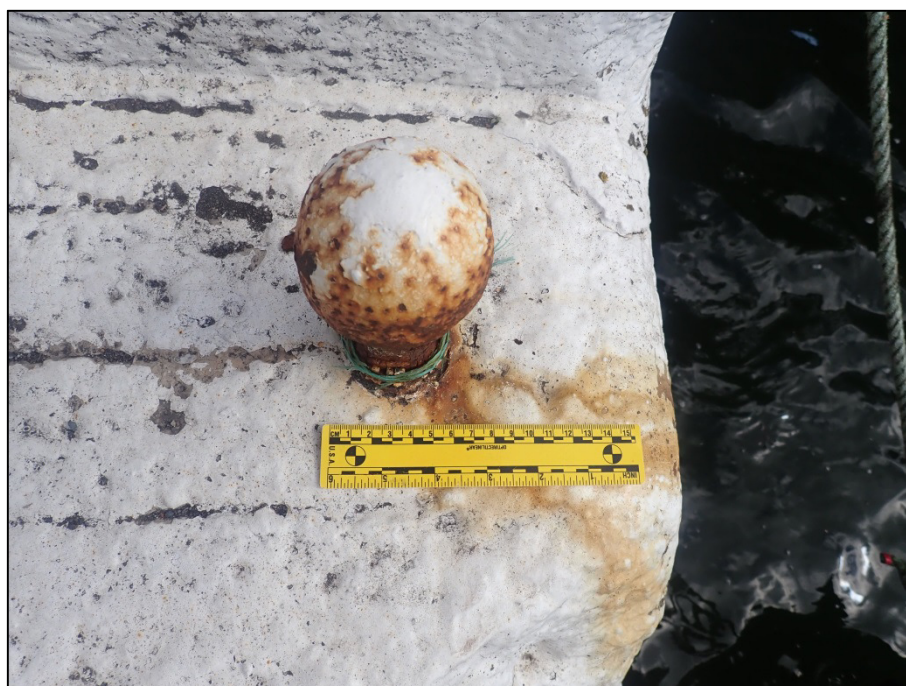
Plate 22: Detail shot showing well-preserved boat tie-off fitting from upstream river access steps; these being inset into every second step (150mm scale).

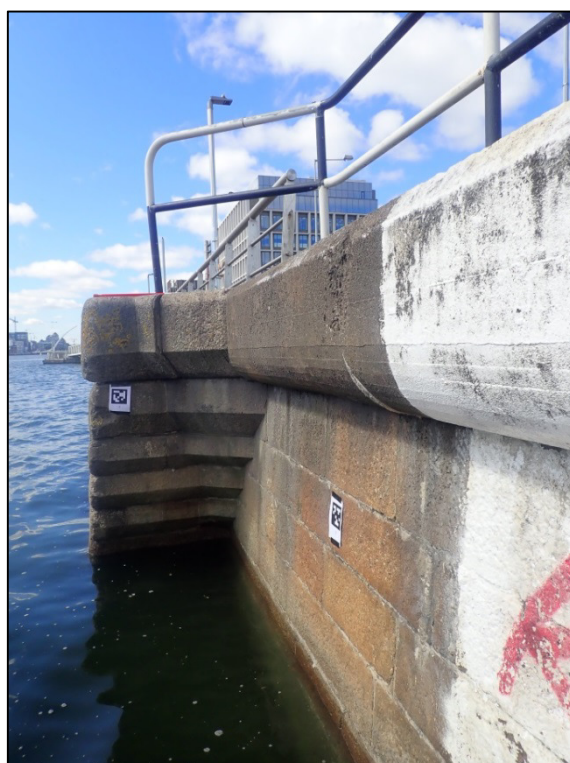
Plate 23: West-facing view of bullnose terminus to cascading masonry on the west side of the upstream river access steps.

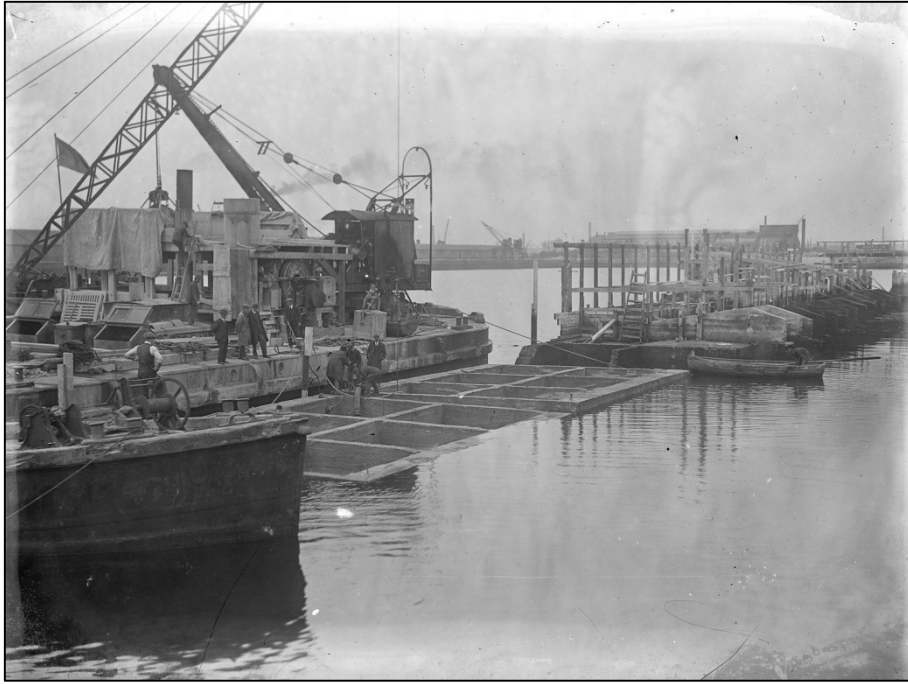
Plate 24: Early twentieth century photograph showing the use of floating caissons in the construction of new quaysides within Dublin Port [source: Dublin Port Archive].

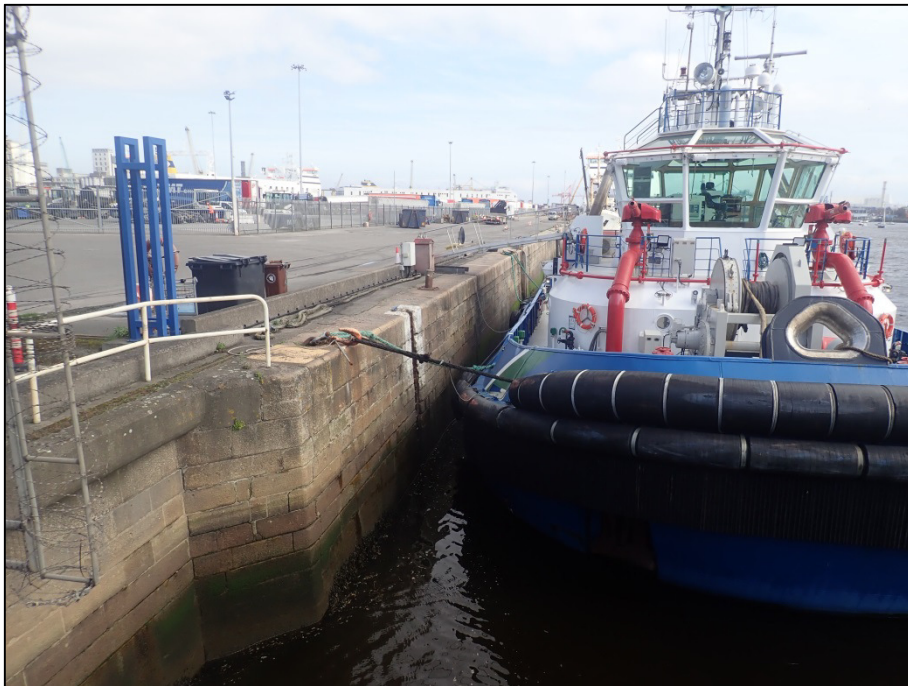
Plate 25: East-northeast facing view along NWQE, Berth 18.

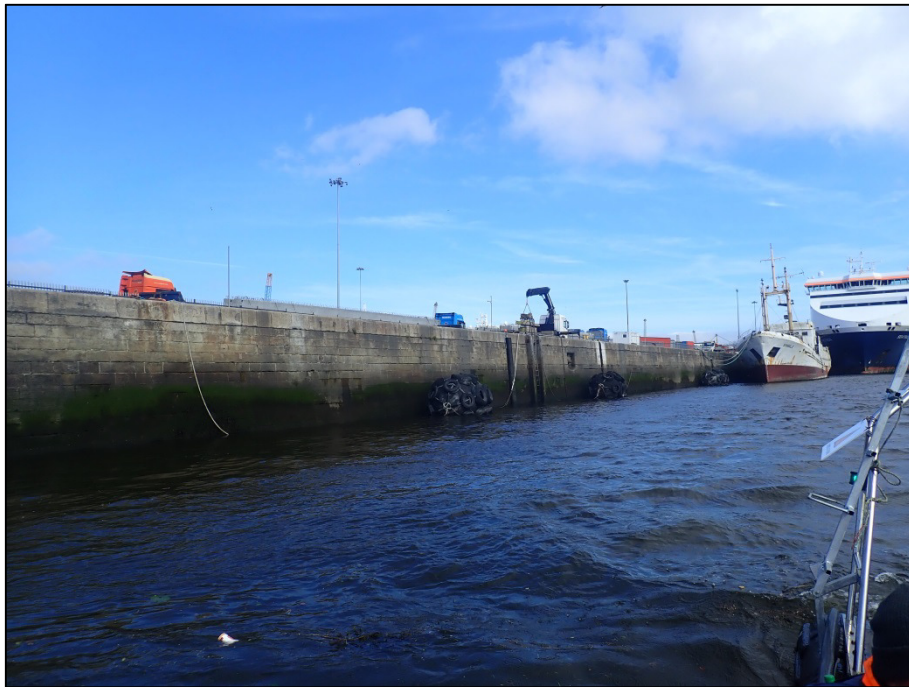
Plate 26: Northeast-facing view along NWQE, coming onto Low Water.

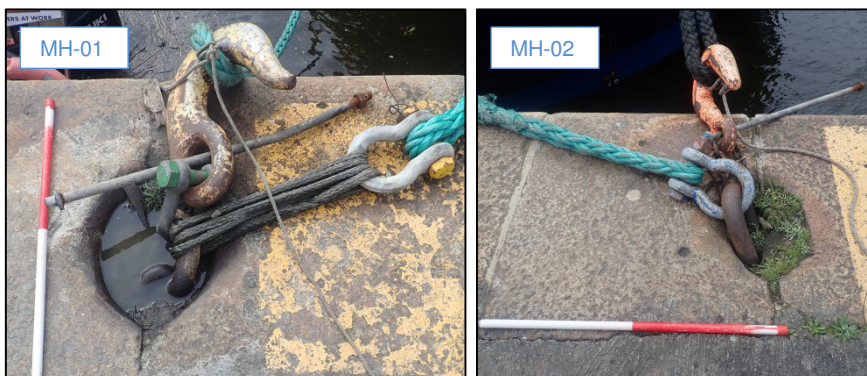
Plate 27: Two (2) sets of iron mooring-hoops (MH-01 and MH-02) which adorn the top of the NWQE at ITM 718048E, 734384N and ITM 718063E, 734382N (1m scale).

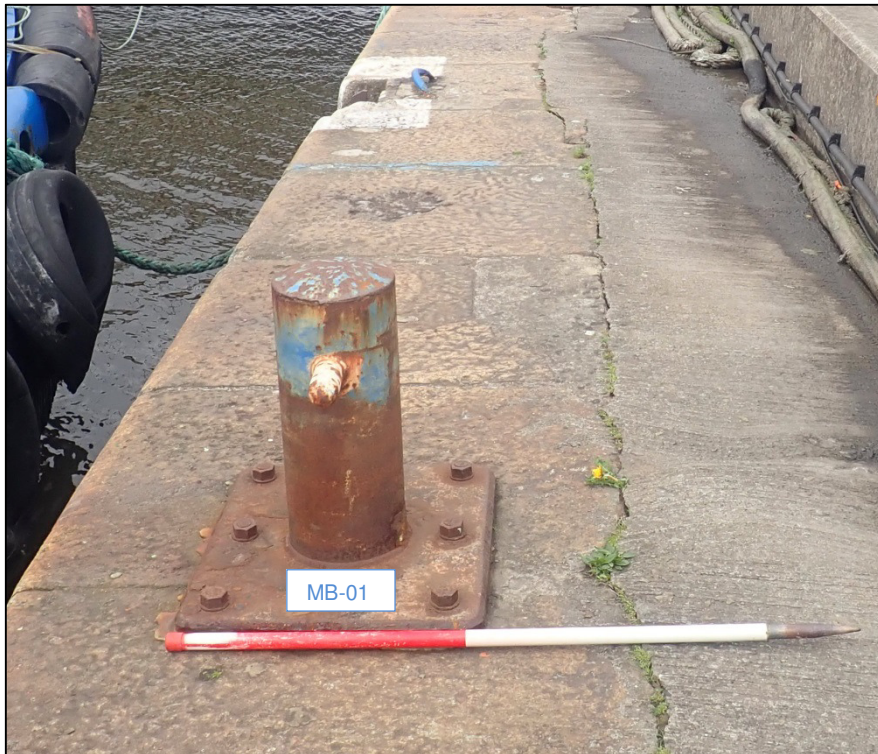
Plate 28: Cast-iron mooring bollard (MB-01) located between mooring hoops MH-01 and MH-02, at ITM 718034E, 734383N (1m scale).

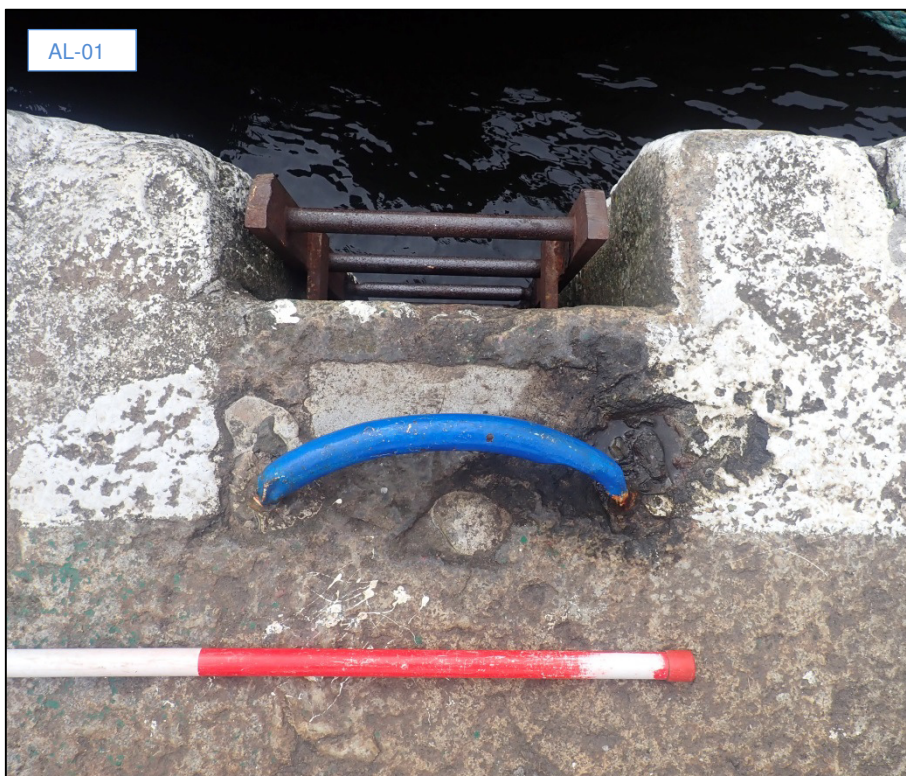
Plate 29: River access ladder and associated grab-handle (AL-01) located at ITM 718051E, 734383N (50mm scale).

River access ladders (AL-01 and AL-02) are located at ITM 718051E, 734383N and 718066E, 734382N (Plates 29-30). The first of these items, positioned 14.8m downstream of Tom Clarke Bridge, has been recessed into the quay wall and is integral to its construction. However, the original wrought-iron ladder does not remain *in situ*, having been replaced by a more recent version. Only the 'grab handle' component of the ladder assemblage retains some age, being an earlier replacement. This handle feature forms a simple wrought-iron
