**Underwater Archaeological Impact Assessment (UAIA)
ADCOCO Areas 1-4, River Liffey, Dublin Port**

**Dublin Port 3FM Project
Project Reference CP1770_021**

Final Report
Client
Project Director

29 May 2024
RPS for DPC
Rex Bangerter MA

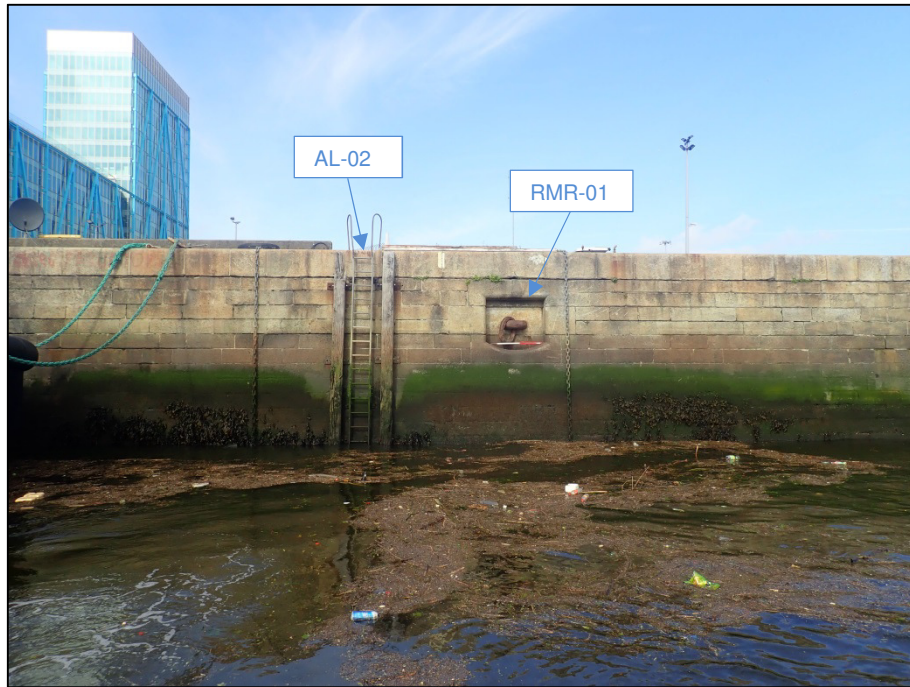
Plate 30: River access ladder (AL-02) and associated timber fenders located at ITM 718066E, 734382N; recessed mooring-ring (RMR-01) located c. 3m downstream (1m scale).

River access ladders (AL-01 and AL-02) are located at ITM 718051E, 734383N and 718066E, 734382N (Plates 29-30). The first of these items, positioned 14.8m downstream of Tom Clarke Bridge, has been recessed into the quay wall and is integral to its construction. However, the original wrought-iron ladder does not remain *in situ*, having been replaced by a more recent version. Only the 'grab handle' component of the ladder assemblage retains some age, being an earlier replacement. This handle feature forms a simple wrought-iron

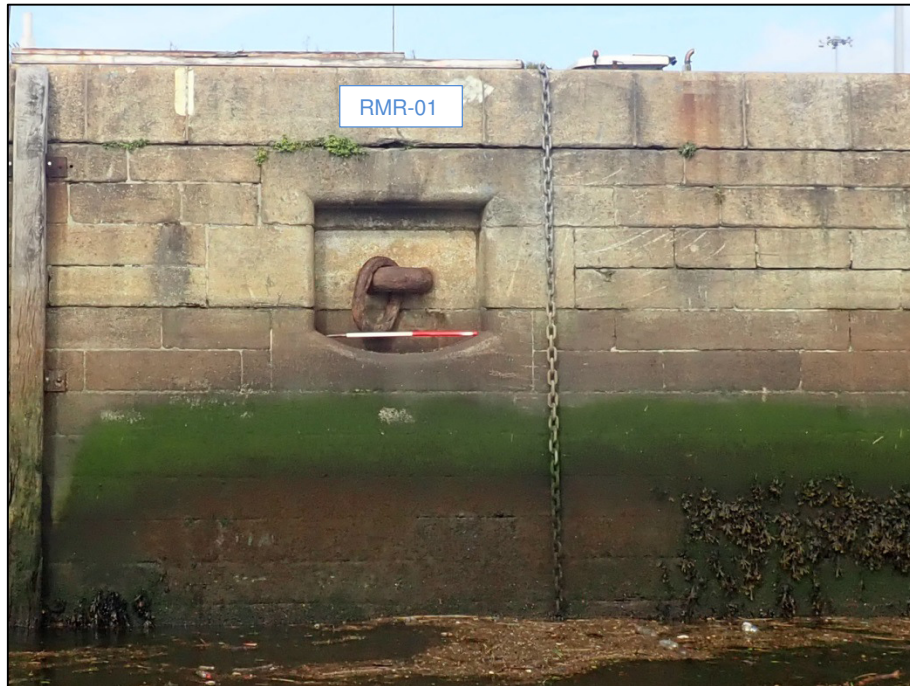
Plate 31: Recessed mooring-ring (RMR-01) located at ITM 718069E, 734381N (1m scale).

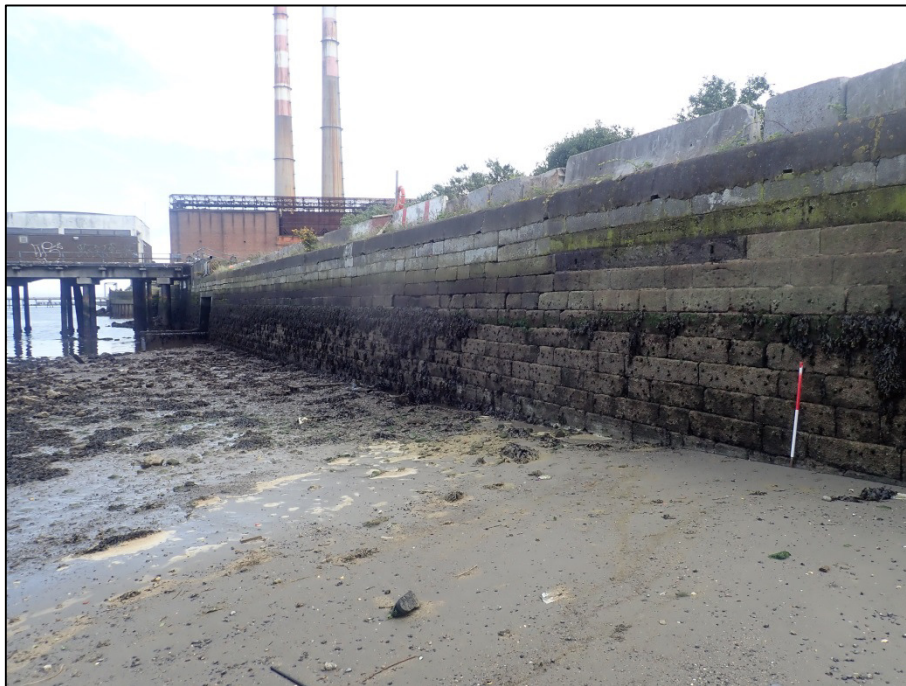
Plate 33: East-facing view of Feature F02, quay-wall on channel side of Pigeon House Harbour, to the west of the Sludge Jetty (1m scale).

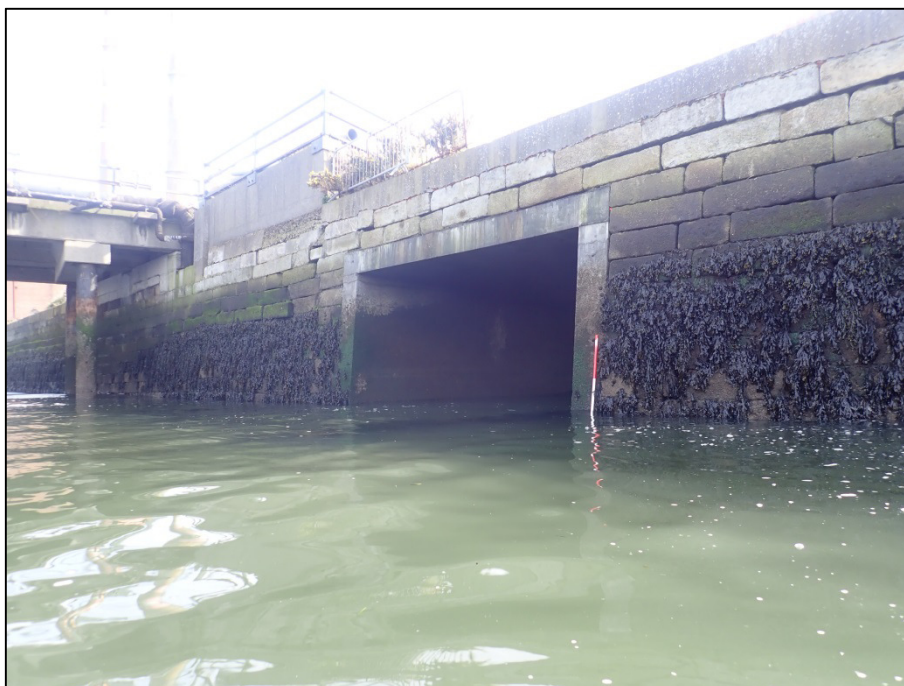
Plate 34: East-southeast facing view of Feature F02 showing impacts to the quay-wall from a box-culvert and the downstream Sludge Jetty (1m scale).

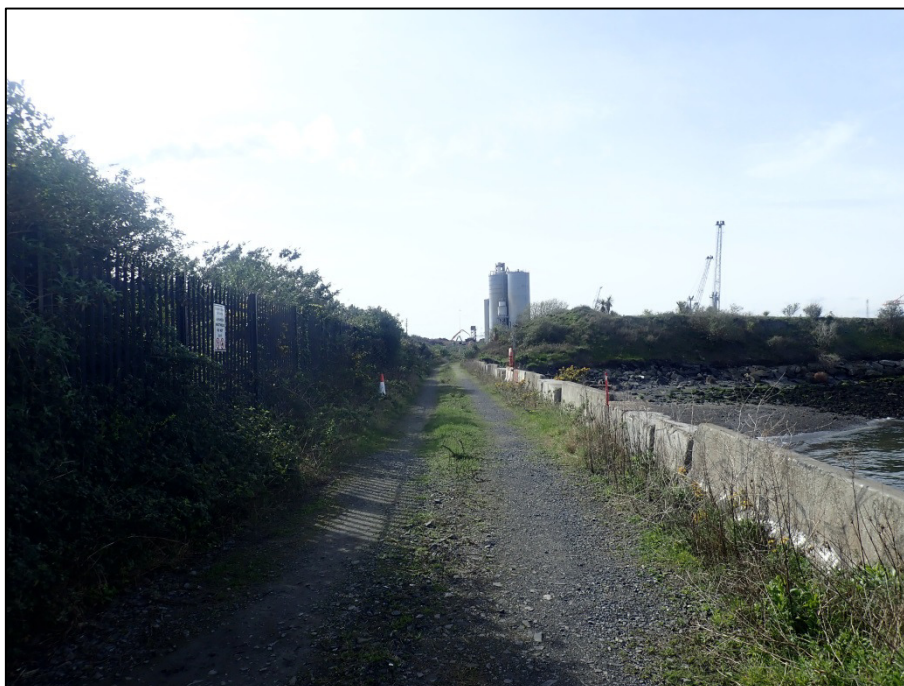
Plate 35: West-facing view along top of Feature F02; shot taken from west side of the entrance to the Sludge Jetty, note reclamation area in distance (1m scale).

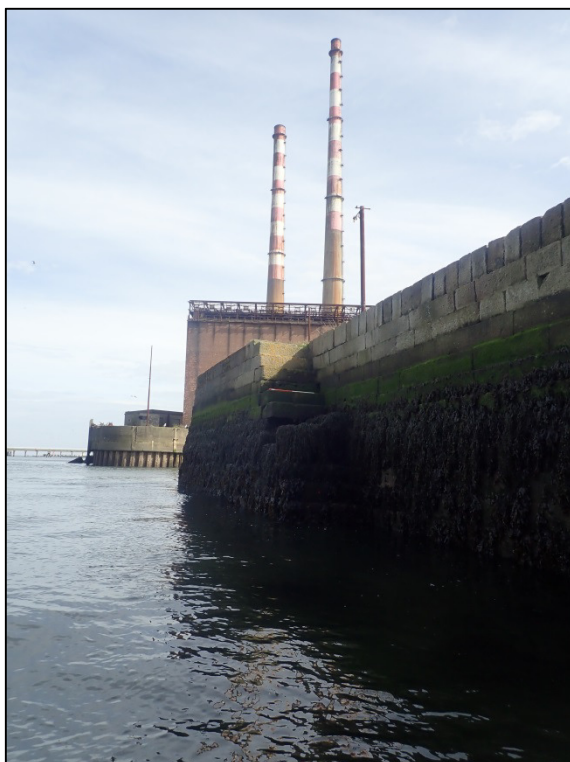
Plate 36: East-facing view of channel side façade of historic pier-head (Feature F02) at entrance to Pigeon House Harbour (1m scale).

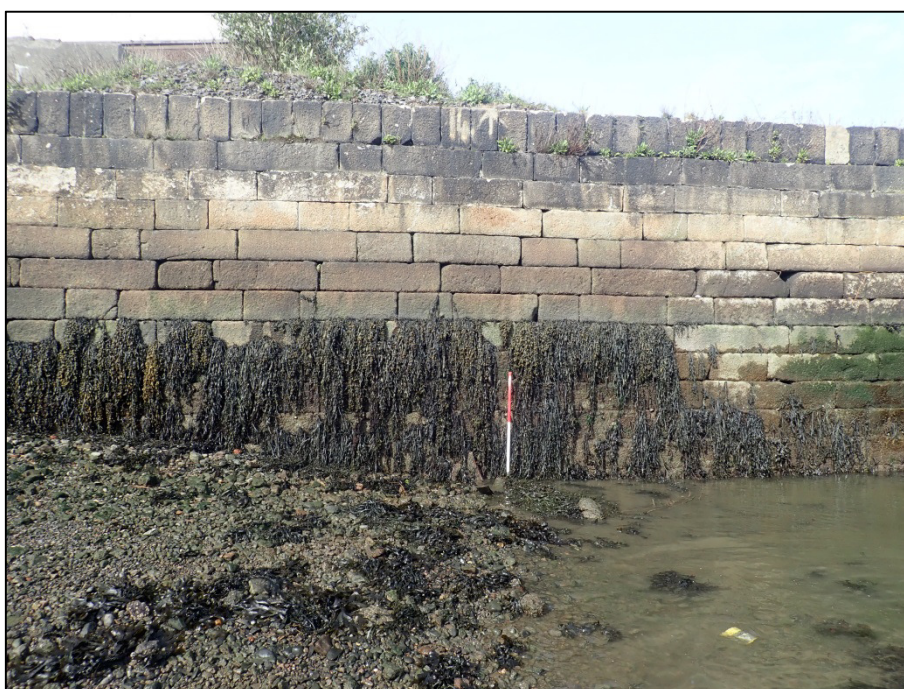
Plate 37: North-facing view of masonry comprising internal façade of pier-head, Feature F02 (1m scale).

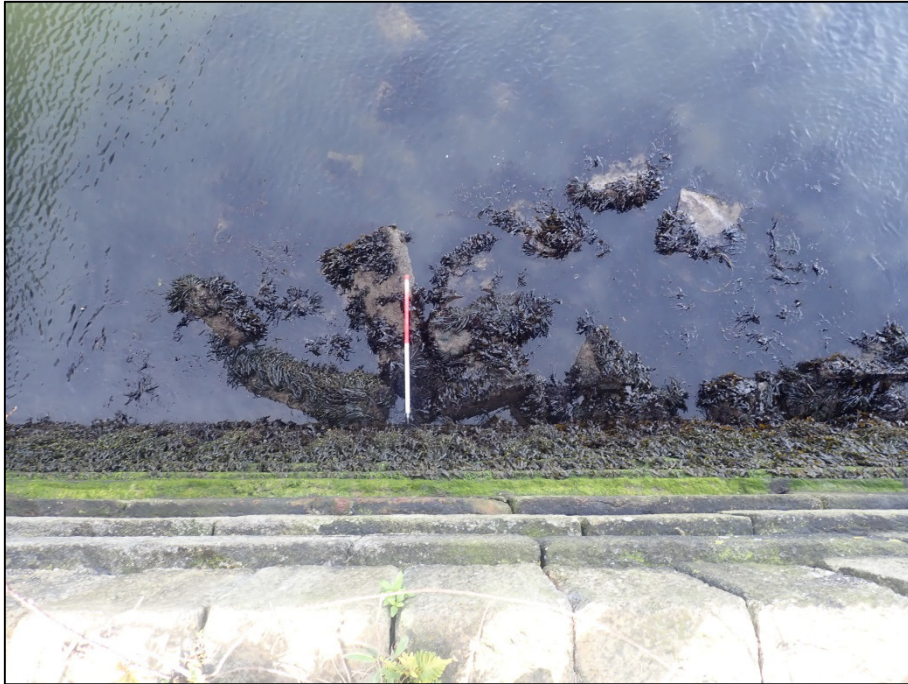
Plate 38: Shot looking down the external façade of the pier-head (Feature F02) showing a stepped profile to the masonry courses (1m scale).

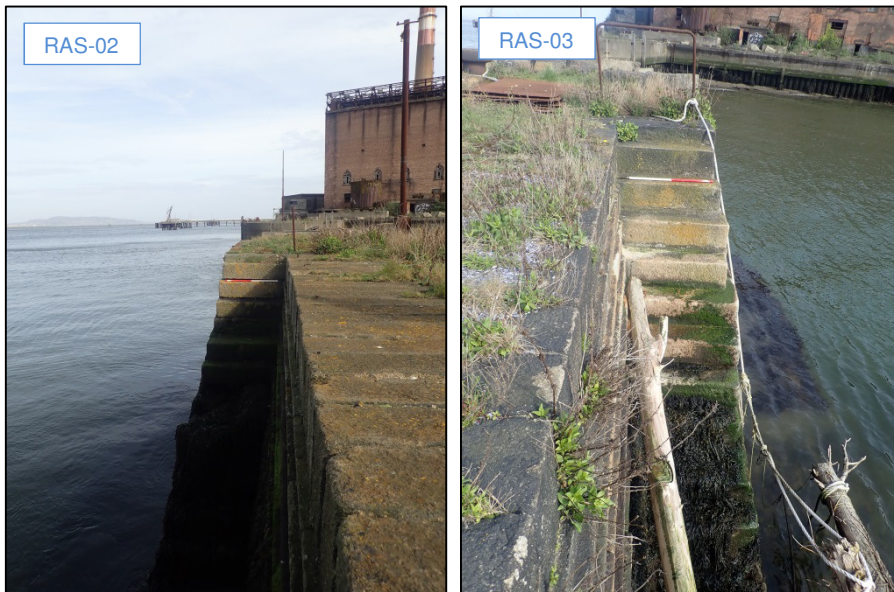
Plate 39: Opposing access steps, RAS-02 and RAS-03, located on the north and south sides of pier-head at the entrance to Pigeon House Harbour (1m scale).

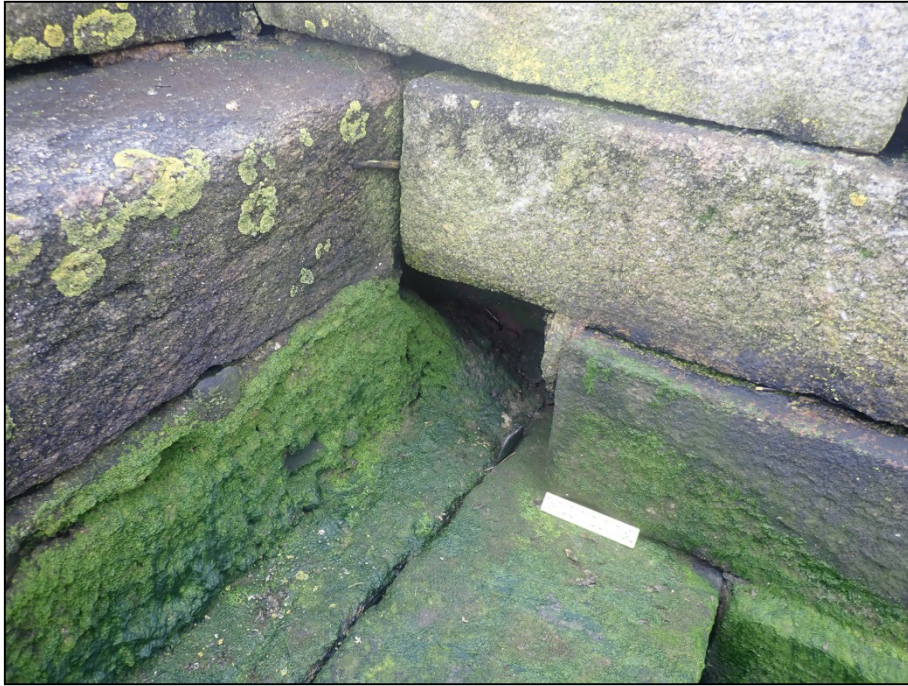
Plate 40: Detail shot showing masonry steps in-set into quay-wall at pier-head, RAS-02 (150mm).

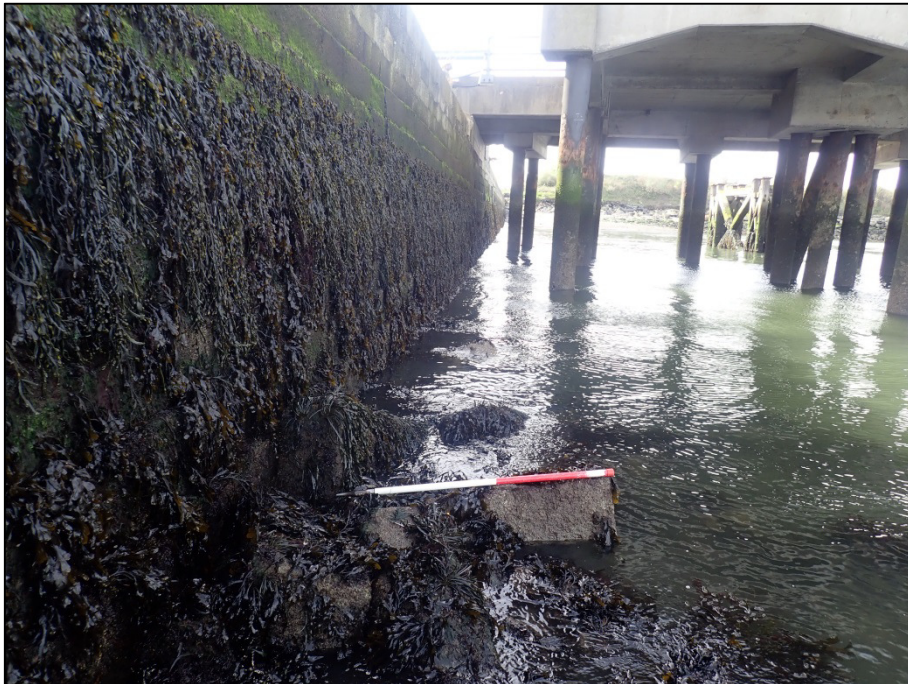
Plate 41: West-facing view along channel side of Feature F02, showing collapsed masonry from the pier-head access steps (RAS-02) in foreground and upstream Sludge Jetty in the background (1m scale).

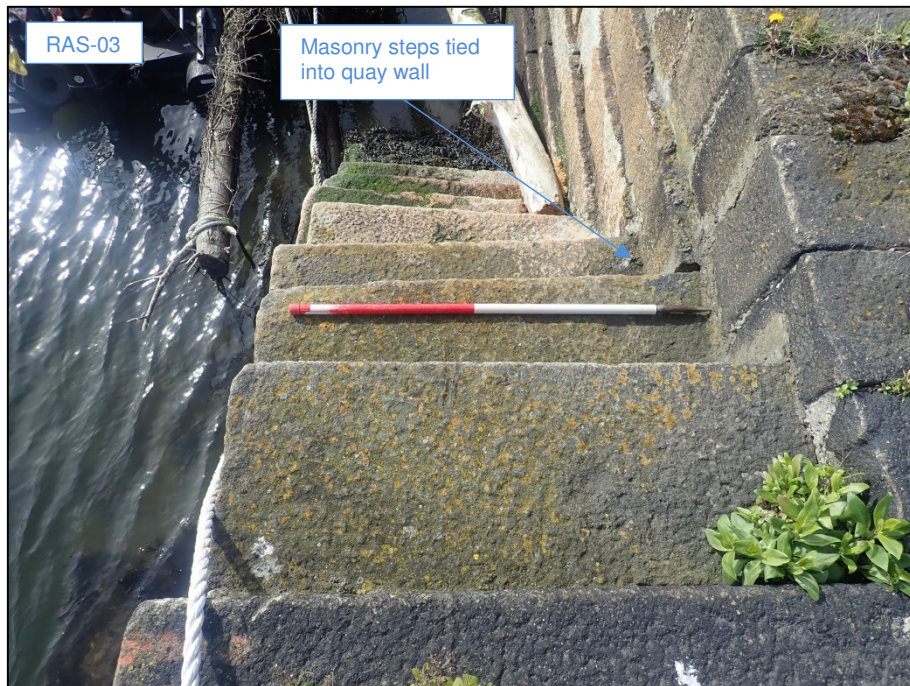
Plate 42: View looking down the set of access steps (RAS-03) located on the south side of the pier-head (1m scale).

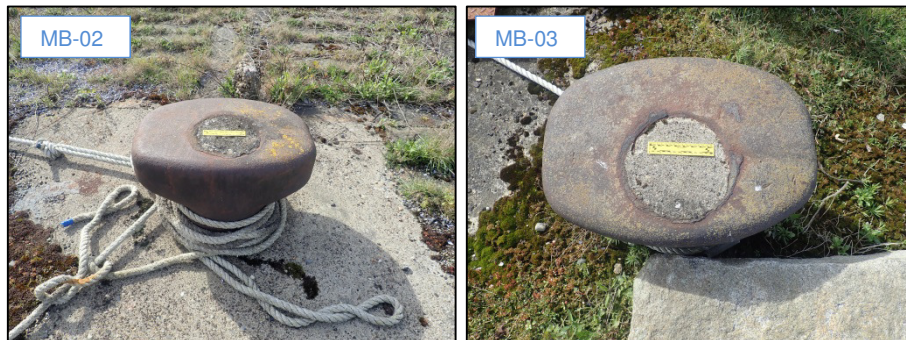
Plate 43: Cast-iron mooring bollards, MB-02 and MB-03, inset into deck of the pier-head of Feature F02 at entrance to Pigeon House Harbour (150mm scale); ITM 720299E, 733844N and ITM 720315E, 733844N respectively.

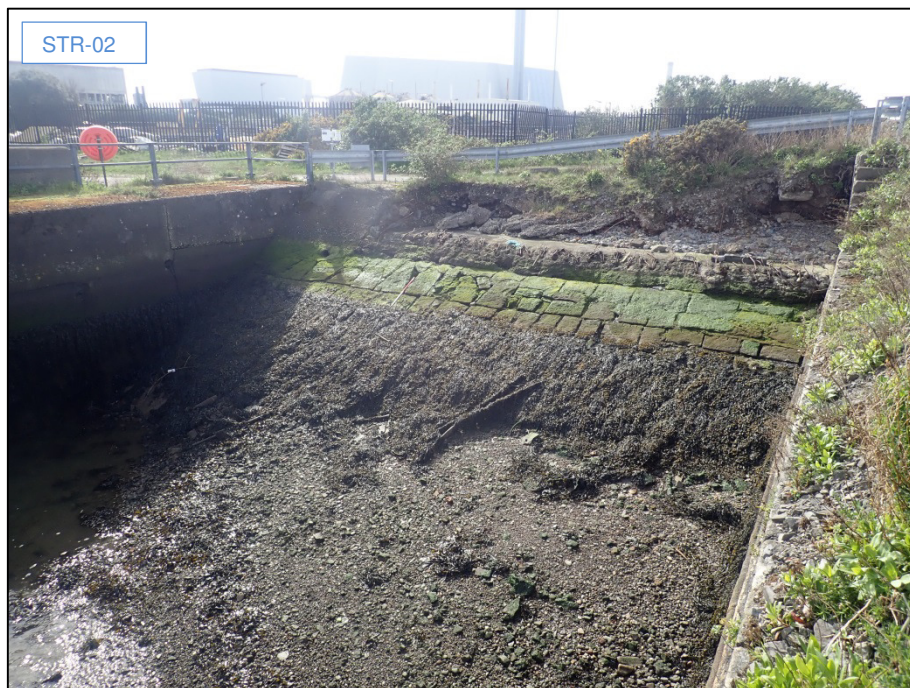
Plate 44: Timber structure (STR-01) located c. 14m north of a culvert for the Pigeon House outfall works at ITM 720262E, 733622; STR-01 is thought to be associated with those works, completed in the 1906 (1m scale).

Plate 45: Southwest-facing view of section of angled retaining-wall (STR-02) located at northwest corner of Pigeon House Harbour (modern extent), ITM 720283E, 733836N; STR-02 comprises the remains of a substructure to a boat launch (1m scale).

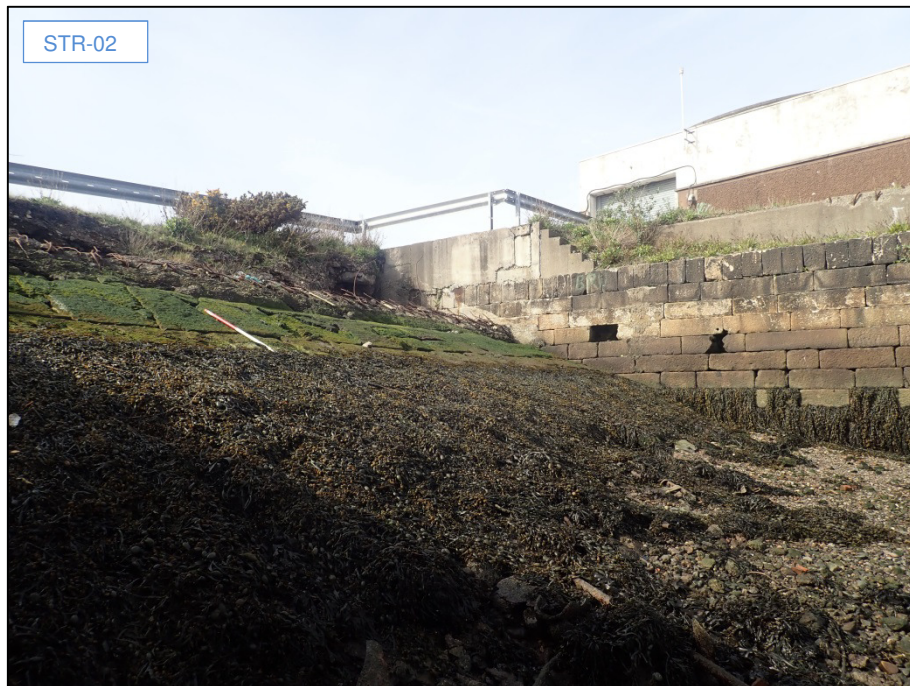
Plate 46: Northwest-facing view across face of angled retaining-wall STR-02 (1m scale).

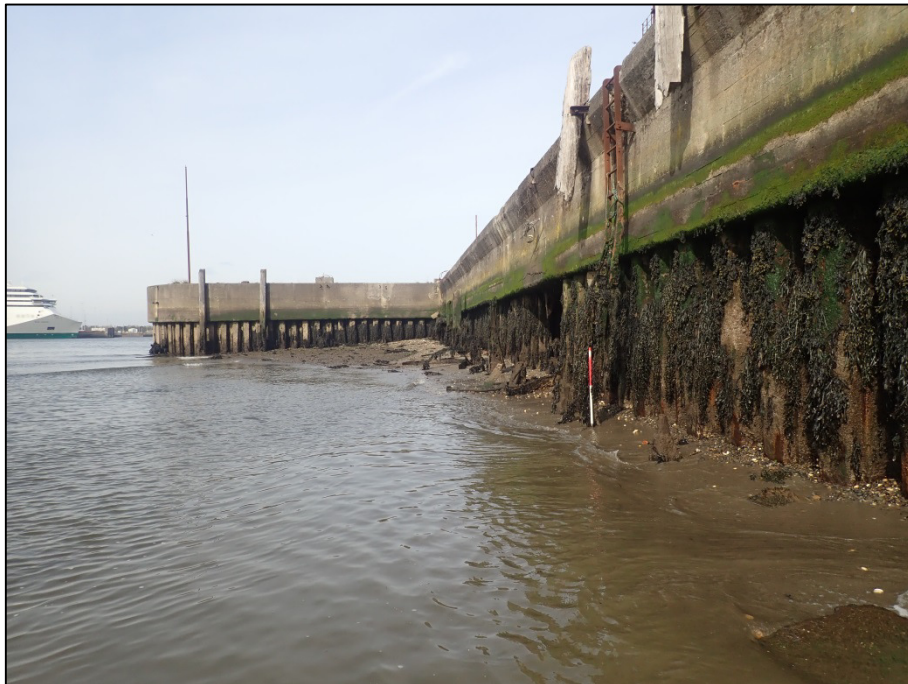
Plate 47: North-facing of sheet pile wall forming a c. 50m-long section of quayside on east side of harbour basin, leading onto modern pier-head at harbour entrance (1m scale).

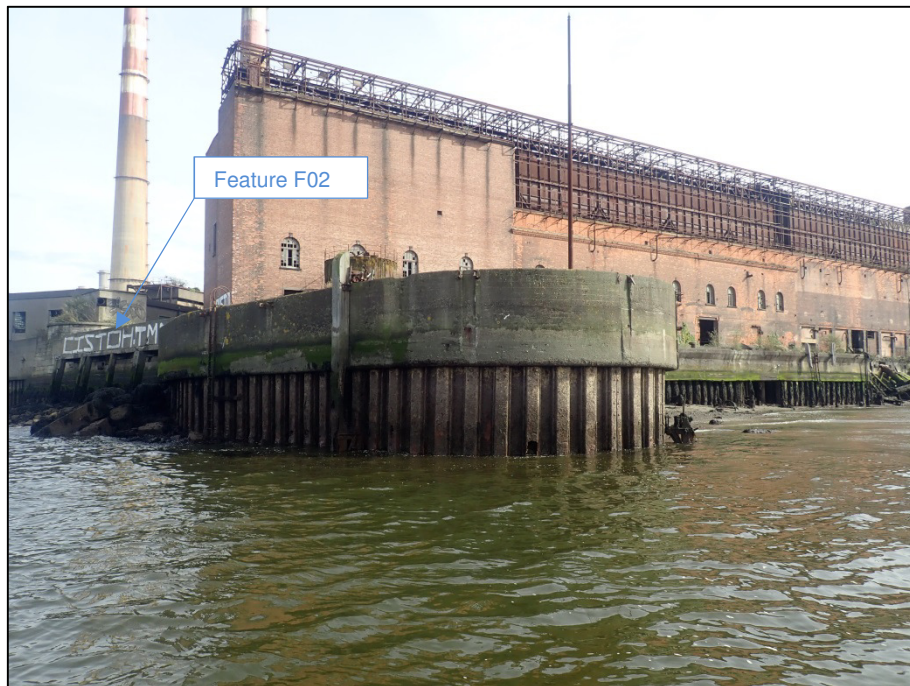
Plate 48: Southeast-facing view of pier-head forming east side of harbour entrance, note presence of original quay-wall behind this structure.

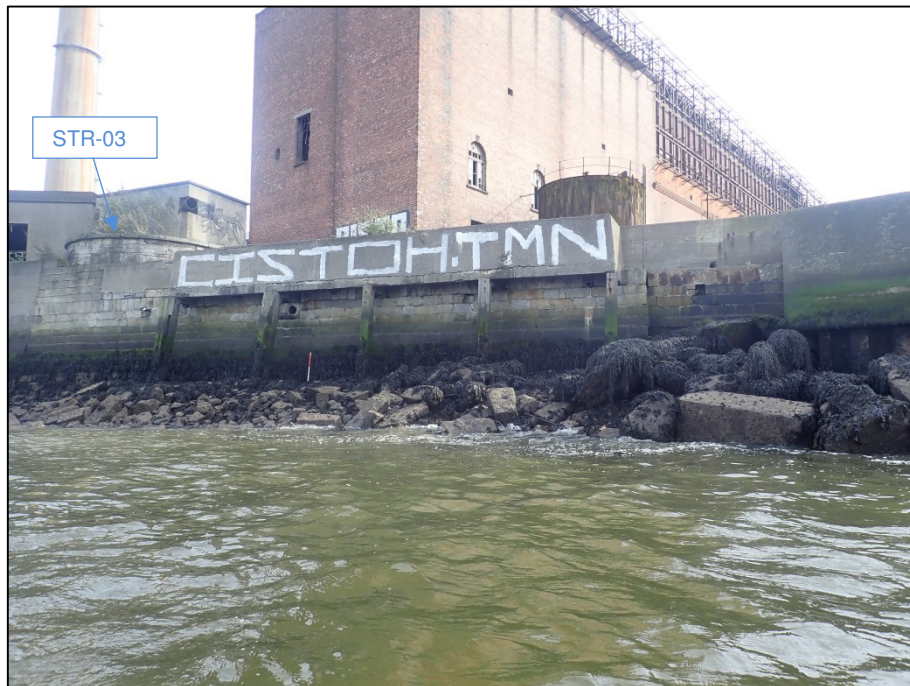
Plate 49: South-facing view of 34m-long section masonry façade from quayside (Feature F02; east) that originally delineated the harbour entrance, on its east side; ITM 720379E, 738546N to ITM 720414E, 733847N (1m scale).

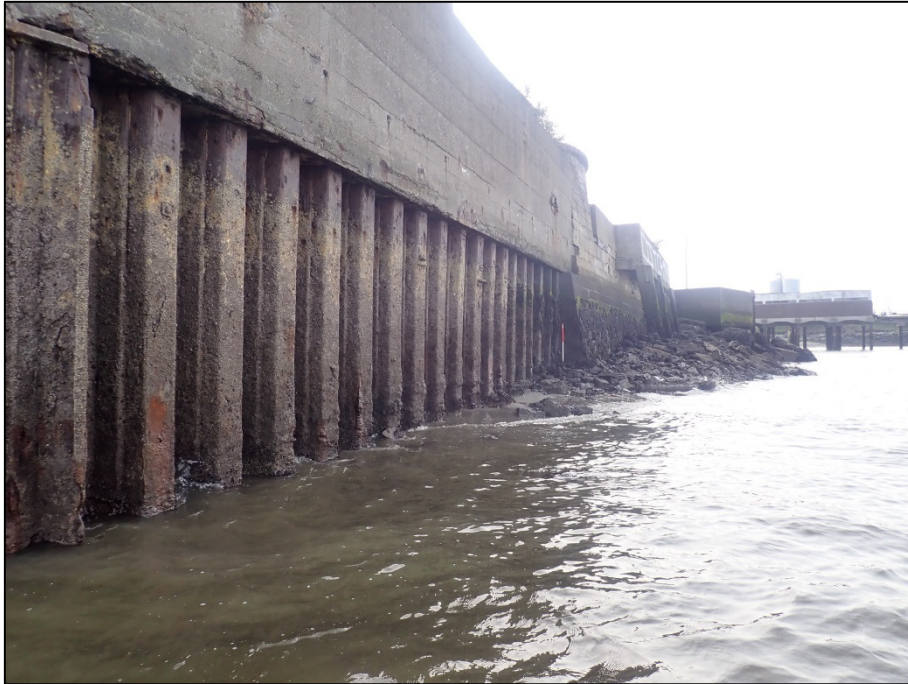
Plate 50: West-facing view along sheet-pile wall located to the east of a section of masonry façade comprising remains of Feature F02; east (1m scale).

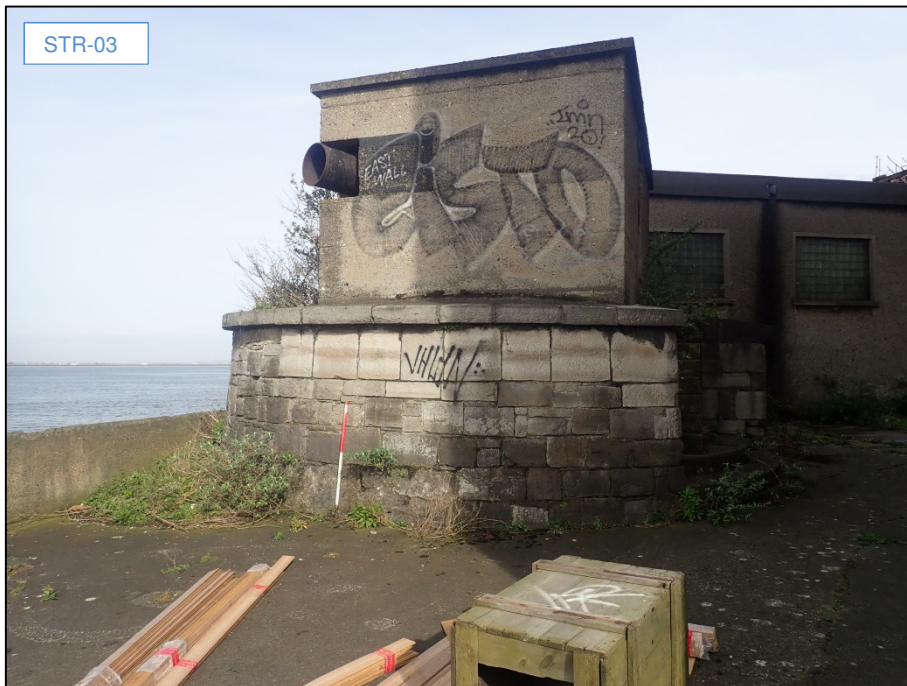
Plate 51: West side of nineteenth-century gun emplacement/viewing platform (STR-03), located c. 45m east of pier-head at the entrance to Pigeon House Harbour (1m scale).

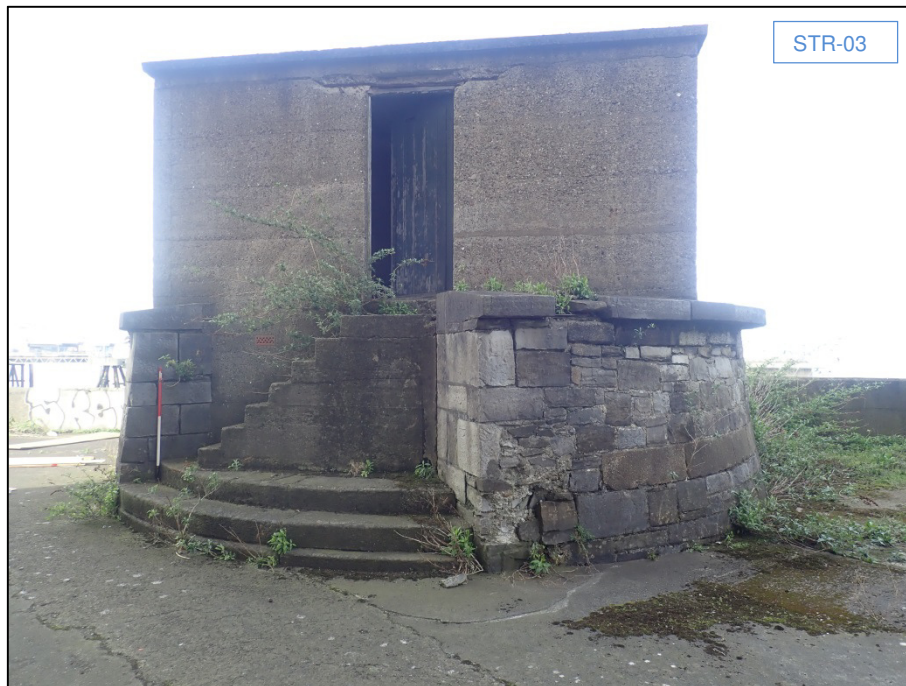
Plate 52: South side of gun emplacement/viewing platform (STR-03) with probable twentieth-century pillbox structure above (1m scale).

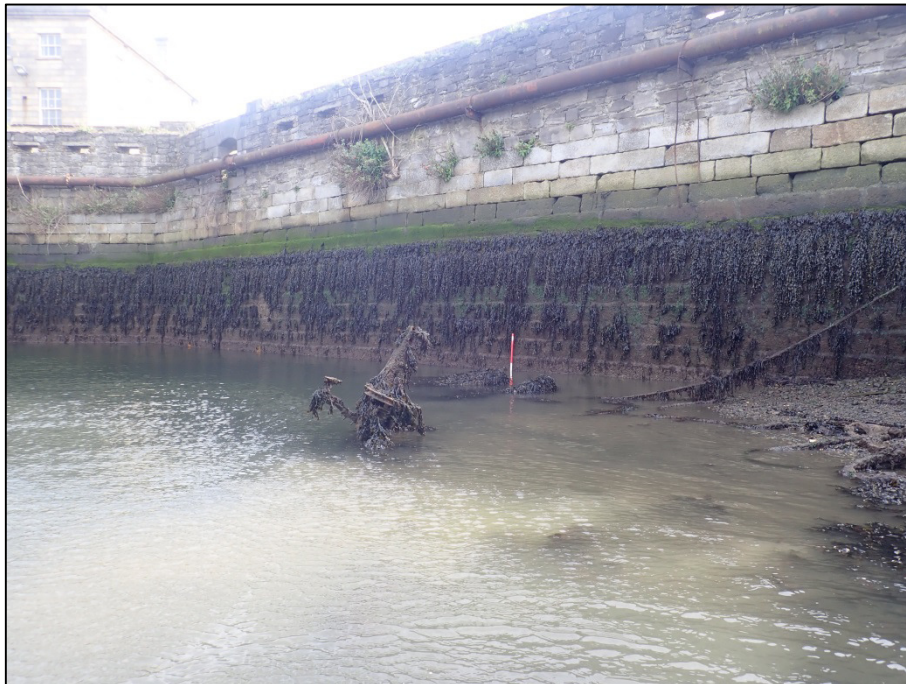
Plate 53: South-facing view of masonry quay that delineates the southeast part of the harbour basin (Feature F03) with defensive parapet-wall above (1m scale).

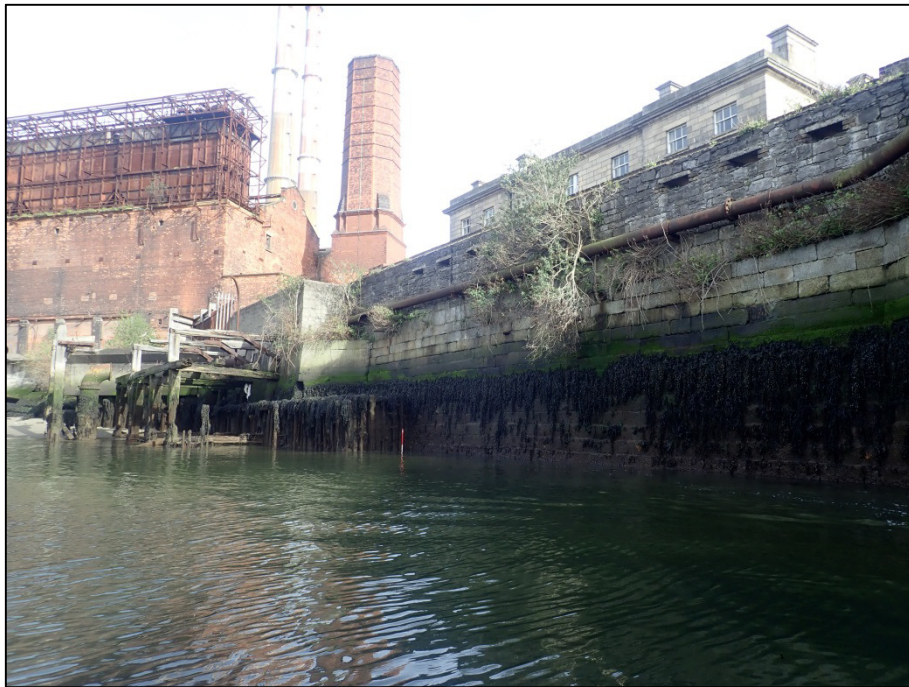
Plate 54: East-facing view of masonry quay that delineates the southeast part of the harbour basin (Feature F03), note underpinning of quay and timber wharf to left of picture (1m scale).

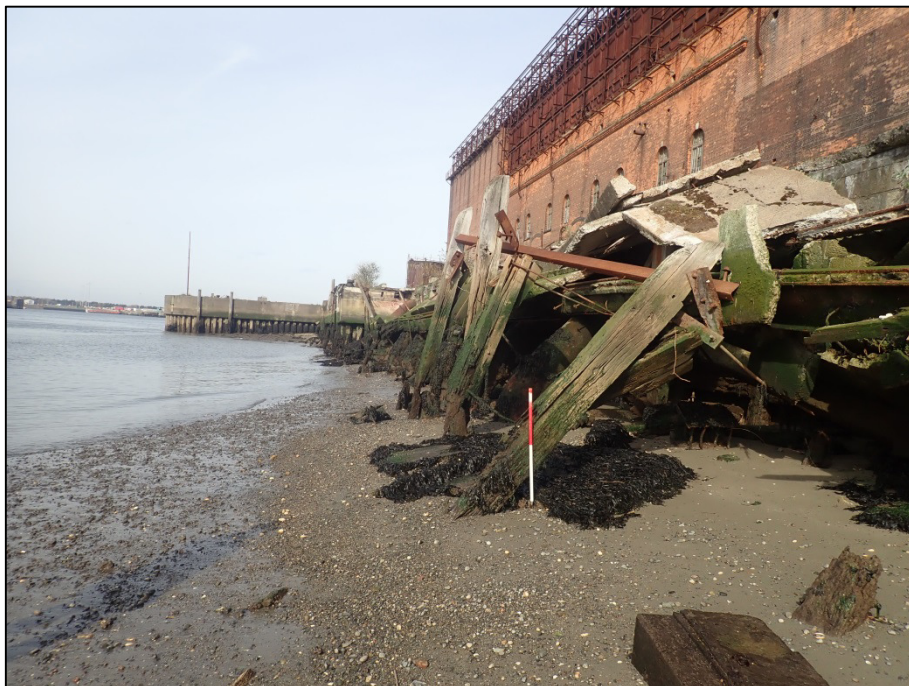
Plate 55: North-facing view of collapsed, twentieth century, quayside on east side of harbour basin, behind which an original masonry quay are located (1m scale).

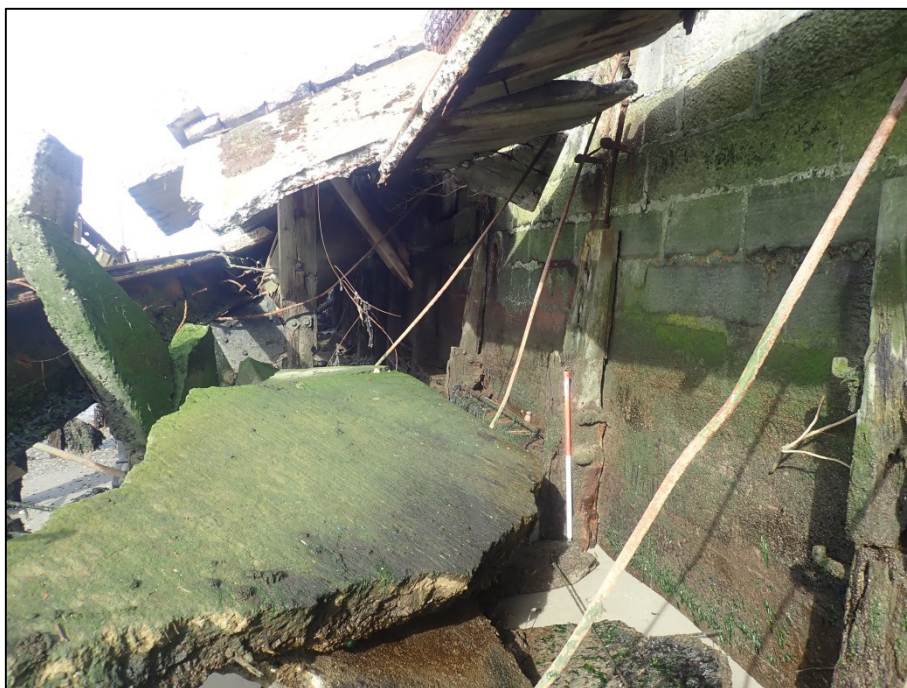
Plate 56: Original quay-wall (Feature F03) located behind the jumble of collapsed debris from a later quayside (1m scale).

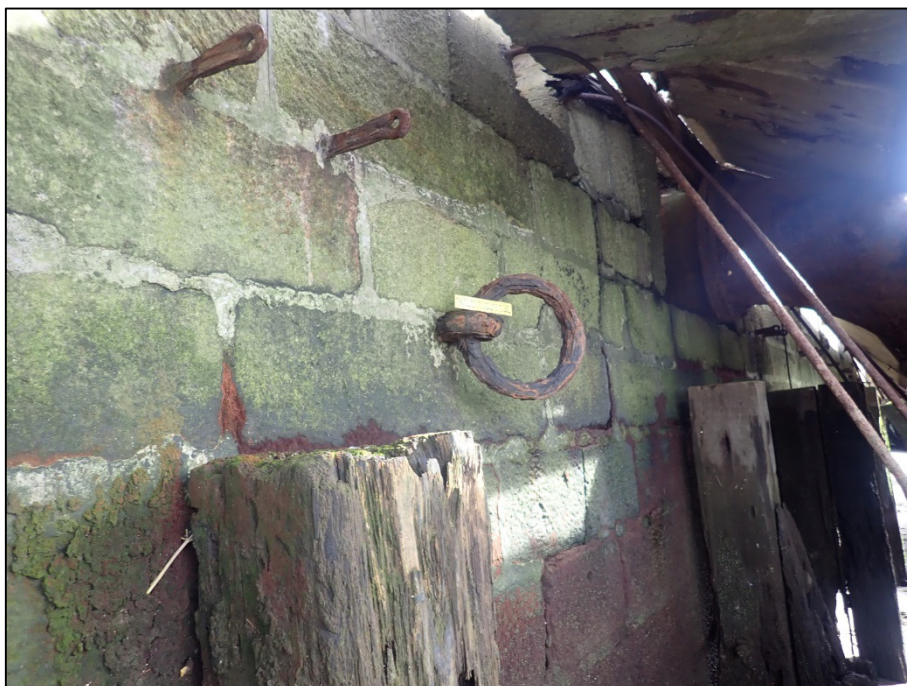
Plate 57: Example of wrought-iron mooring rings that are retained along the façade of masonry quay Feature F03; on east side of harbour basin (150mm scale).

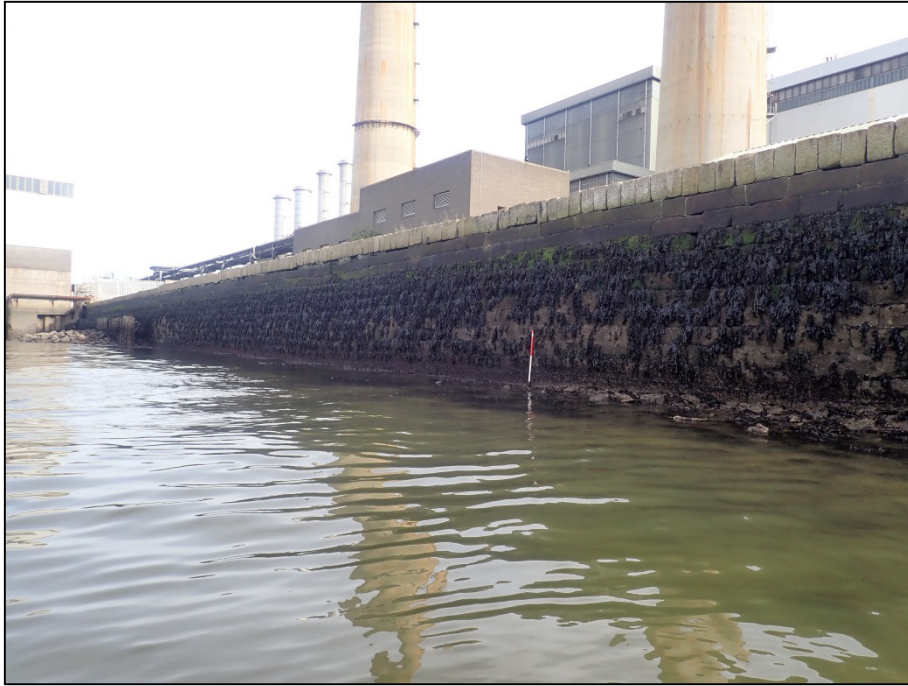
Plate 58: East-facing view along a 120m section the GSW, where it extends between Pigeon House Fort and an ESB Jetty; Survey Area 4, GSW-west (1m scale).

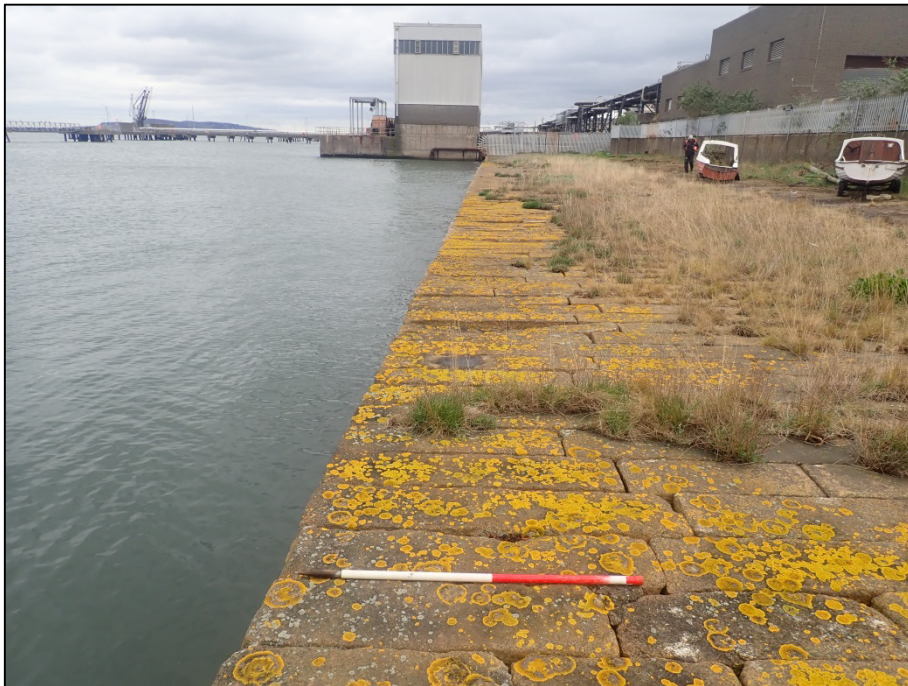
Plate 59: East-facing view along surface of the sea-wall; Survey Area 4, GSW-west (1m scale).

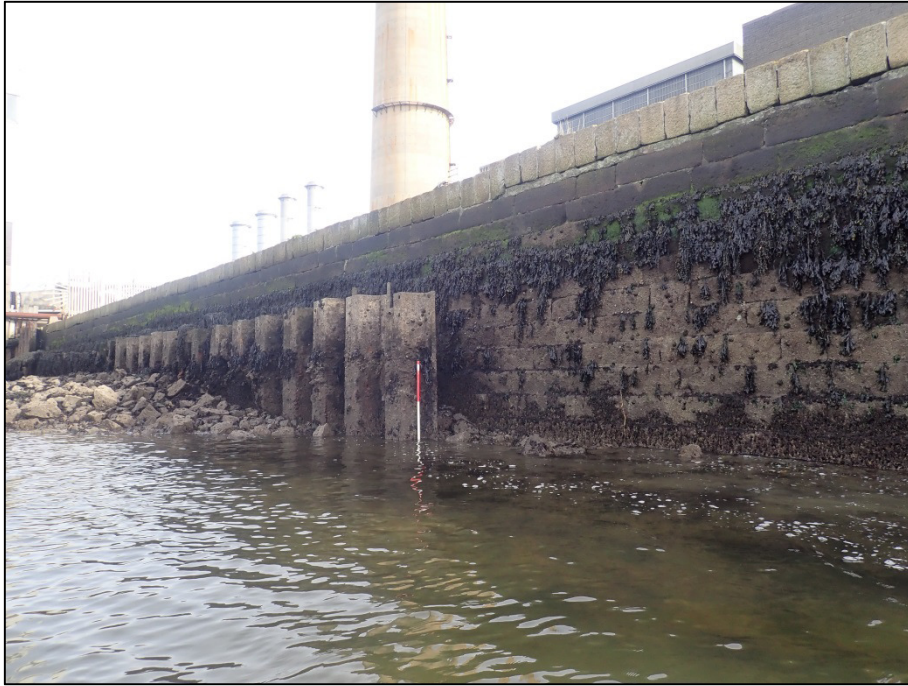
Plate 60: East-facing view of sheet-pile wall and associated rock-armour placed along eastern part of the sea-wall, leading onto the ESB Jetty; Survey Area 4; GSW-West (1m scale).

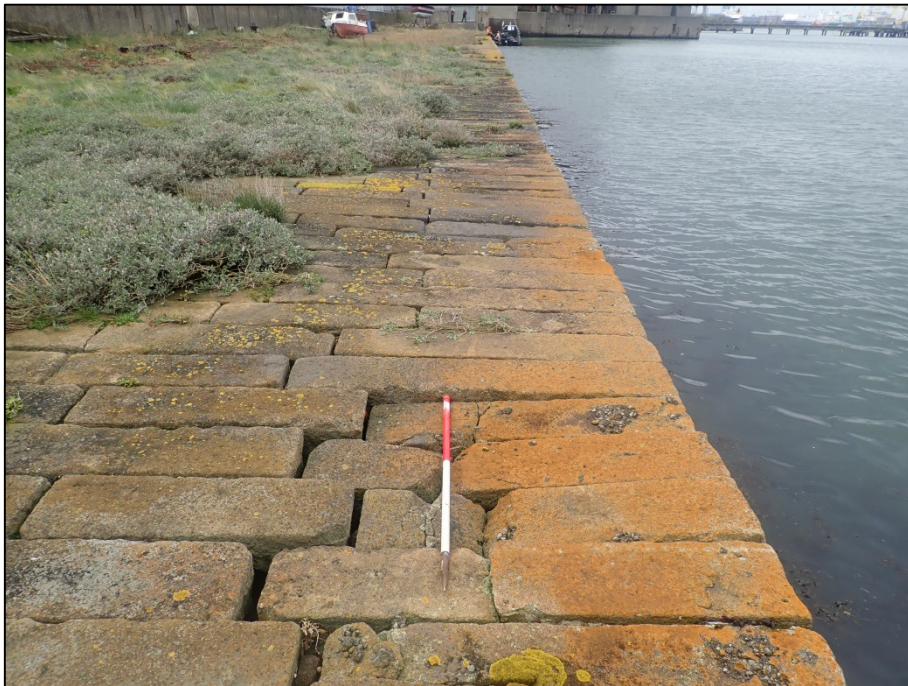
Plate 61: West-facing view of the surface of the sea wall where slumping/separation of masonry has occurred; Survey Area 4; GSW-West (1m scale).

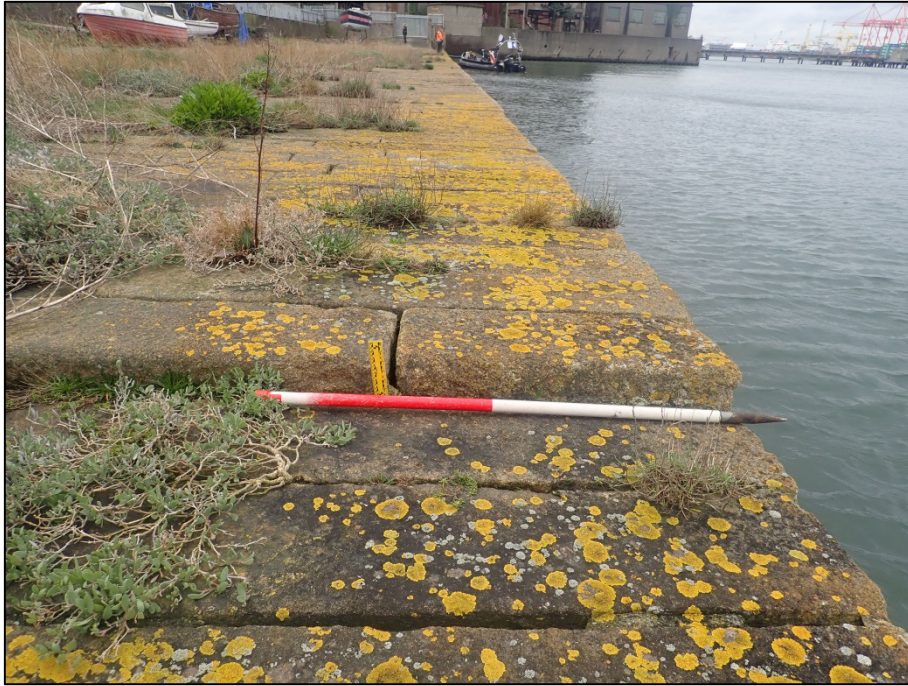
Plate 62: West-facing view of the surface of the sea wall at a point where there is a noticeable drop in the deck-level; Survey Area 4; GSW-West (150mm/1m scales).

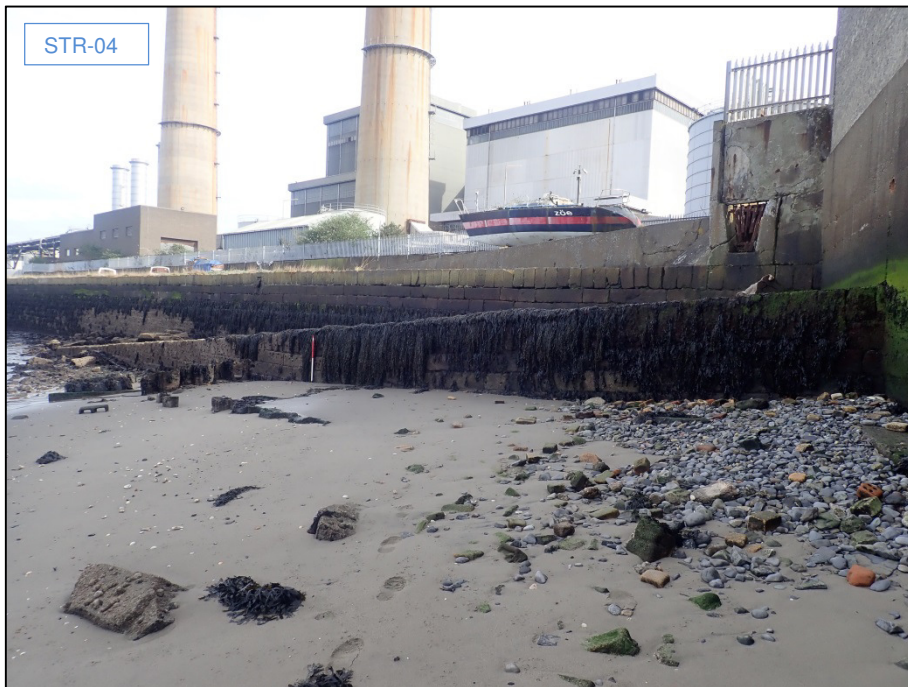
Plate 63: South-southeast facing view of masonry boat-slip (STR-04) located alongside the sea-wall on the east side of Pigeon House Fort Survey Area 4; GWS-west (1m scale).

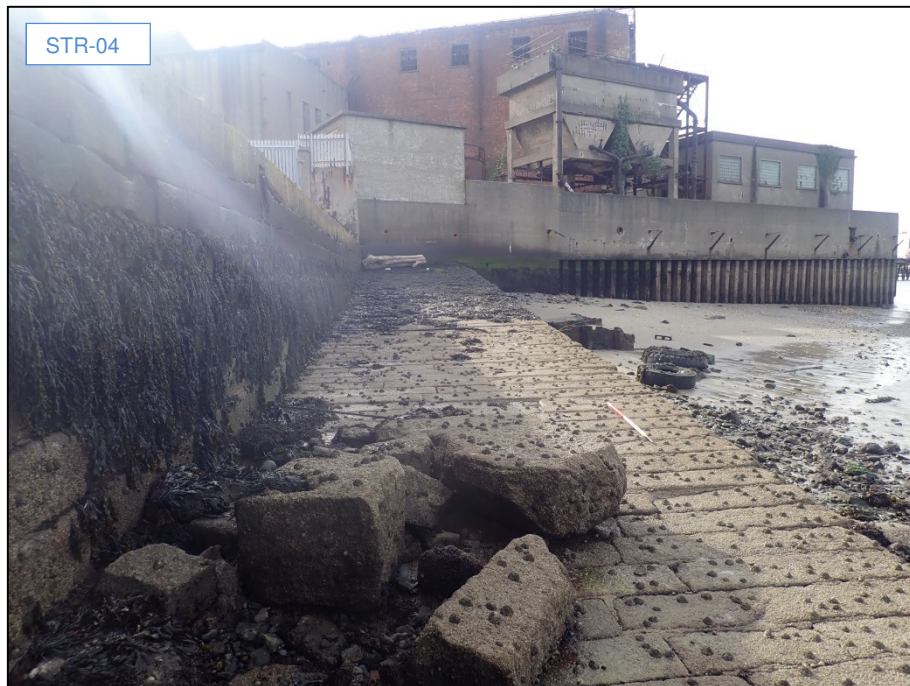
Plate 64: West-facing view of along the surface of masonry boat-slip STR-04; Survey Area 4; GWS-west (1m scale).

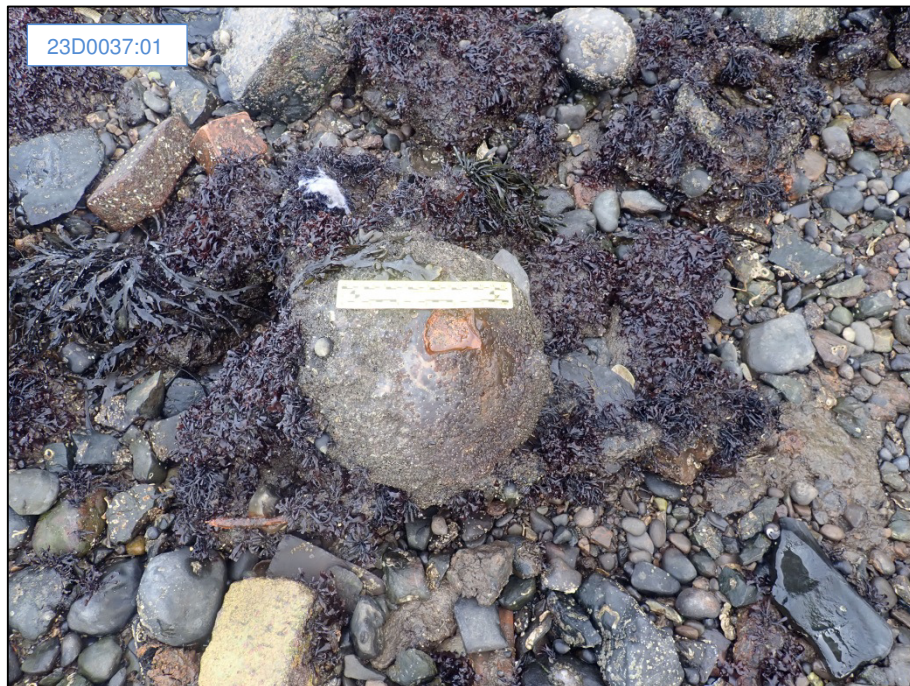
Plate 65: Concreted cast-iron cannon ball, Find No. 23D0037:01; Survey Area 4; GWS-west (150mm scale).

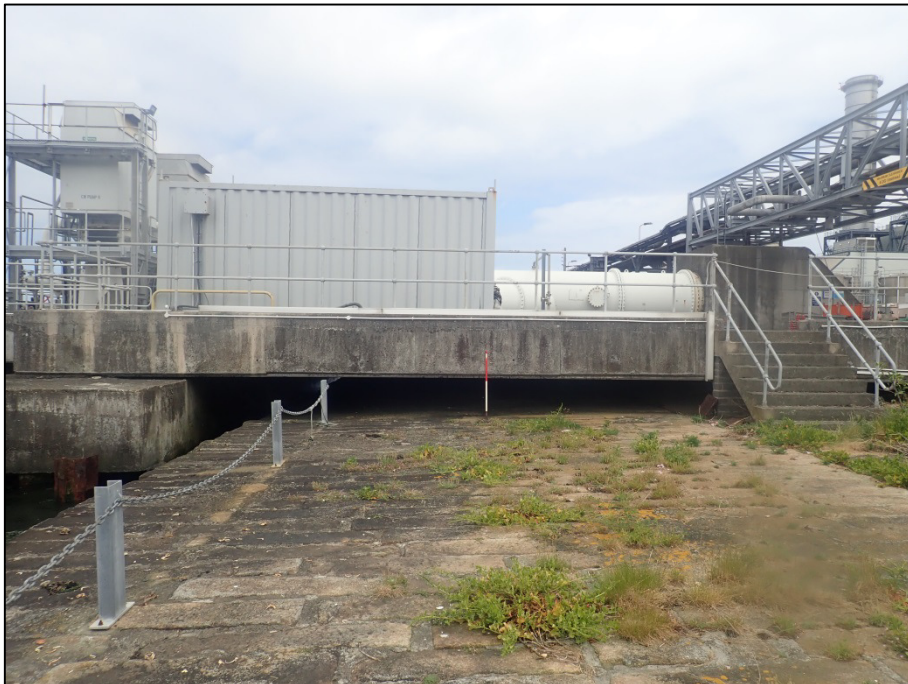
Plate 68: West-facing view of ESB Jetty located on the west side of Survey Area 4, GSW-West 1 (1m scale).
