**Underwater Archaeological Impact Assessment (UAIA)
ADCOCO Areas 1-4, River Liffey, Dublin Port**

**Dublin Port 3FM Project
Project Reference CP1770_021**

Final Report
Client
Project Director

29 May 2024
RPS for DPC
Rex Bangerter MA

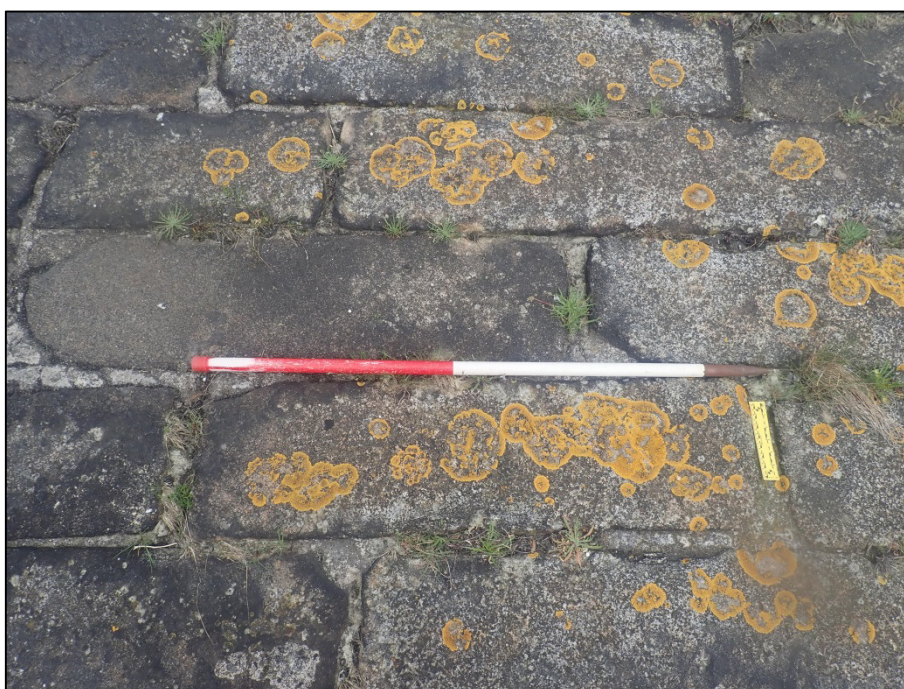
This section of the GSW remains in a relatively good state of preservation, the deck area remaining level and no evidence of dipping/ slumping cross its surface being present (Plate 72). The Oil Jetty sits upon the GSW, obscuring a c. 14m section of the structure. Concrete ramps provide access to the jetty from the sea-wall on either side of the structure; extending across a c. 13.4m section of the GSW to the west, and a c. 9.8m section to the east. As per the previous section of sea-wall, the following applies:

Plate 72: East-facing view of the surface of the sea-wall; Survey Area 4, GSW-west 2 (150mm/1m scales).

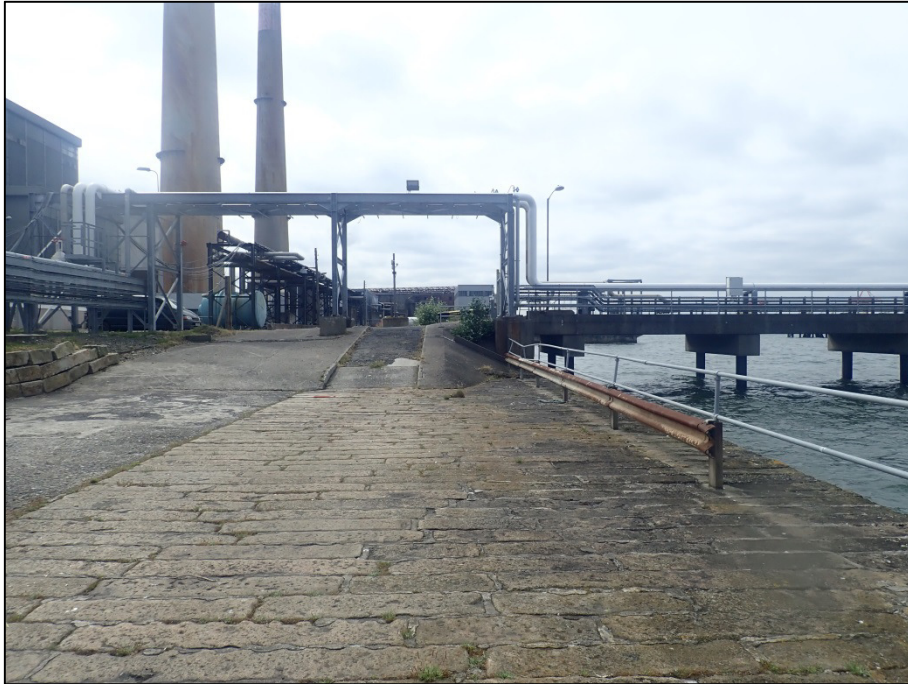
- The south side of the structure remains buried behind an area of poured mass-concrete that leads onto the ESB site.
- The deck-level has been repointed using cement to consolidate the upper surface of the structure (Plate 73).
- A series of equidistantly spaced metal-bollards, fastened with link-chain, form a safety barrier close to the edge of the GSW.
- Rock-armour has been placed along the base of the sea-wall which obscures the channel-side façade, leaving only the upper most courses of the structure visible.

Plate 73: Example shot of deck masonry forming surface of the sea-wall (Survey Area 4; GSW-west 2); repointed using cement (150mm/1m scales).

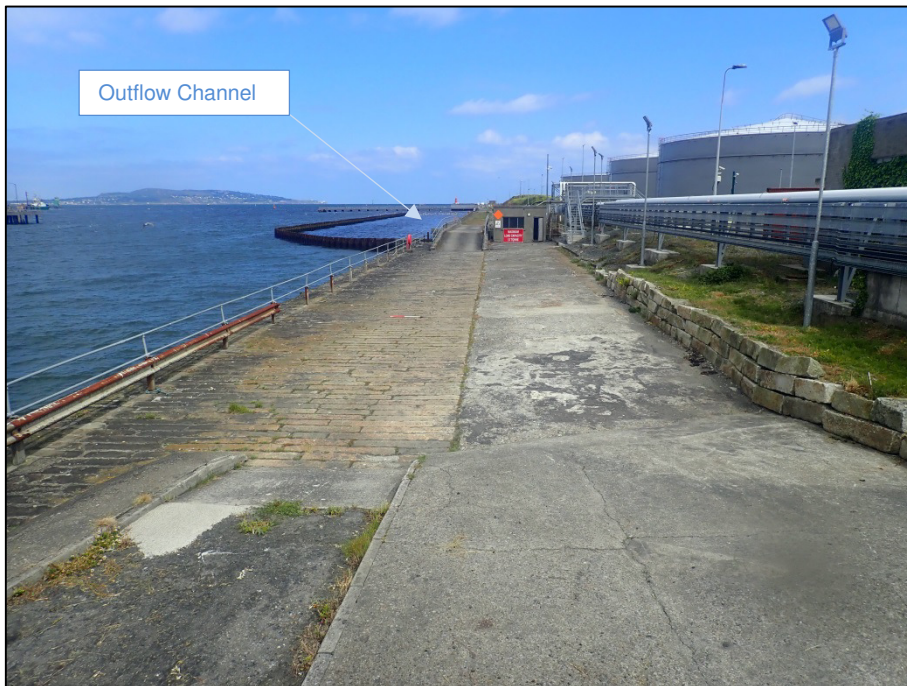
This comprises a 108.5m section of the GSW, extending to the west of the NORA Oil Jetty, ITM 720753E, 733821N to ITM 720861E, 733824N (Plate 74-75). The sea-wall is truncated by an outflow channel for the ESB power station, impacting a c. 22m section of the structure between ITM 720820E, 733815N and ITM 720840E, 733518N (Plate 76). A ramped concrete structure, measuring 42m length by 4m in width, forms a bridge over the outflow channel (Plate 77). A sheet-pile wall extends, in a gentle curve, from the west side of the outfall for a distance of c. 36m, before turning due east to run parallel to the sea-wall for a distance of c. 193m.

Plate 74: West-facing view of the surface of the sea-wall with NORA Oil Jetty in background; Survey Area 4, GSW-west 3 (1m scale).

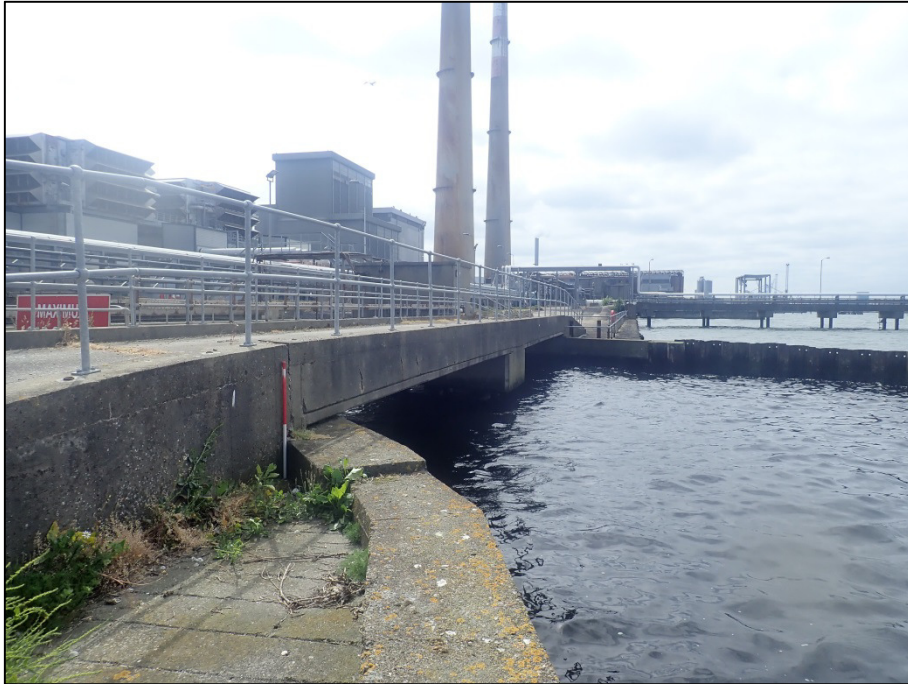
Plate 75: East-facing view of the surface of the sea-wall with outflow channel background; Survey Area 4, GSW-west 3 (1m scale).

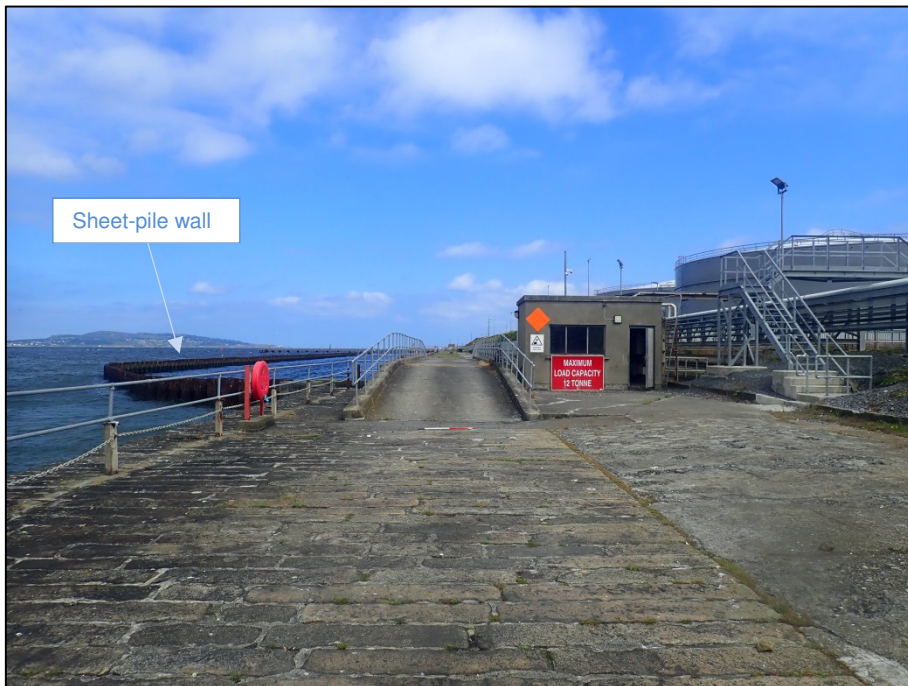
Plate 76: West-facing view of outfall channel that truncates c. 22m section of the GSW between ITM 720820E, 733815N and ITM 720840E, 733518N (1m scale).

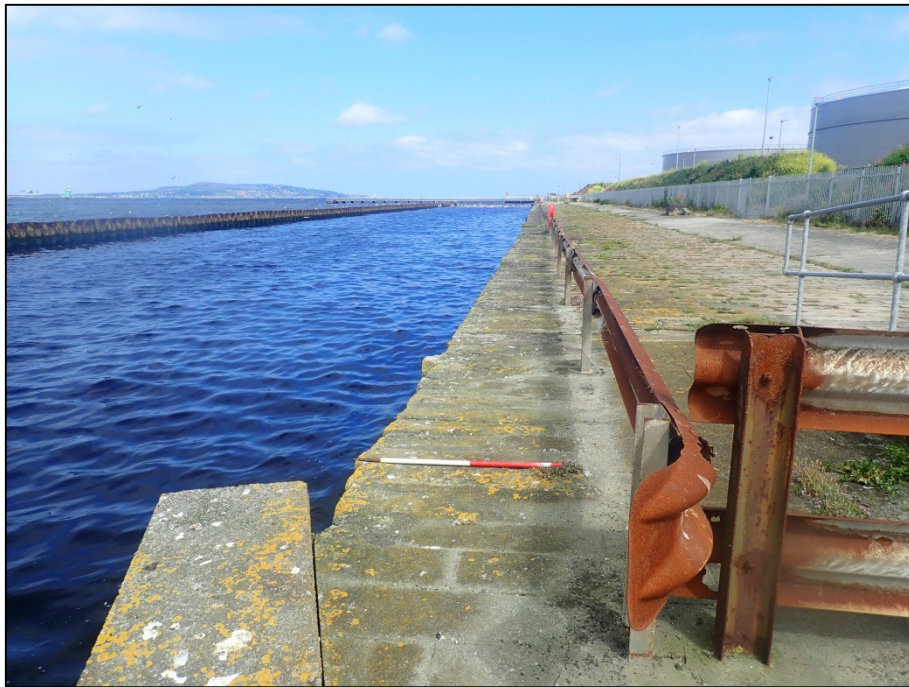
Plate 77: East-facing view of the surface of the sea-wall, leading onto bridge over outfall channel; Survey Area 4, GSW-west 3 (1m scale).

Plate 78: East-facing view of channel formed by the GSW and the adjacent sheet-pile wall; Survey Area 4, GSW-east (1m scale).

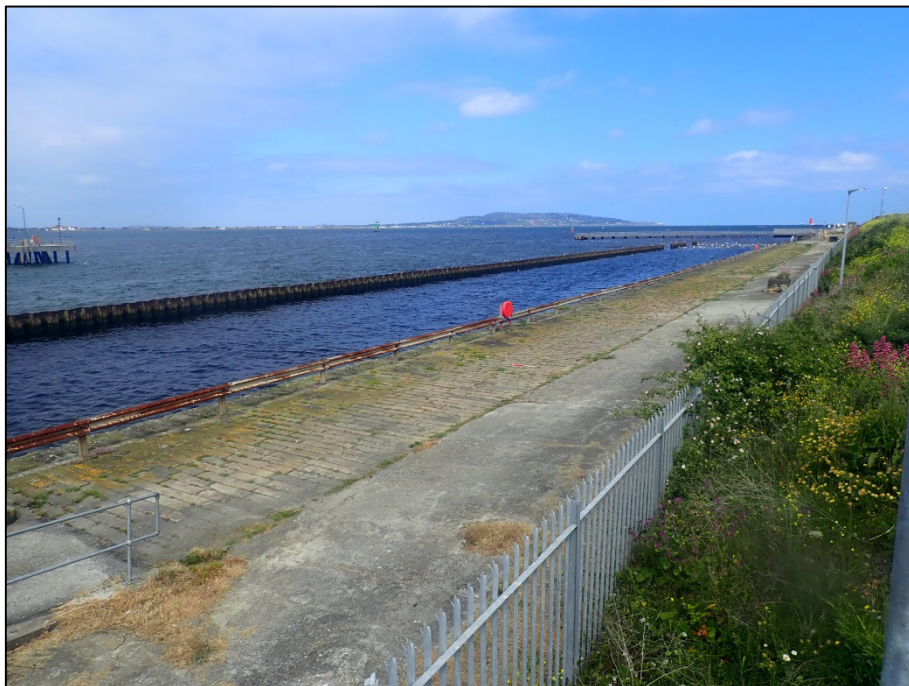
A significant portion of the GSW within this area (192m section) lies behind a sheet-pile wall, the channel formed between this and the GSW measuring 22m in width (Plates 78-79). A series of diffusers release treated effluent at a location c. 180m along this channel (Plate 80). An associated outfall pipe truncates the GSW at this location, ITM 721002E, 733830N (Plate 81).

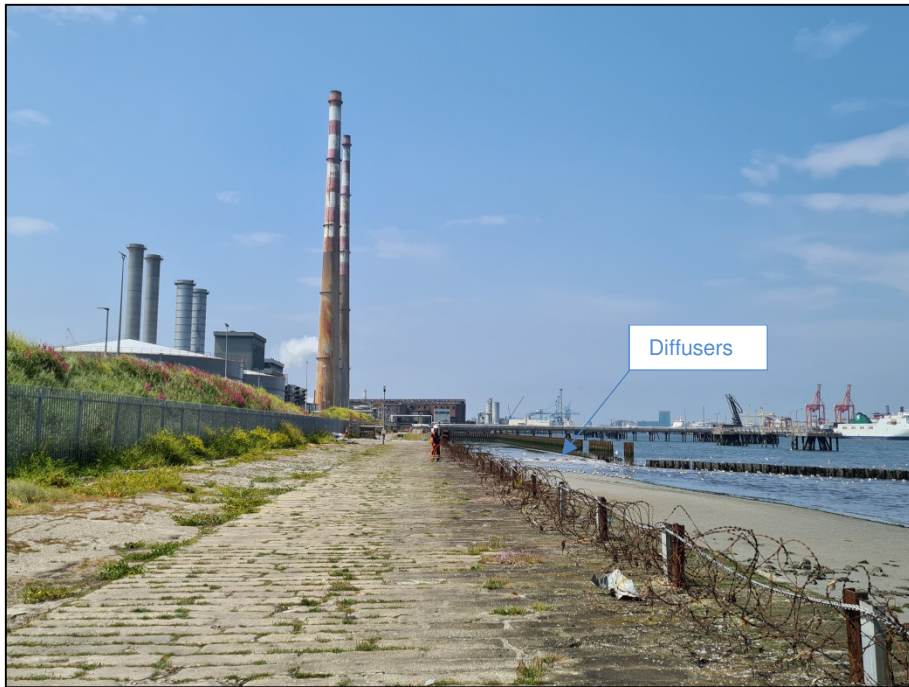
Plate 79: Northeast-facing view of the surface of the sea-wall with adjacent sheet-pile wall located 22m to the north; Survey Area 4, GSW-east (1m scale).

Plate 80: West-facing view along the surface of the sea-wall; Survey Area 4, GSW-east.

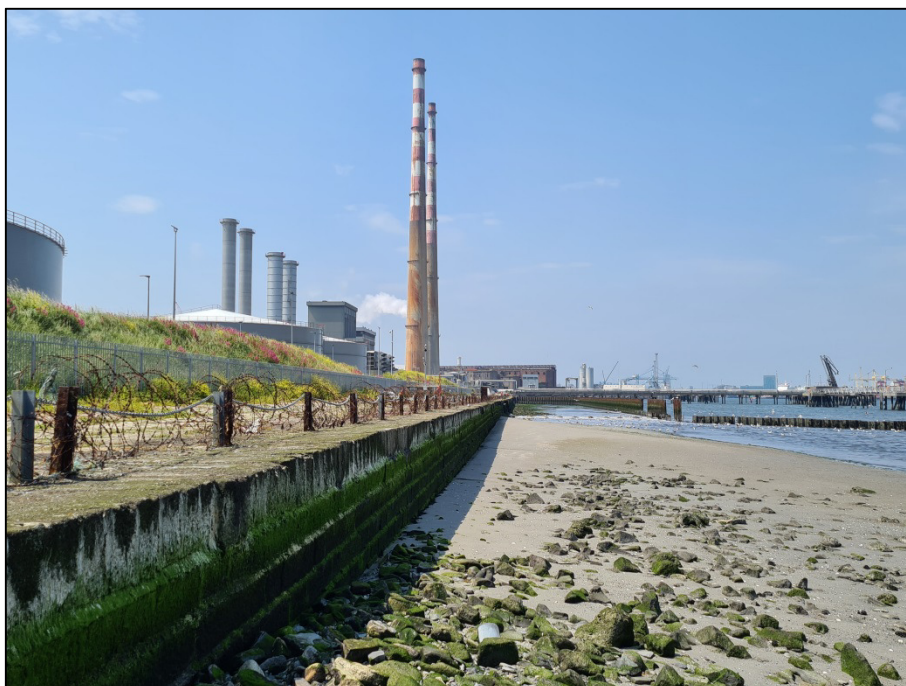
Plate 81: West-facing view of the surface of the GSW at the location of an outfall pipe that truncates the structure, Survey Area 4, GSW-east (1m scale).

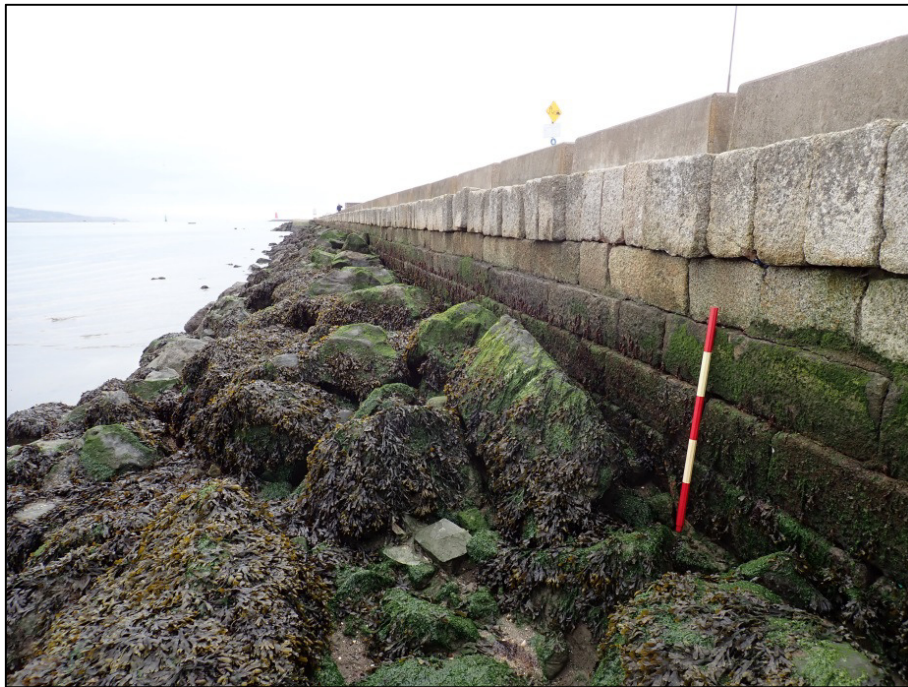
On the west side of the ESB Jetty, a heavily eroded sheet-pile wall extends southward across the intertidal zone to conjoin with the outflow channel (Plate 83).

Plate 83: South-facing view of the GSW from the terminus of the ESB Jetty.

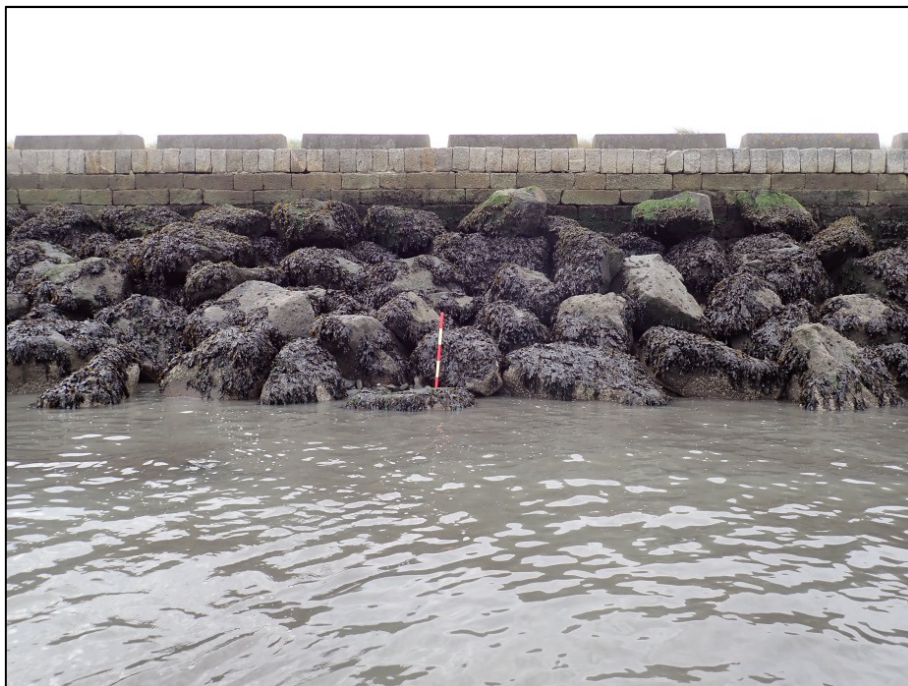
Plate 84: East-facing view of the channel-side façade of the GSW at a point c. 20m east of the ESB Jetty (Survey Area 4, GSW-east); note four masonry courses visible below capping stones before being covered by rock-armour protection (1m scale).

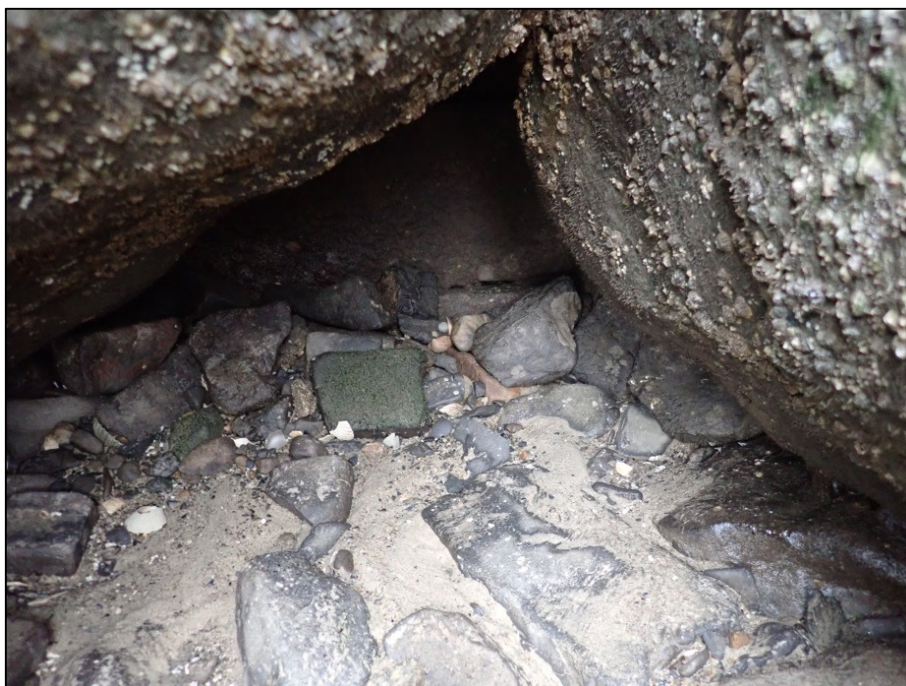
To the east of ESB power station, the GSW forms a promenade that delineates the southern side of the channel until its terminus at Poolbeg Lighthouse. Much of the structures north/south façades are obscured by the placement of rock-armour protection along its base. This protection extends to a width of up to 6m from the sea wall. The boulders used in the protection works are substantial, with some measuring more than 2m in length (Plates 84). As a result, where rock armour is present, only between four (4) and nine (9) masonry courses are visible below the capping stones (Plate 85). Despite the rock armour protection, slumping/dipping of the wall's masonry is visible in several places along its extent. The structural deterioration is most likely due to the fact the only the largest rock armour components remain present; smaller boulders having been washed away over time. Consequently, sea-wash is able to penetrate the larger gaps that are frequently present across rock-armour (noted to be up to 500mm x 1m in size); undermining the sea wall as a result (Plate 86).

Plate 85: East-facing view GSW (north façade) showing extent of associated rock-armour protection, Survey Area 4, GSW-east (1m scale).

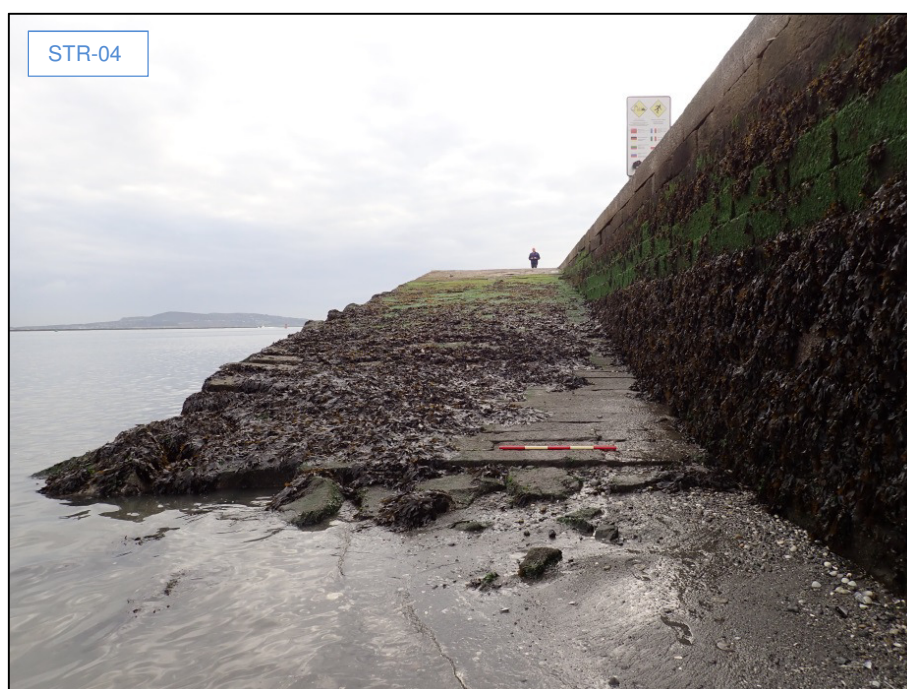
Plate 87: South-facing view of the GSW at location of set of masonry access steps, located short distance upstream of a boat-slip (STR-04); twelve (12) masonry courses visible for this section sea-wall (1m scale).

Plate 88: East-facing view of masonry slipway (STR-04) that abuts the north side of the GSW at the eastern limit of Survey Area 4 (1m scale).
