Environmental Impact Assessment Report

# DUBLIN PORT: 3FM

## Preliminary Risk Assessment (Desk Study) Report

794-NI-WAE-02239  
Dublin Port 3FM  
Preliminary Risk  
Assessment (Desk Study)  
Report  
Rev 01  
June 2024

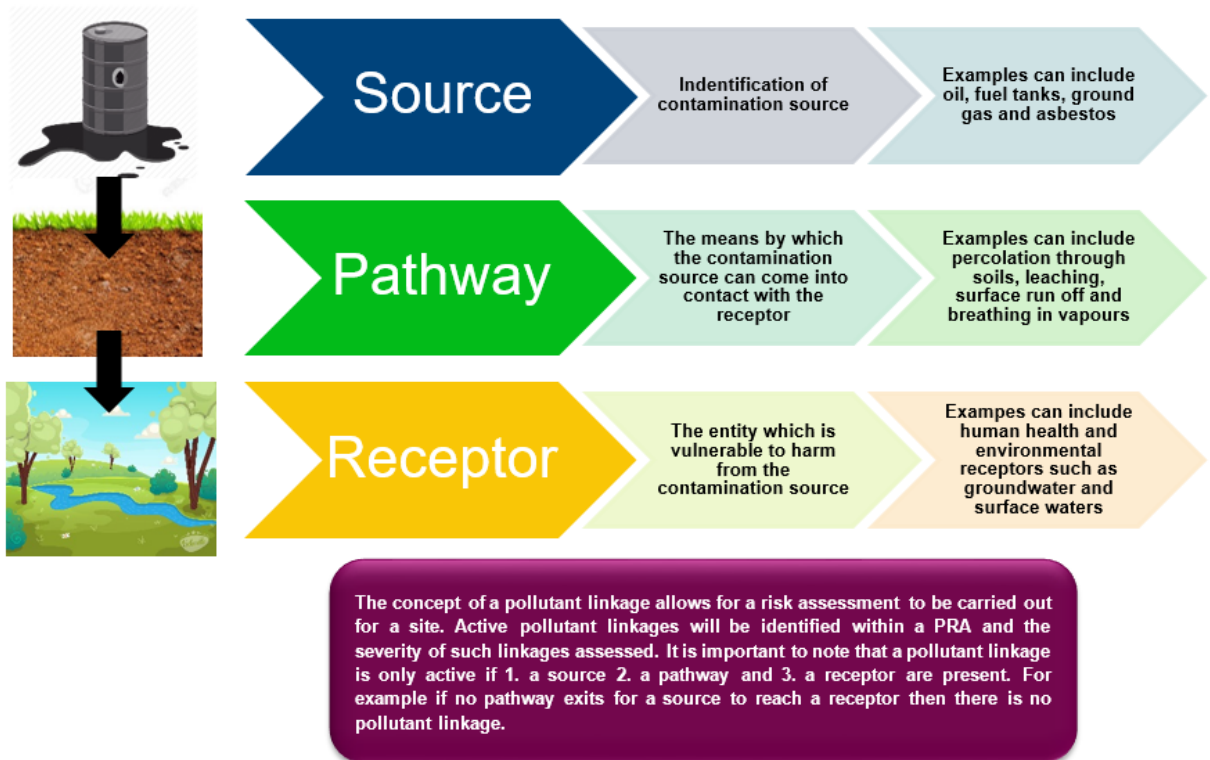
Figure 1-1 Pollutant Linkage Diagram

- **Source:** a contaminant or pollutant that is in, on or under the land and that has the potential to cause harm or pollution.
- **Pathway:** a route by which a receptor is or could be affected by a contaminant
- **Receptor:** something that could be adversely affected by a contaminant, for example a person, controlled waters, an organism, an ecosystem, or Part 2A receptors such as buildings, crops, or animals

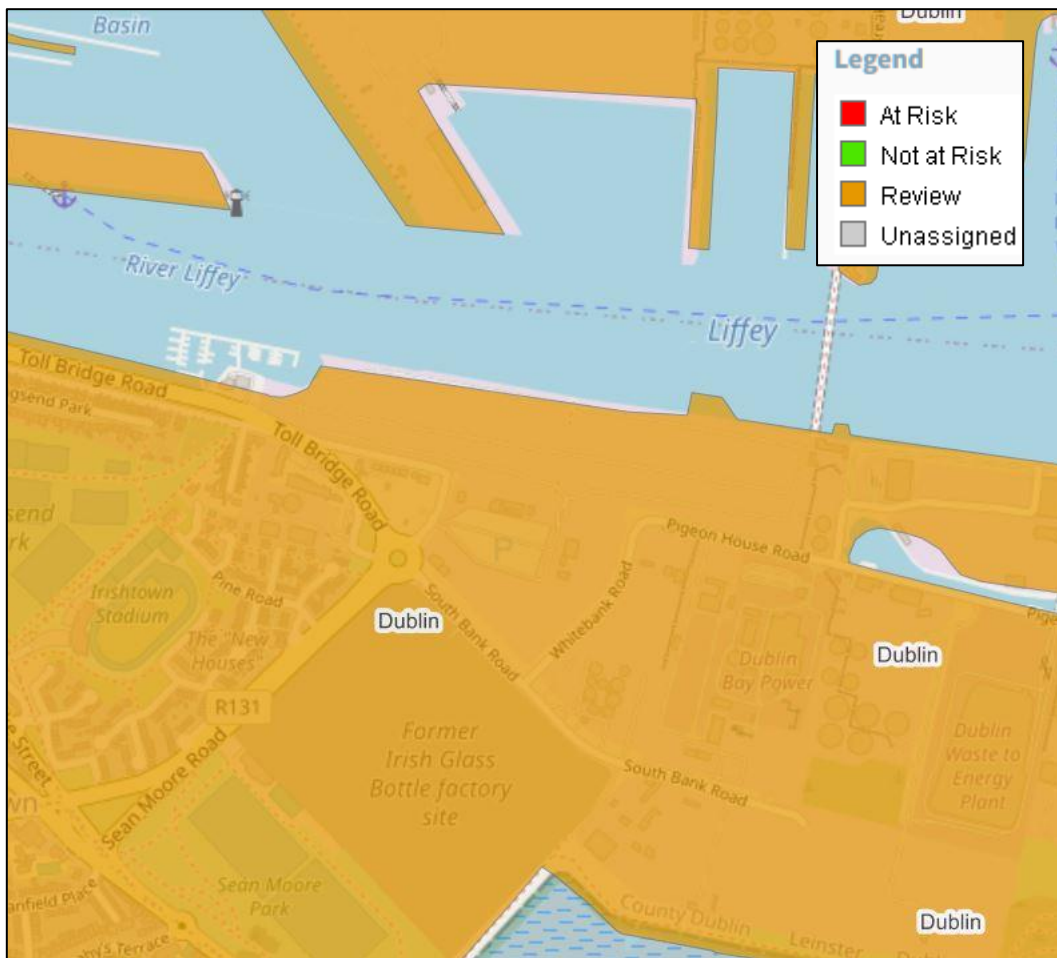
Figure 4-6 Water Framework Directive risk status (taken from EPA maps)

Groundwater Risk looks at the current water quality and trends and is used to highlight waterbodies that are at risk of deteriorating or being at less than Good status in the future. As seen in Figure 4.6, the site is categorised as being under review.

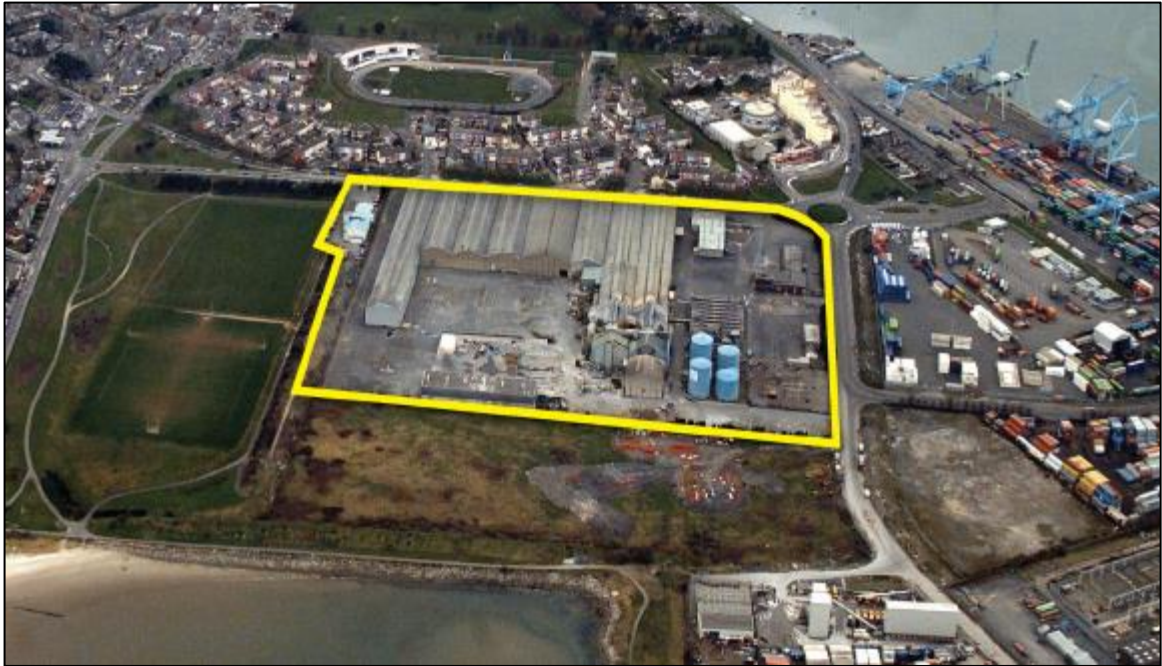
**Figure 5-2 Aerial Photograph of the Irish Glass Bottle Site prior to remediation**

The Closure, Restoration and Aftercare Management Plan for the IGB site documented the site conditions and mapped the path to clean closure of the site. Extensive environmental monitoring and validation was carried out throughout each phase. The validation sampling process demonstrated that no potential residual impacts of the IGB operations remained at the site. This sampling formed part of the Site-Specific Quantitative Risk Assessment. Validation sampling carried out throughout the remediation works ensured all remnants of the IGB operations had been removed, the quality of the material underlying the landfill was determined; and the protection measures utilised were validated.

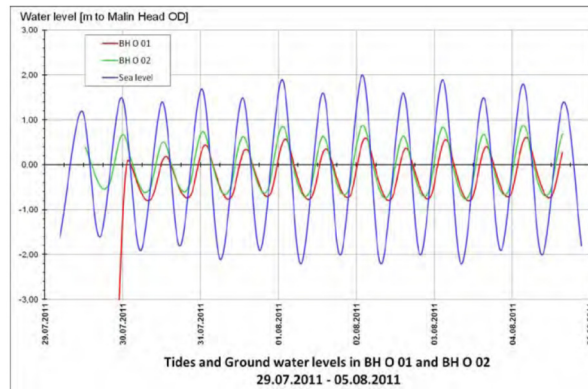
Figure 16.3: Sea level and ground water levels - BH O 01 and BH O 02

Figure 4 Extract from the Ringsend WWTP Extension EIS illustrating the link between tidal movements and groundwater levels

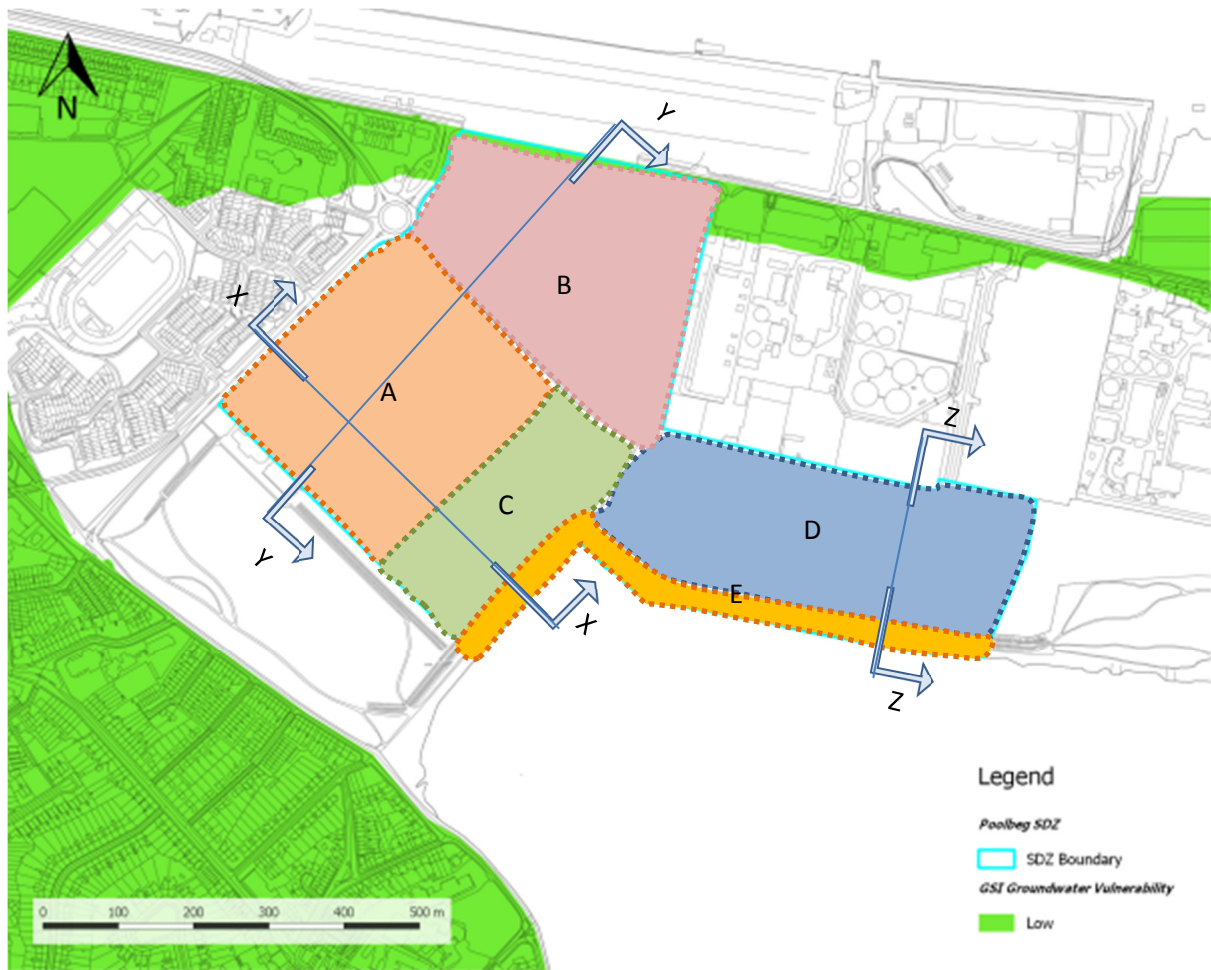
Figure 5 Characterisation Areas used for study

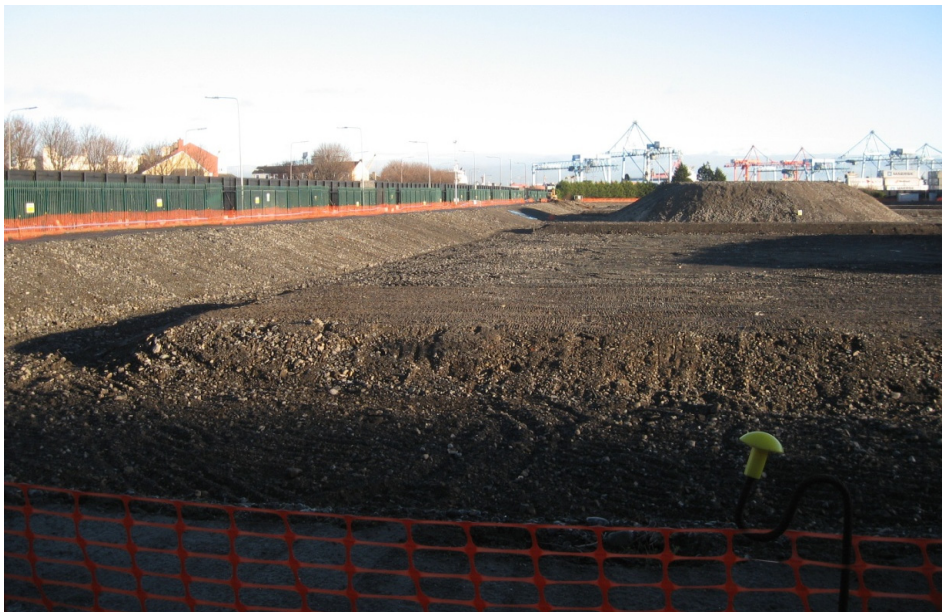
The sides of the berm incline at a slope of 1:2.5 into the excavation and are capped with a cover of 300 mm of crushed site won material. The material within the berm is similar to the material removed from elsewhere within the site during excavation, and consists of residual legacy landfill material.

Photograph 2: site condition showing the perimeter berm

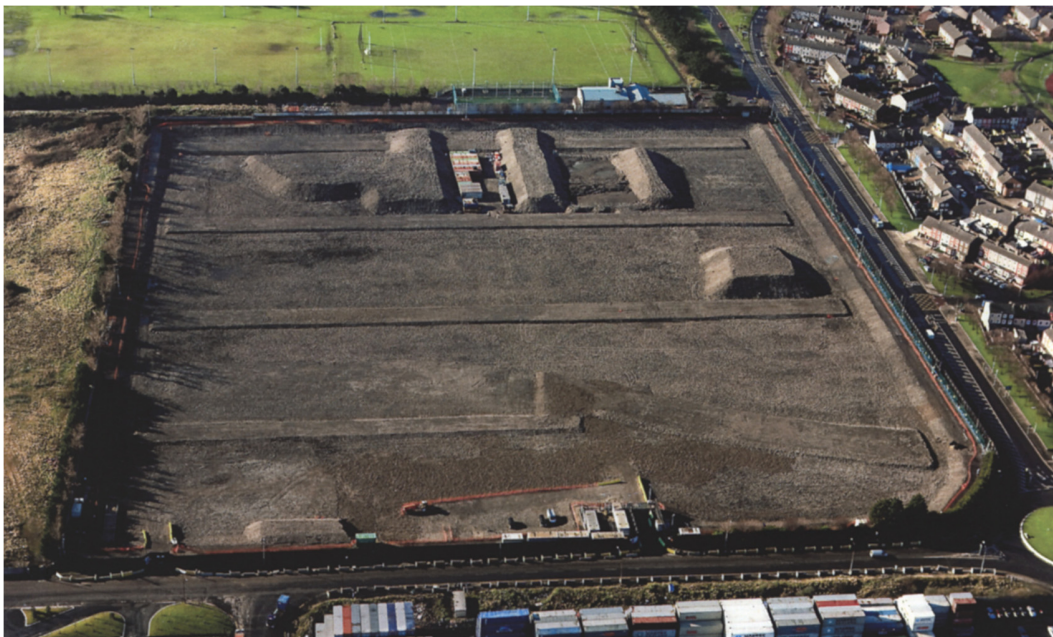
A number of stockpiles of site won crushed material, produced during the demolition works remain on site for future use in site development. It was intended that this material will be re-used on site, and would not be removed from site.

Photograph 3: Aerial photograph indicating the road footprints and stockpiles present

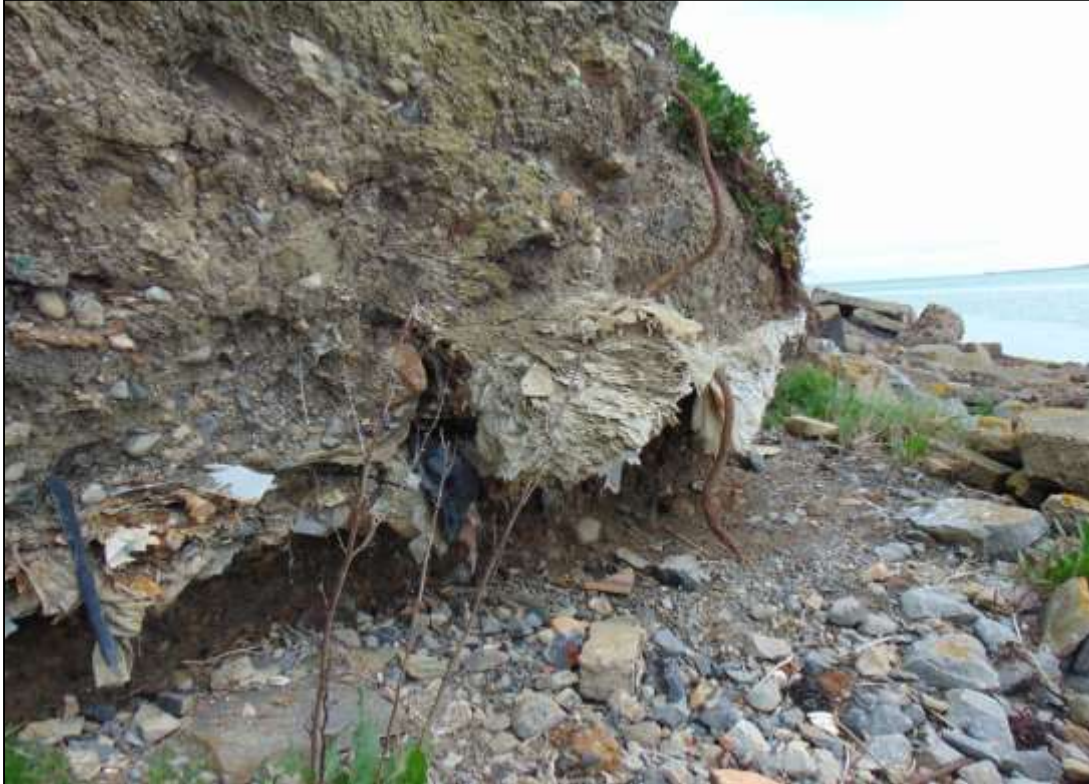
The area of visible coastal erosion where waste has been exposed stretches approximately 200m along the south facing edge of landfill. The types of waste encountered within the exposed clay embankment included fragments of residual domestic and C&D waste (steel bars, plastic sheeting, glass bottles, steel sheeting & mesh, fabric, steel piping, plastic containers, rubber tubing, tin cans, etc.), see Plate 2.1. No obvious signs of hazardous waste were observed during the walkover; however, asbestos could to be present in the waste body given the visible evidence of industrial and domestic waste encountered, the majority of which was reportedly sourced from the redevelopment of Wood Quay during the 1970s.

**Plate 2-1: Waste exposure and signs of undercutting due to wave action**

The rock armour and concrete groins appear to have slumped, and waste is exposed in the bank up to 4.5m above the top of the rock armoury.

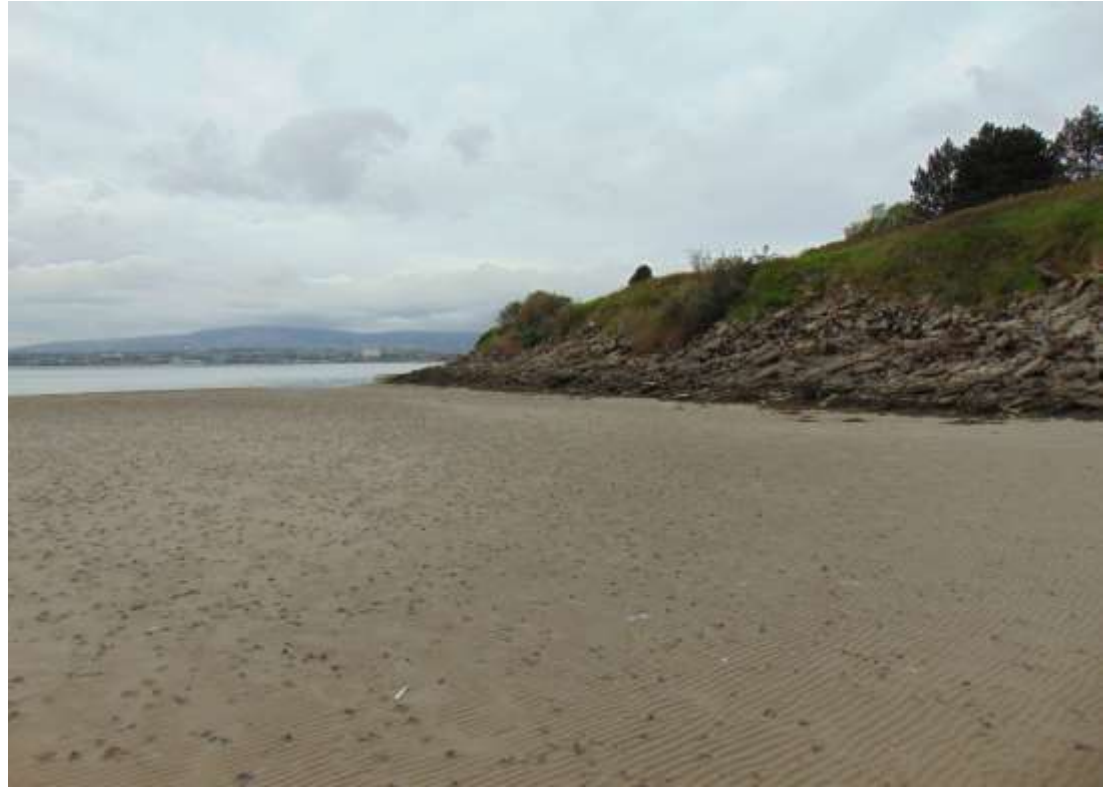
View from Shelley Banks beach at low tide showing rock armour perimeter and mature vegetation on top of landfill.

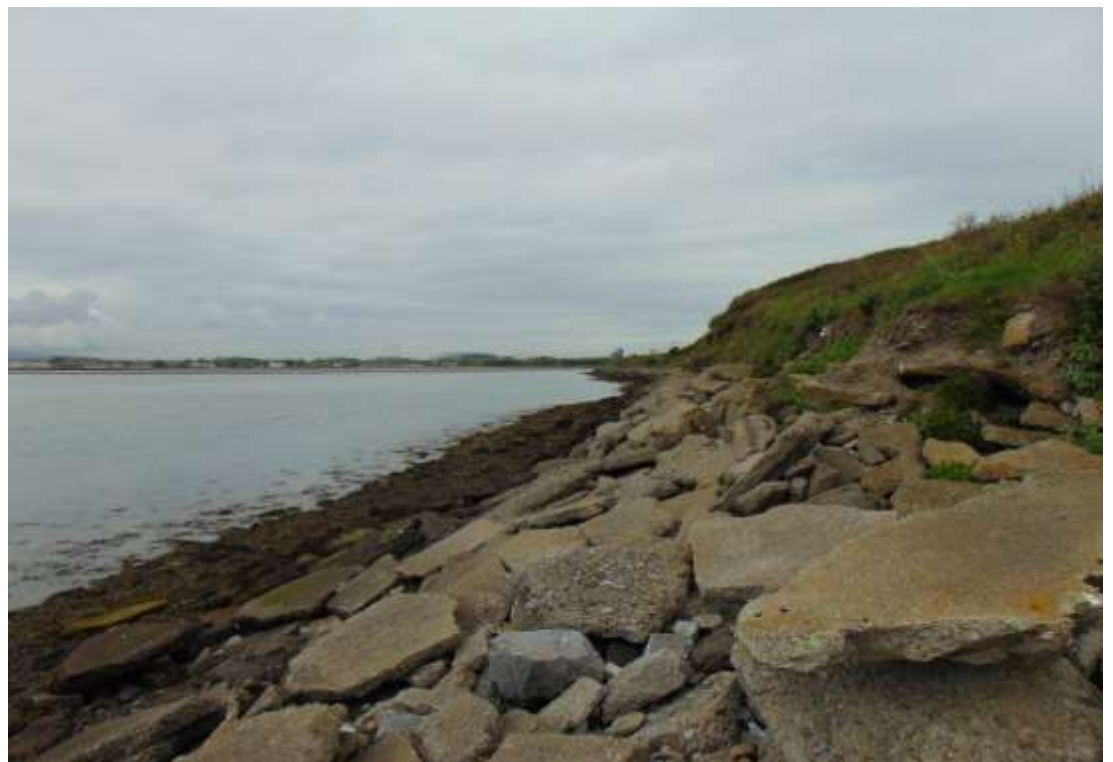
View looking west along the southern perimeter of the landfill where exposed waste and disturbed rock armour have been discovered.

The site walkover noted evidence of recent erosion and exposure of the waste body along the southern perimeter of the site. During the site walkover it was found that substantial stretches of the clay walls of the former landfill have been eroded, leaving the waste body exposed to the intertidal movements of South Dublin Bay.

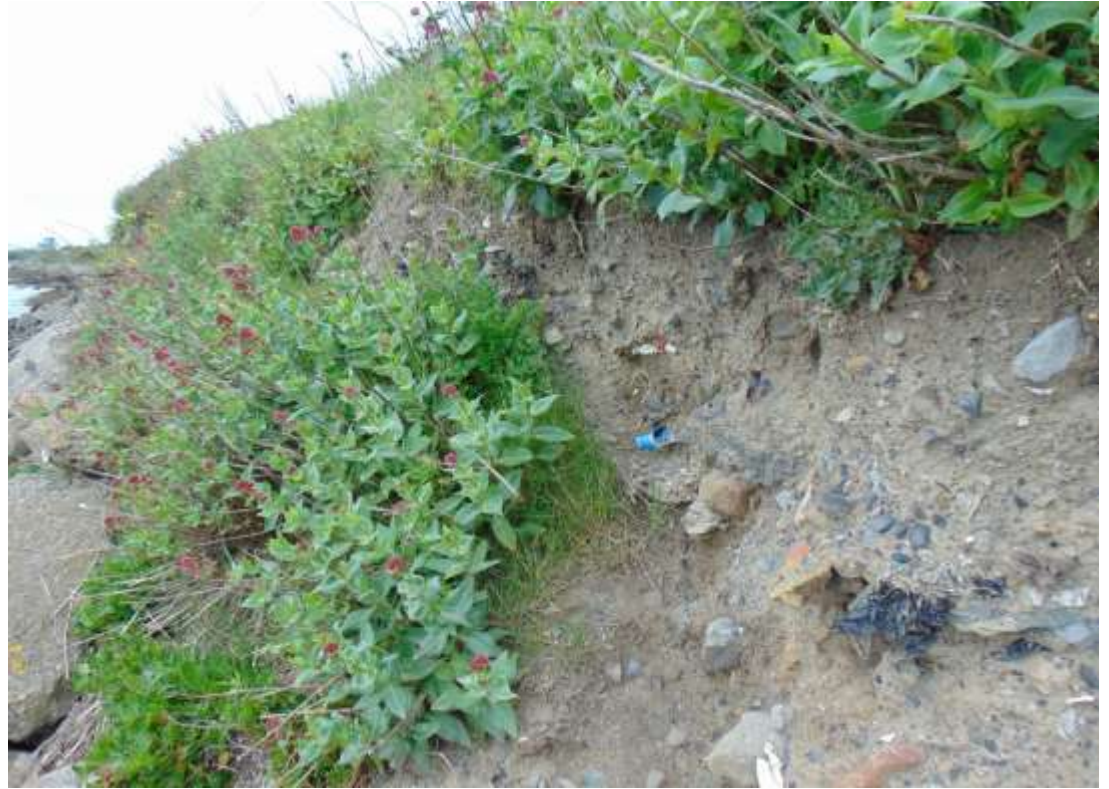
View showing the evidence of recent erosion and exposure of the waste body where clay walls of the former landfill have been eroded.

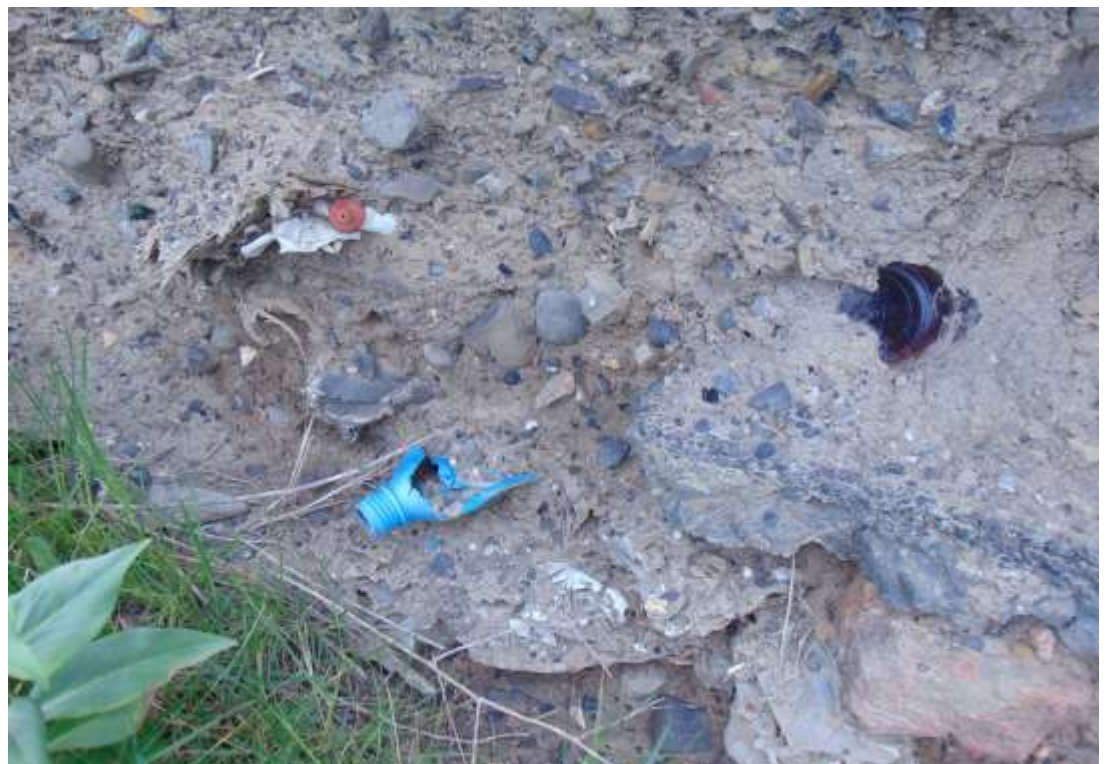
View showing forms of waste encountered on the site included fragments of residual domestic and C&D waste (steel bars, plastic sheeting, glass bottles, steel sheeting & mesh, fabric, steel piping, plastic containers, rubber tubing, tin cans, etc.).

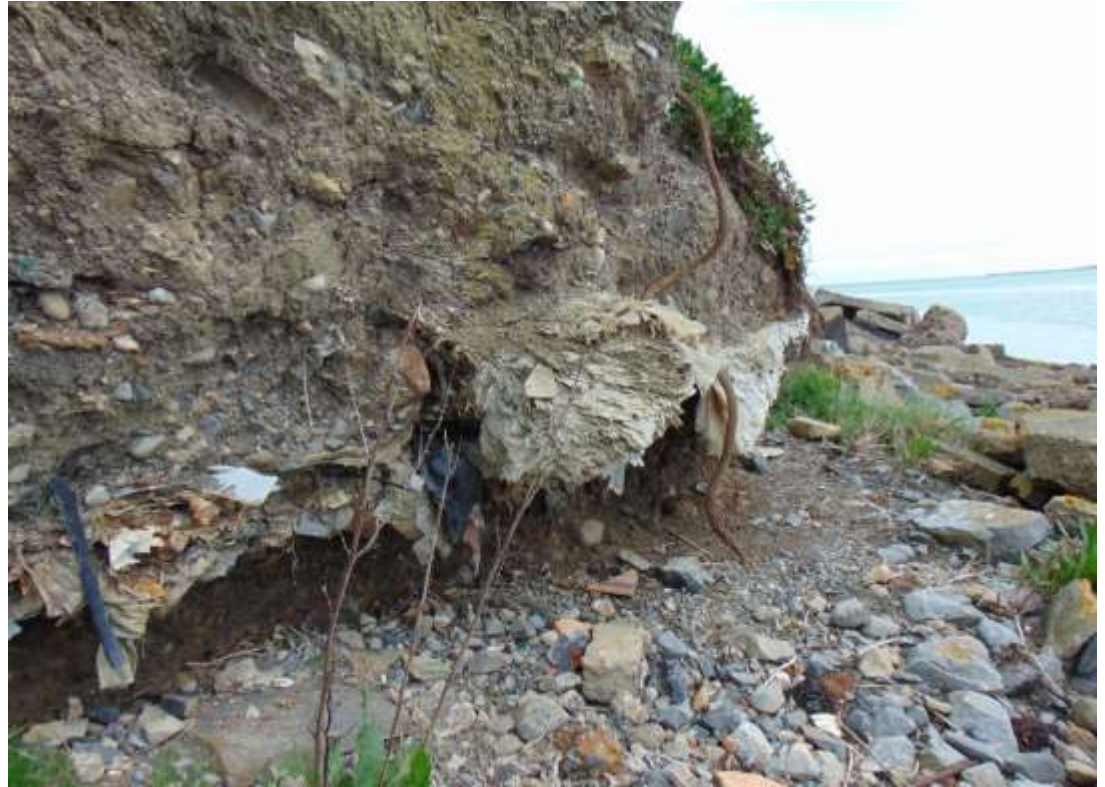
View showing evidence of wave-cutting the landfill bank.

Forms of waste encountered on the site included fragments of residual domestic and C&D waste (steel bars, plastic sheeting, glass bottles, steel sheeting & mesh, fabric, steel piping, plastic containers, rubber tubing, tin cans, etc.).

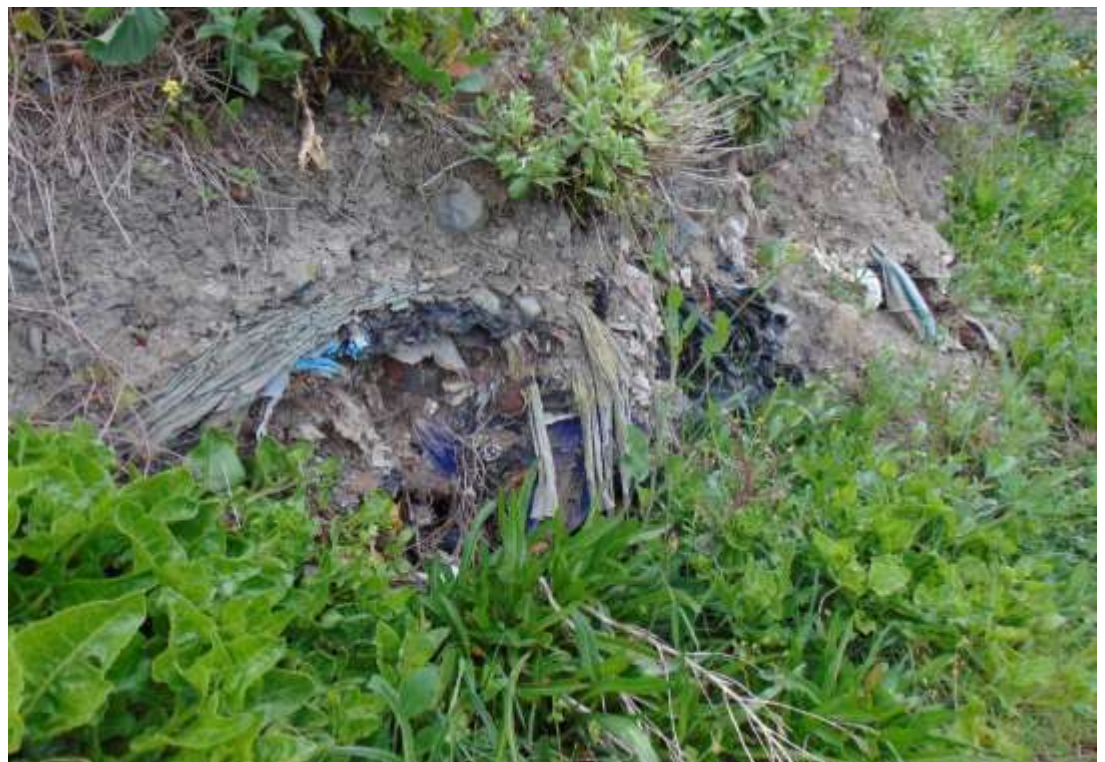
View showing forms of waste encountered on the site included fragments of residual domestic and C&D waste (steel bars, plastic sheeting, glass bottles, steel sheeting & mesh, fabric, steel piping, plastic containers, rubber tubing, tin cans, etc.).

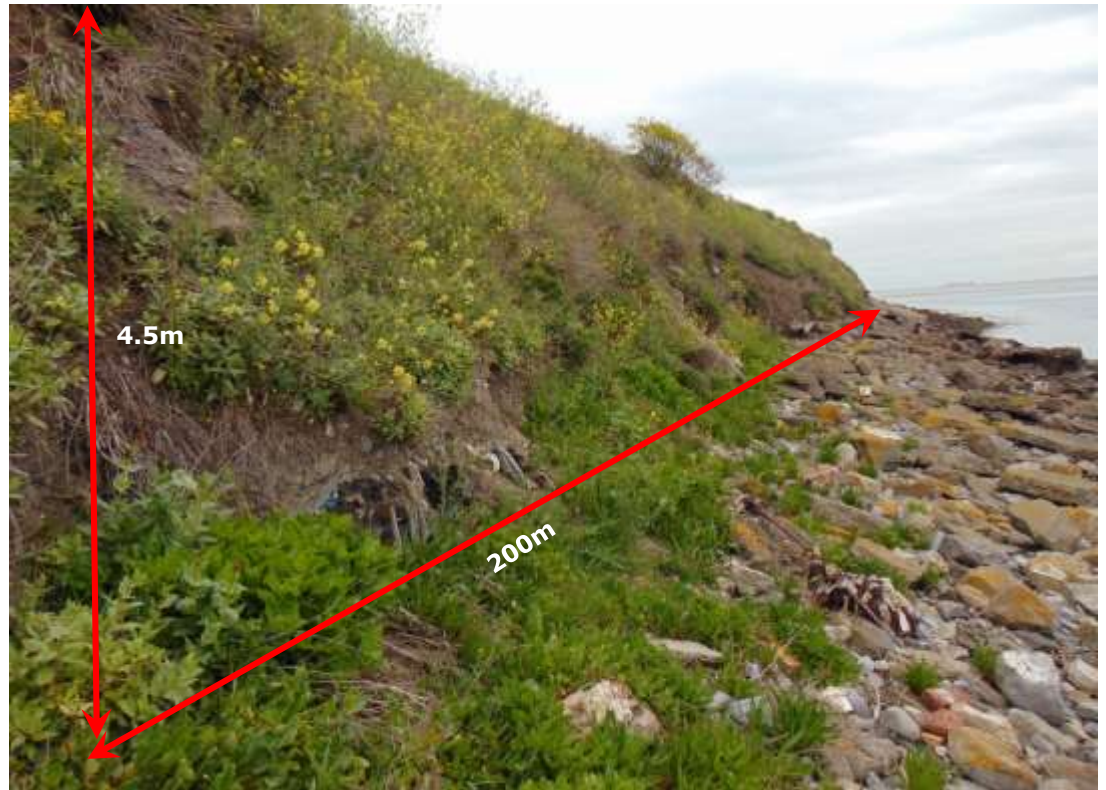
**Description:**  
View east showing the area of visible coastal erosion where waste has been exposed stretches approximately 200m along the south facing edge of landfill.

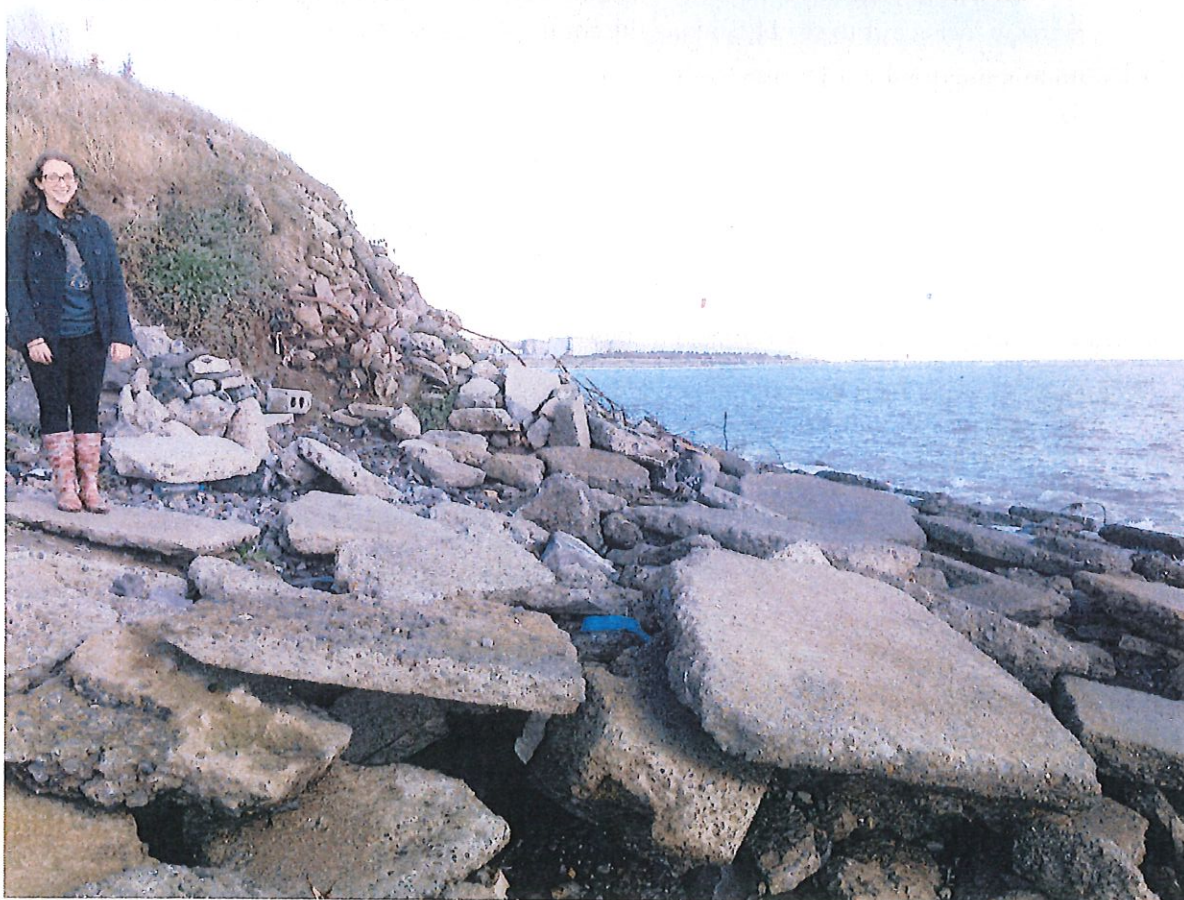
During a shore visit one hour after spring high tide on Tuesday 27<sup>th</sup> October, Coastwatch surveyors observed almost calm sea water reaching well into the base of the erosion control material. This further supported the view that on a full spring tide or during a swell with wave action the sea could easily extend above the armour and cause the erosion.

Additionally, it was noted that the armour was quite unsteady in this area, with a large number of slabs and rocks shifting as surveyors walked on them. With an unstable rock armour, high tides, and waves, it is very likely that the exposed dump area will continue to grow in size.

*Image 3: High water line reaches well into the hard erosion control material of Ringsend landfill.*

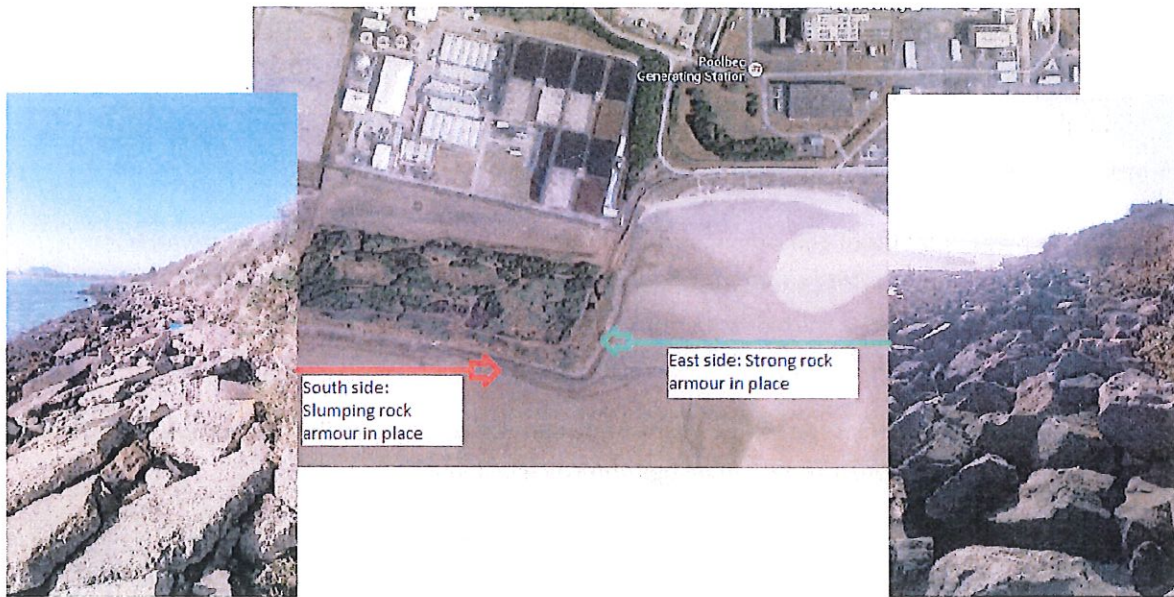
The photographs below (Images 4A, 4B, and 4C) show the differences in the type of protective material and in the rock armour angle on the south-facing coast where the waste exposure has occurred, compared to the east side of the dump adjacent to Shellybanks beach.

The damaged south-facing perimeter is made of demolition waste concrete slabs with some rock. It appears to have slumped so it doesn't reach high enough anymore. The east-facing perimeter defence is made of rock armour. Some slumping may have occurred here too, but this isn't obvious and would need to be confirmed by reference to the original design angle.

*Image 4A, 4B, and 4C: Showing the comparison of rock armour on both the East and South side of the Ringsend site. (Source: Google maps)*

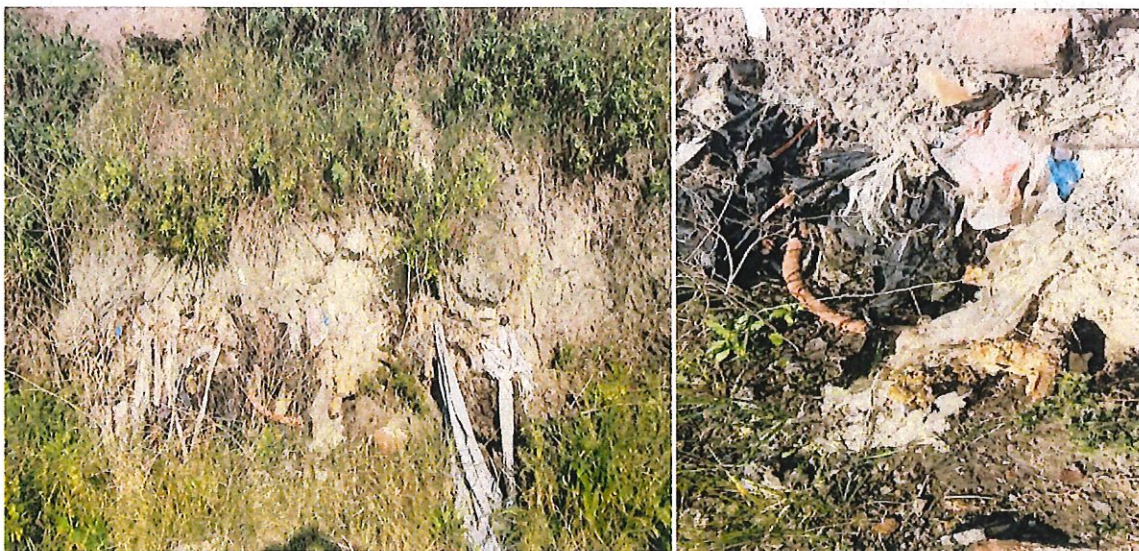
The type of waste exposed included cloth, plastic sheeting, tin cans, rubber tubing, and various types of metal and glass bottles. No obvious signs of hazardous waste were observed at the time of the walk over.

*Image 5A and 5B : Showing the largest exposure of waste occurring at the base of the Ringsend landfill.*

The photos above (Images 5A and 5B) show that the sea is pulling out material, which then becomes marine litter. Currently, some of the dislodged waste remains at the base of the Ringsend landfill; how much waste gets washed out to the sea is unclear.

The type of waste observed includes construction and demolition, metal, plastics, textiles, rubber tubing, along with possibly domestic or commercial waste such as tin cans, glass bottles. No obvious signs of hazardous waste were observed at the time of the walk over.

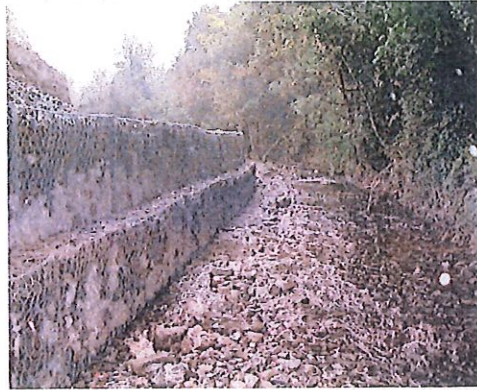
*Image 7: Showing an example of woven mesh gabions constructed along a riverbank. (Source: [www.geo-coastal.ie](http://www.geo-coastal.ie))*

- Low cost emergency works to avoid further waste exposure and possible sealing of the damaged areas prior to winter storms. Gabions (See Image 7) which are removable and can be filled with citizen participation may suit on the wave cut platform above the rocks/cement slabs.

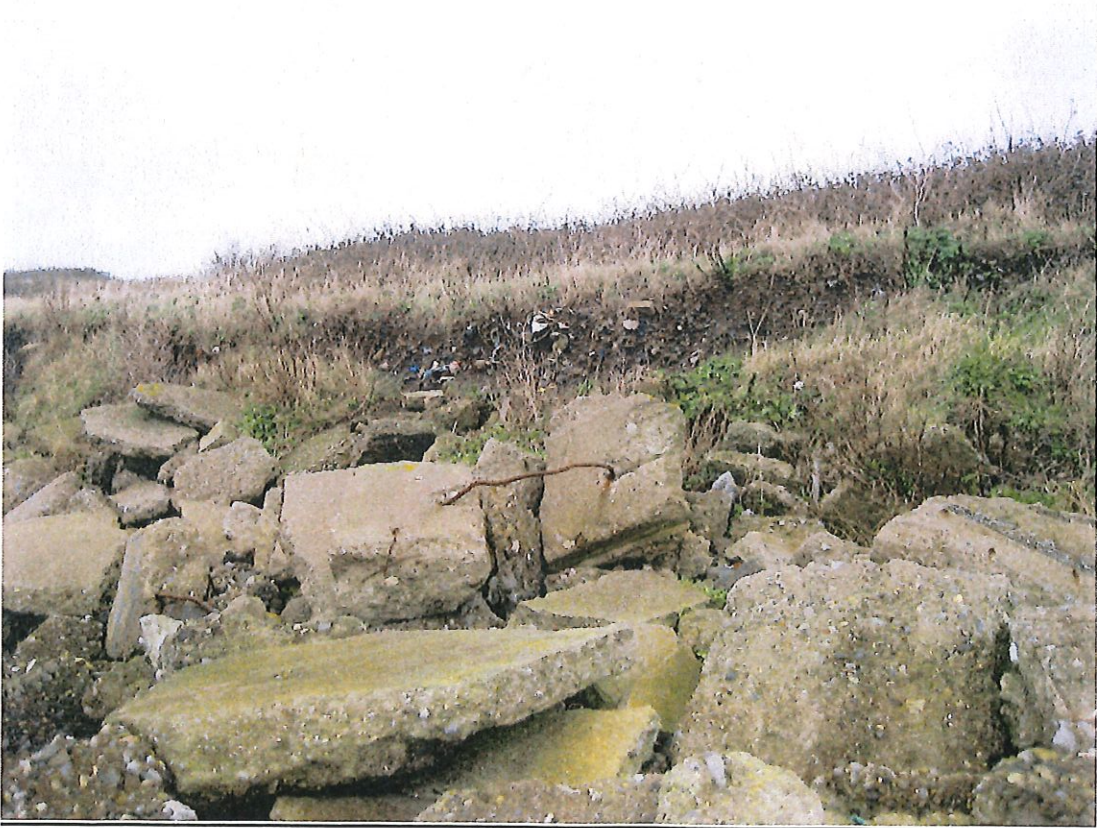
**Photograph 4: Waste Exposed at Southern Face of Landfill**

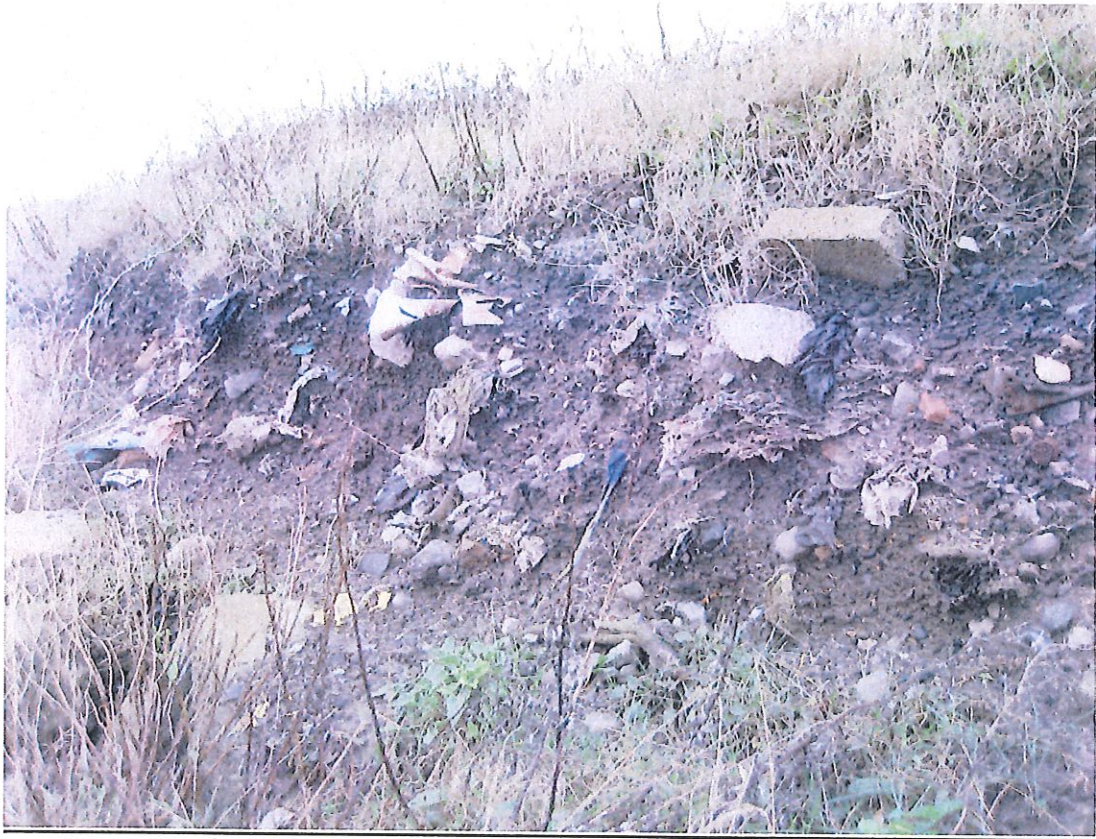
**Photograph 7: Waste Exposed along Southern Face of landfill**

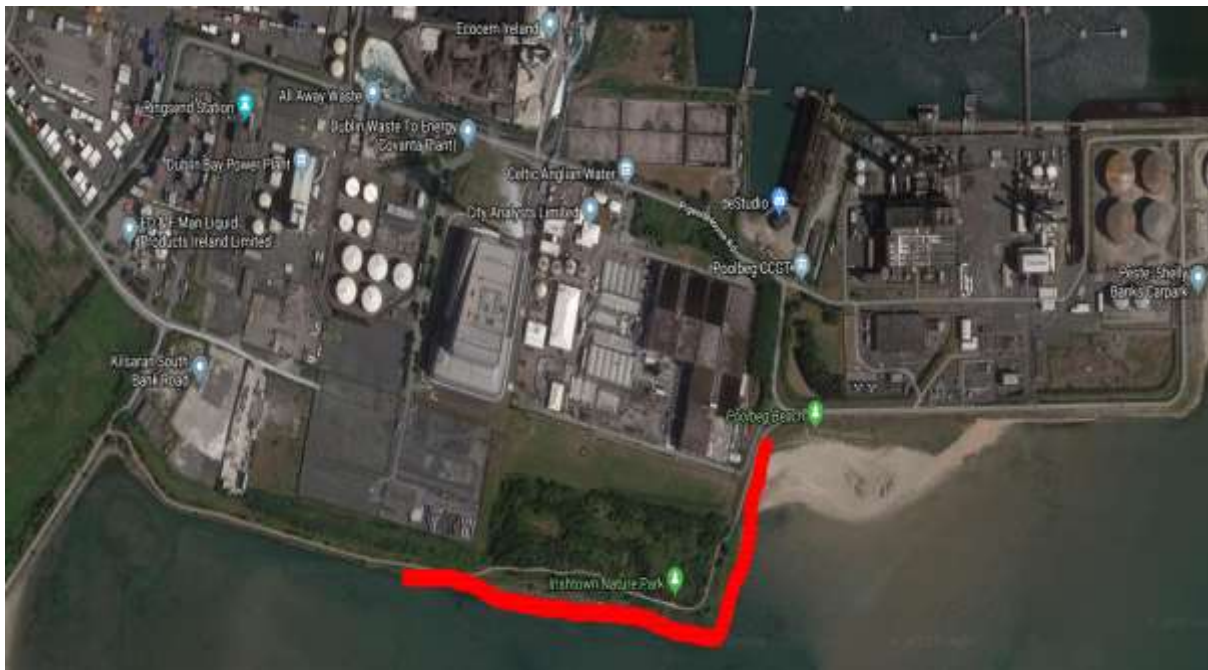
Red line denotes area of visible waste

During the site walkover it was found that significant stretches of the clay walls of the former landfill have been eroded, leaving the waste body exposed to the sea along the southern and eastern site boundaries. Approximately 400m of the face of the former landfill was found to be exposed. The forms of waste encountered on the site included residual domestic and C&D waste, with identifiable waste fragments were found to be consistent with the reported closure date of 1978. Asbestos was not encountered during the site walkover but is likely to be present in the waste body given the visible contents encountered. Staining was frequent along the exposed sections of the waste body.
