Environmental Impact Assessment Report

Appendix 16.2

Dublin Port 3FM Archaeo-geophysical survey report

October & November 2022

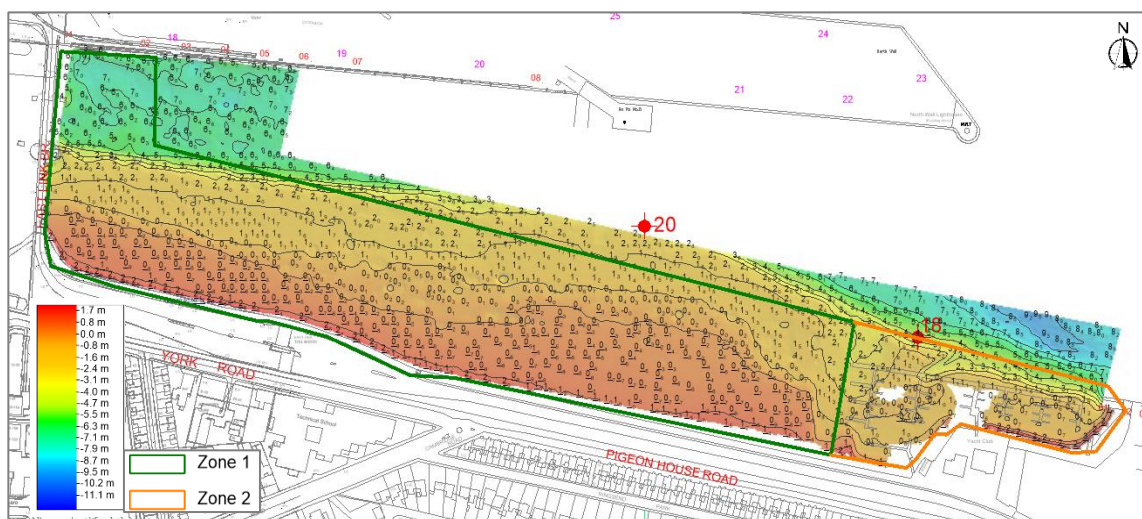
Figure 3: Bathymetry for Zones 1 & 2

Water depths in Zone 1 range from drying 2.8 m to 7.0 m chart datum and from 3.0 m to 9.5 m chart datum in Zone 2, with the seabed gently sloping away from the quayside. See figure 3. *Detailed bathymetric chart in Appendix 1.*

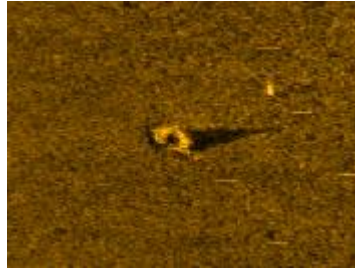
- Target 146: Boulder

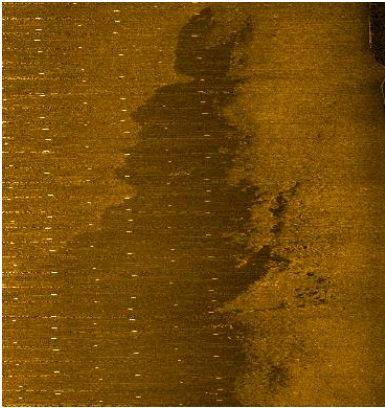
- Target 299: sand feature
